Case History

Experience with API Plan
53B

Pressurized Dual Seal
Systems

Roger Jones, Ken Savoie & Zhou DaLi

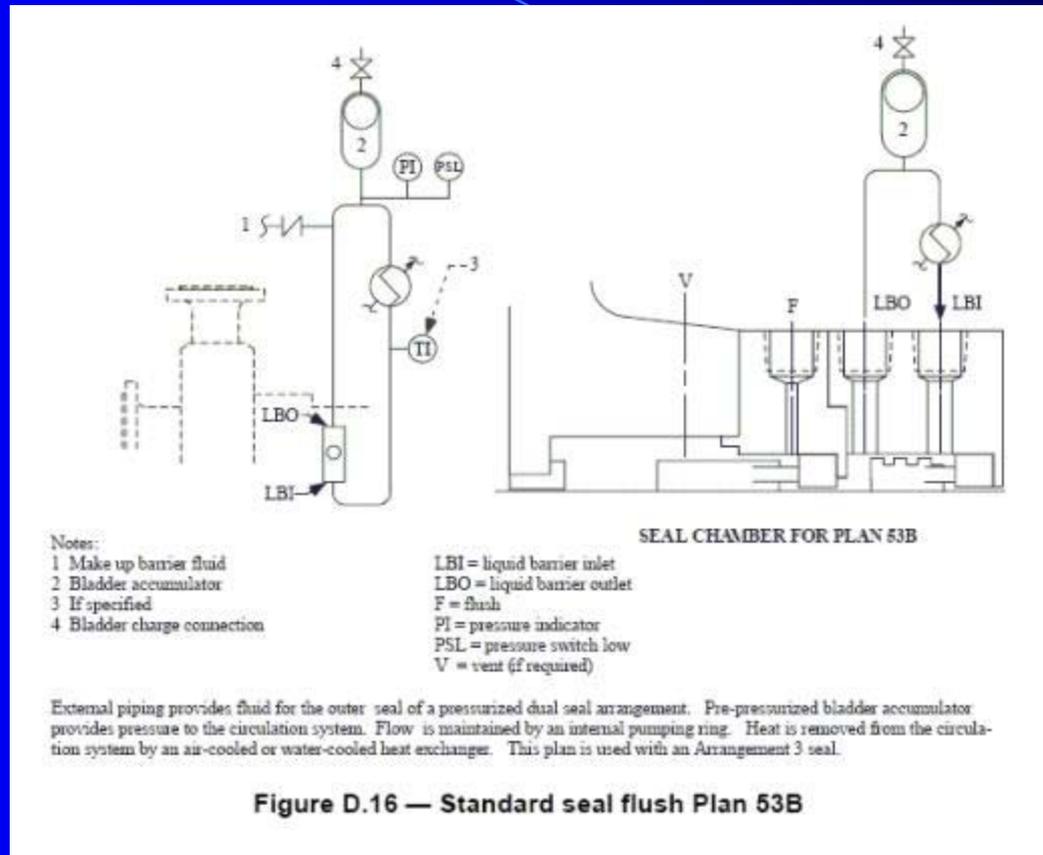
Figure D.16 — Standard seal flush Plan 53B

This API 682 Second Edition schematic is incomplete and it won't keep you out of trouble.

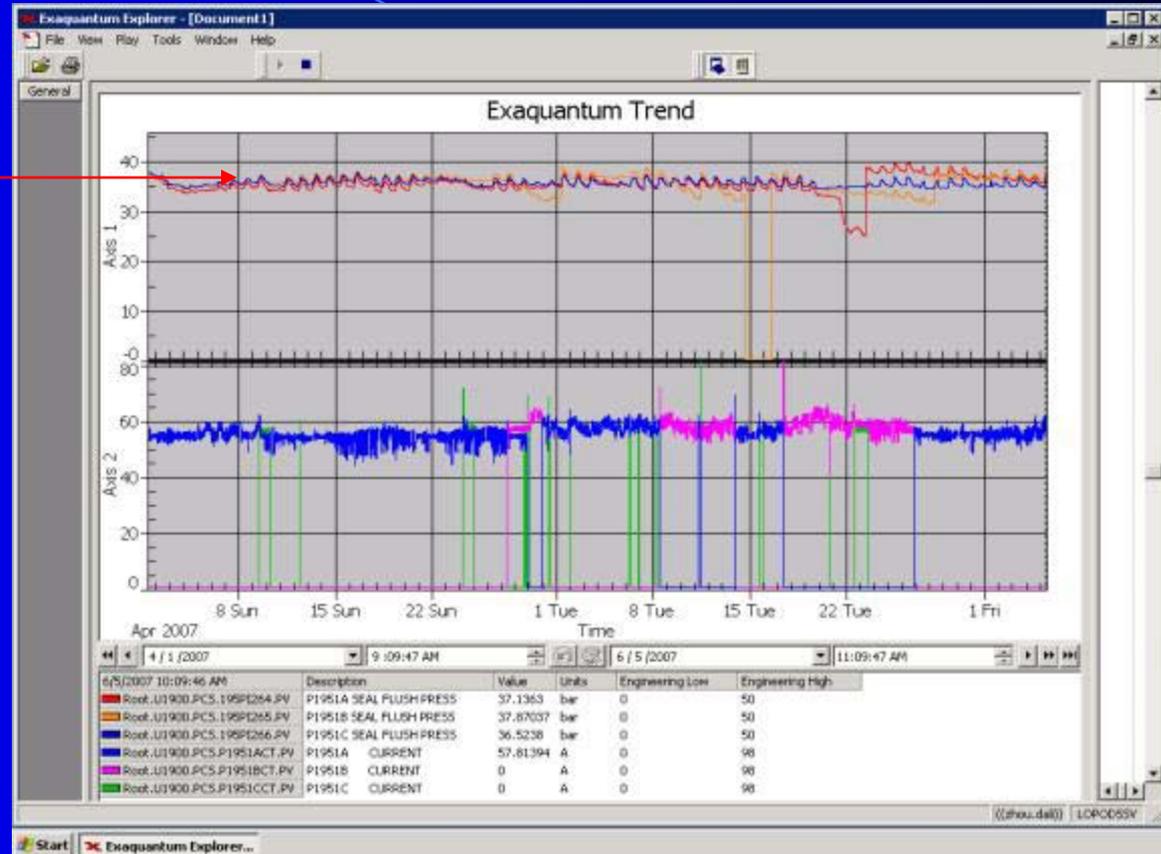
System Pressure Fluctuates

Daily fluctuations in pressure due to ambient temperature.

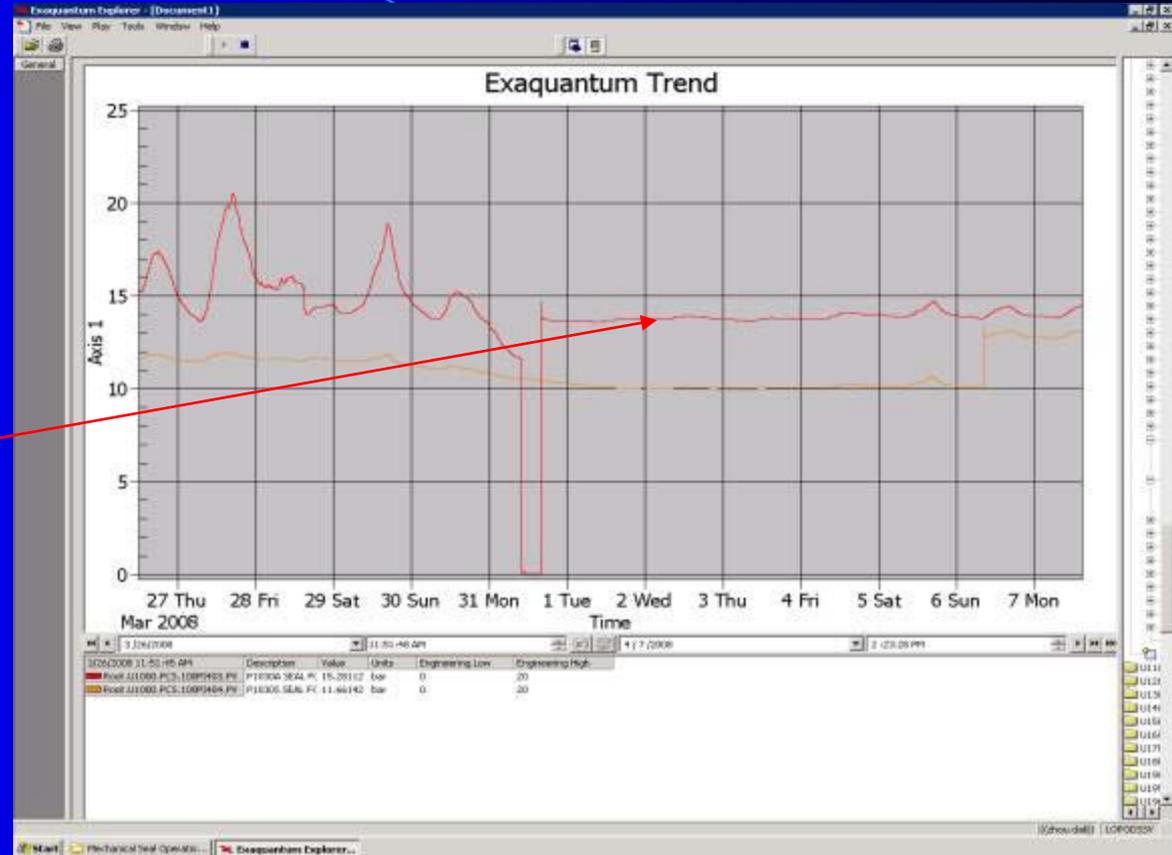
Bladder Charge Pressure Affects Pressure Fluctuations

Low bladder pressure makes for wider daily pressure fluctuations.

Pressure fluctuations reduced after recharging bladder.

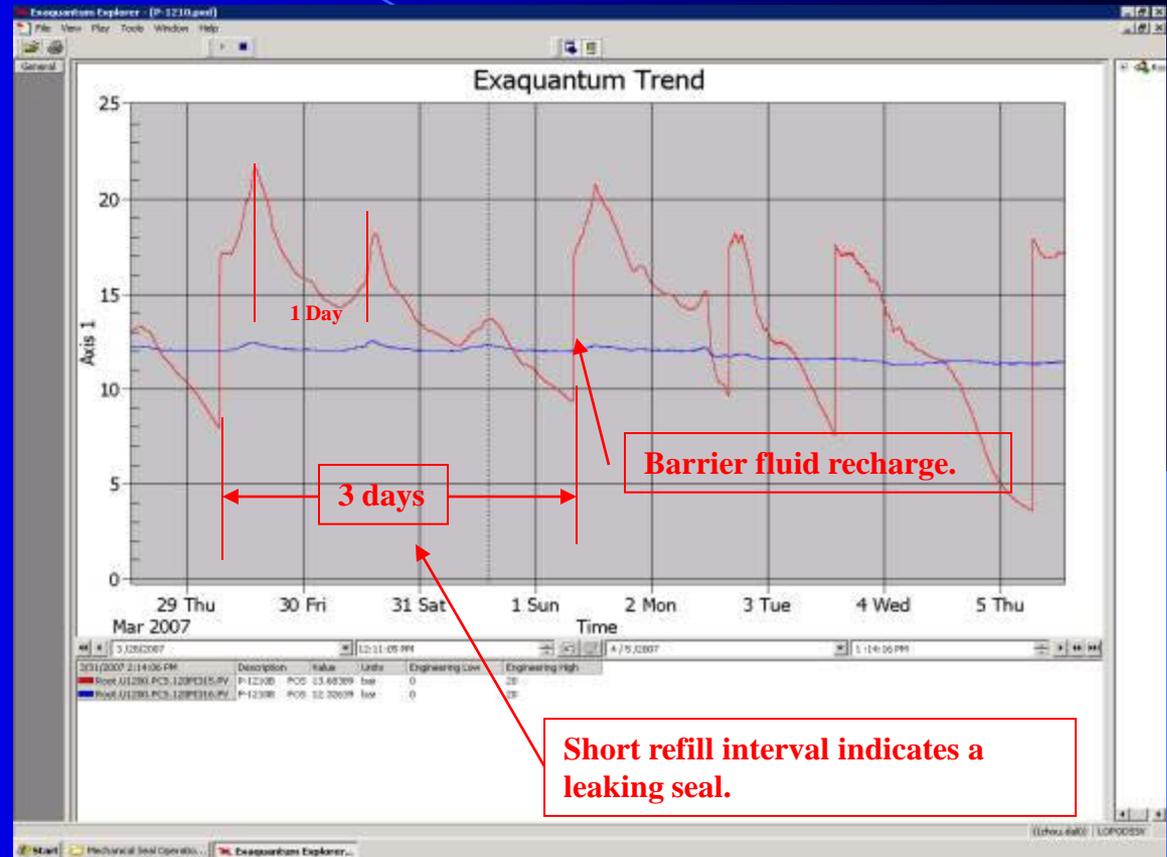
Bladder and Seal Failure

Between Bearings Pump with 2 seals

The barrier liquid system pressures fluctuate on the same daily period but one seal (red) fluctuates much more than the other (blue). This is clearly abnormal. Bladder (red line) was confirmed to have failed.

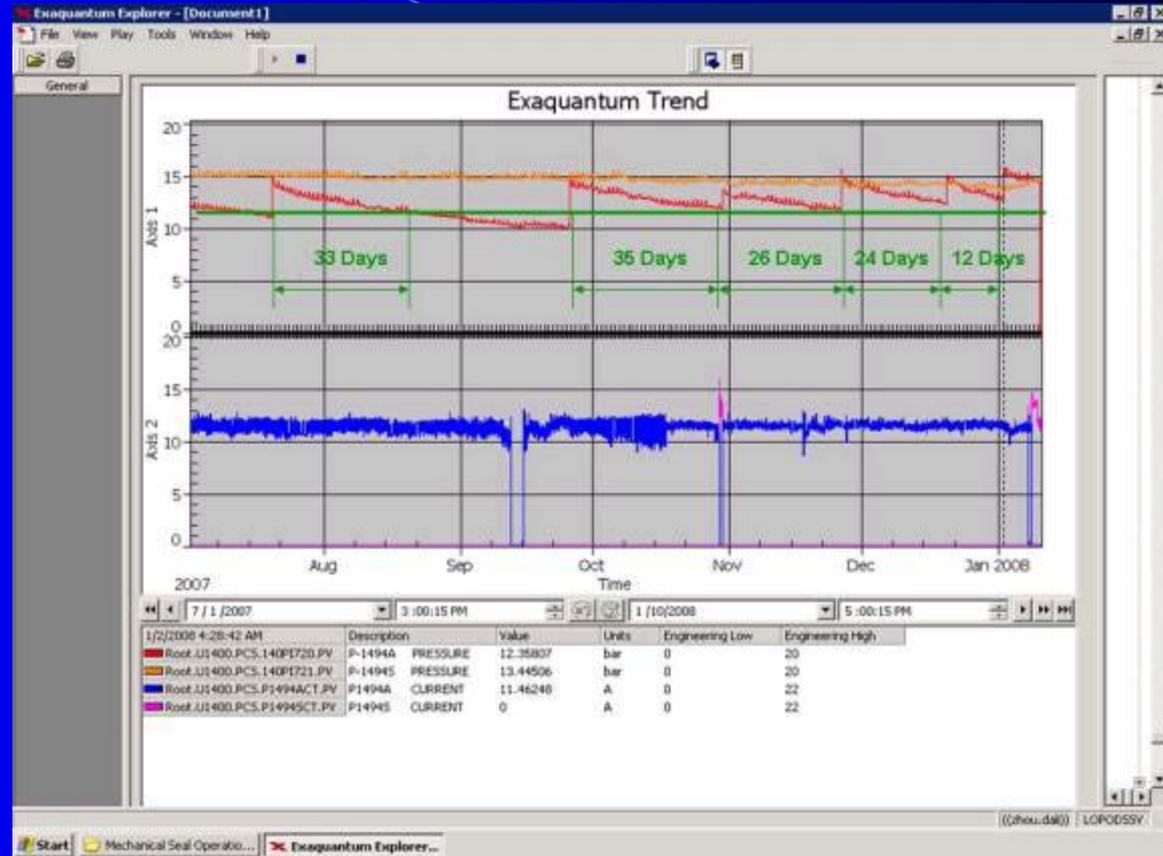
A typical rate of bladder pressure decline

When the system pressure reaches a preset limit the system must be refilled.

Declining refill interval is a sign of a deteriorating seal or other leak.

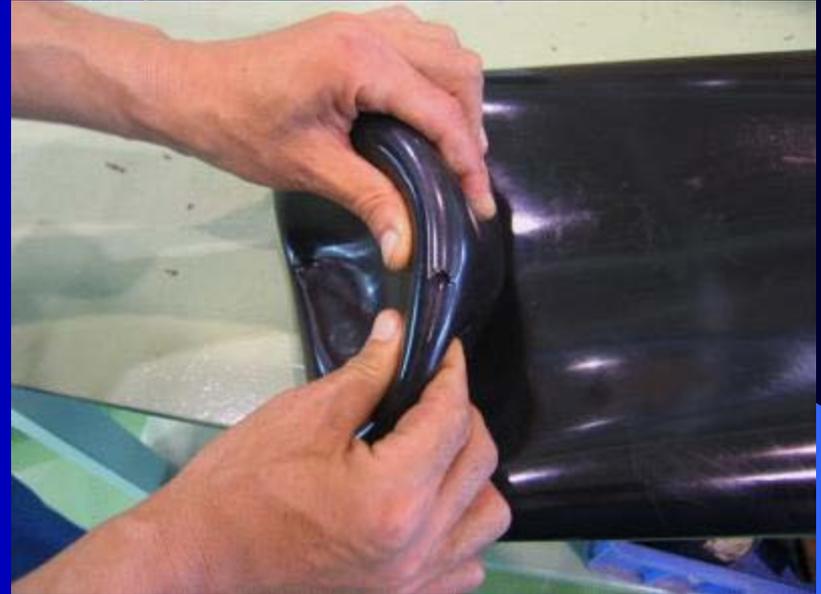
Bladder Failure

- Bladder damage can occur if the precharge pressure falls below 35% of the working pressure
- With low pressure the bladder flexes excessively as system pressure fluctuates
- This crack at the bladder rim suggests this cause of failure.
- One must shut the pump down and depressure the system to detect bladder failure
- If “apparent bladder pressure” goes to zero bladder has failed

Pay attention to compatibility of bladder material to barrier fluid. Chose barrier fluids that allow less expensive bladders.

Have spare bladders on hand. You will fail a few as you learn to operate this plan. Project had half a dozen failures.
