HIGH ENERGY ABRASIVE SERVICE PUMP UPGRADE

ABSTRACT

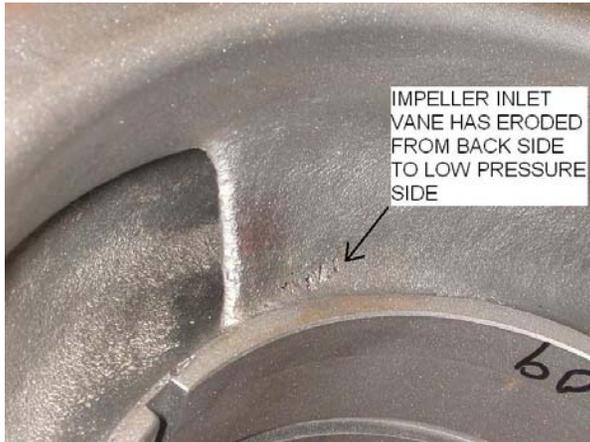
SUCTION RECIRCULATION DUE TO LOW FLOW OPERATION

- SUBTLE DESIGN CHANGES IMPLEMENTED TO COMPLIMENT COATING PROCESS
- CORROSION RESISTANT WELDED OVERLAYS APPLIED WHERE NECESSARY
- MINIMUM FLOW POINT RAISED TO REDUCE SUCTION RECIRCULATION CAVITATION DAMAGE AT STAGE 1 IMPELLER. MINIMUM FLOW CONTROLLED BY A 3 WAY CONTROL VALVE. ORIFICE ASSEMBLIES WITHIN THE VALVE WERE MODIFIED TO INCREASE FLOW WHEN IN BYPASS MODE (MINIMUM FLOW).

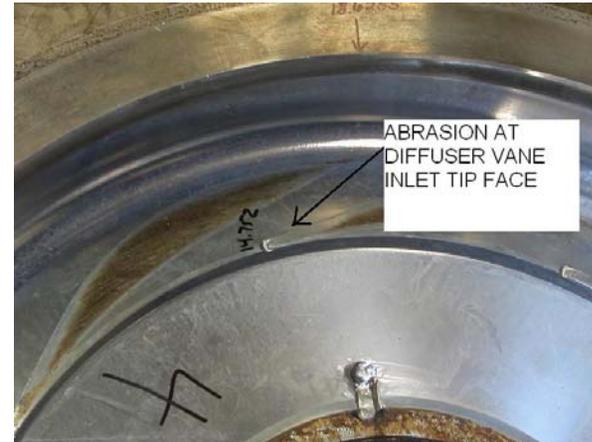
HIGH VELOCITY ABRASION AT DIFFUSER INLET

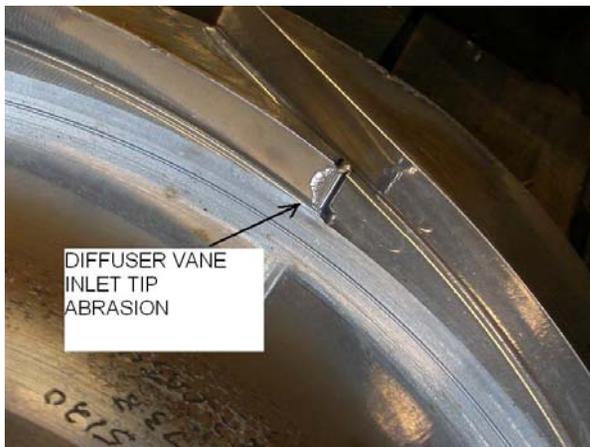
HIGH VELOCITY ABRASION AT DIFFUSER INLET

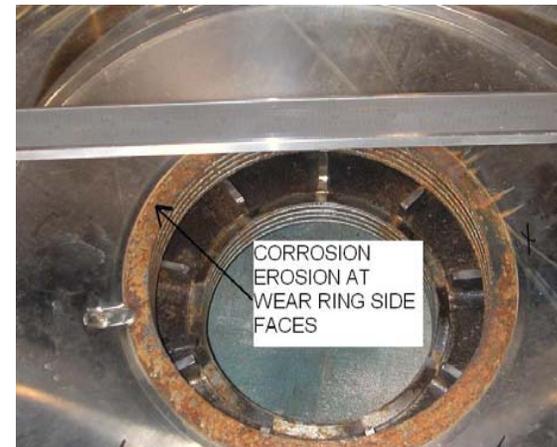
CORROSION EROSION AT SIDE FACES. SIGNIFICANT LOSS OF MATERIAL AT RUNNING SURFACES

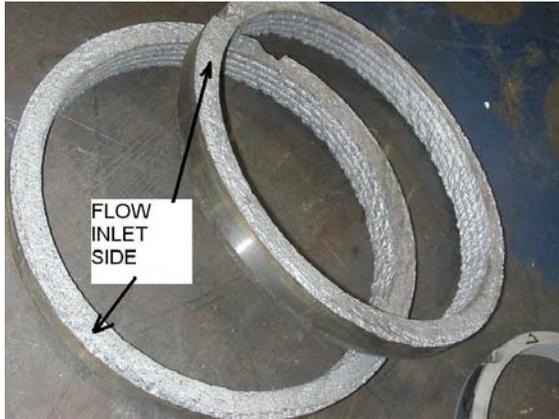
CORROSION EROSION AT SIDE FACES.
SIGNIFICANT LOSS OF MATERIAL AT
RUNNING SURFACES

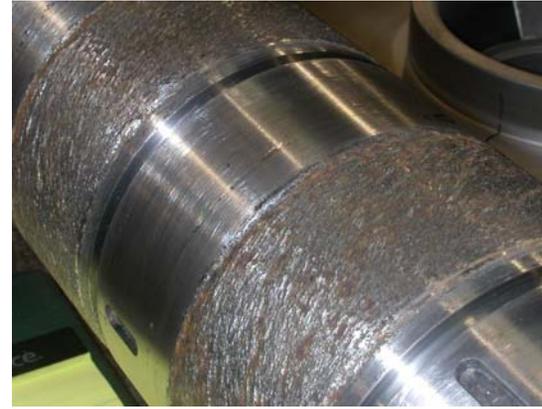
SEVERE EROSION OF SHAFT AT IMPELLER
WATERWAYS

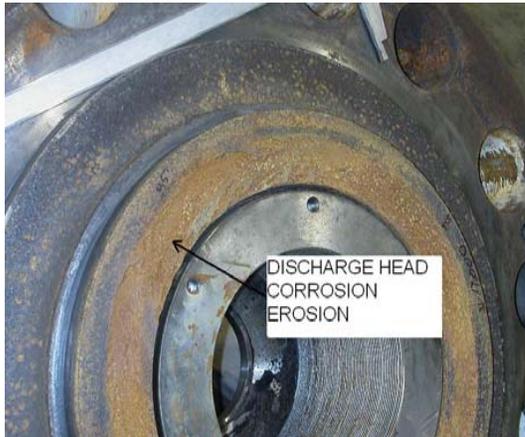
CORROSION EROSION OF CARBON STEEL
DISCHARGE HEAD.

- HEAD OVERLAID WITH AUSTENITIC MATERIAL AND ADDITIONALLY COATED USING HIGH VELOCITY OXY FUEL PROCESSES
- HIGH PRESSURE BUSHINGS COATED USING HIGH VELOCITY OXY FUEL PROCESS

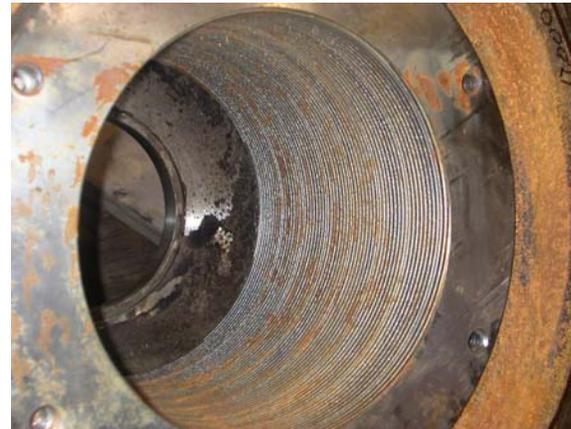
SIGNIFICANT LOSS OF MATERIAL AT
RUNNING SURFACES

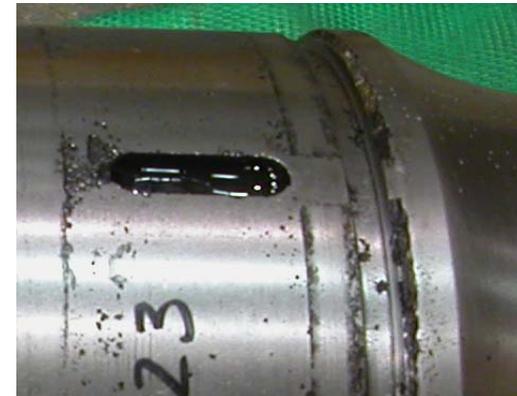
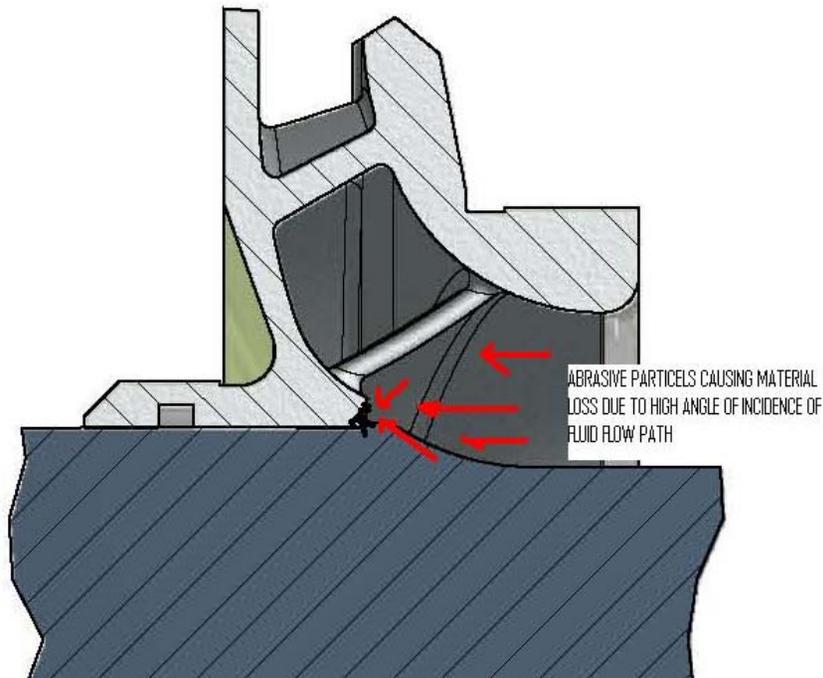
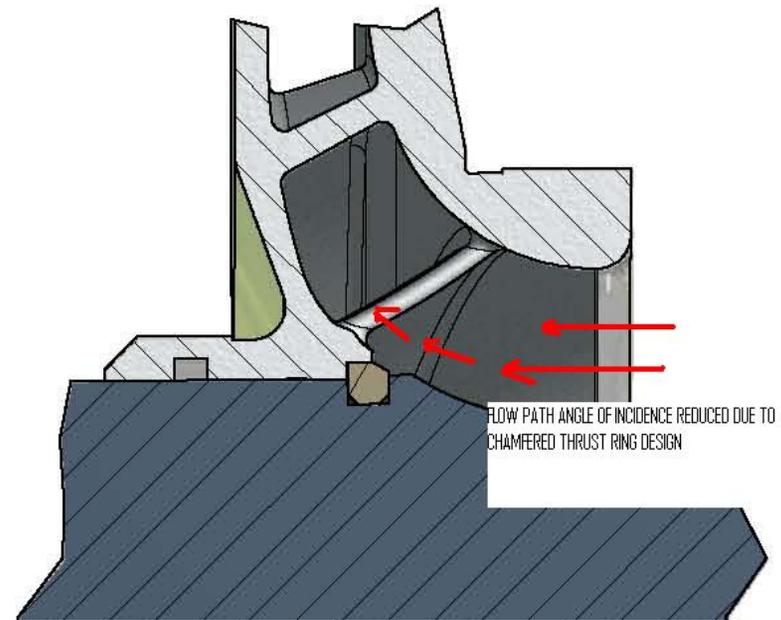
STAGE 1 SHAFT DAMAGE

- PUMP SHOWED EXCESSIVE DAMAGE AT ABUTMENT SHOULDER OF STAGE 1 IMPELLER. PROFILED THRUST RING ADDED

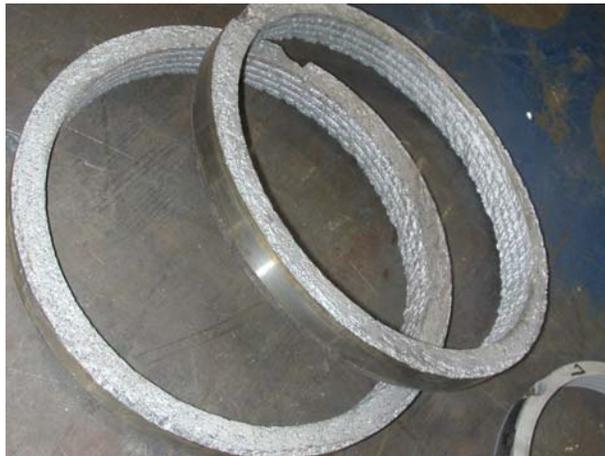
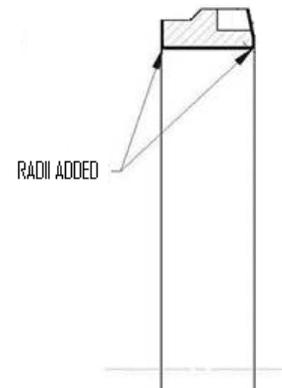
WEAR RING MODIFICATIONS

- FINE GROOVES ON WEAR RINGS INCREASE EFFICIENCY BY INDUCING TURBULENCE THAT RESTRICTS BUSH FLOW. THIS TURBULENCE CREATES ADDITIONAL UNWANTED ABRASION
- GROOVES ARE TYPICALLY DESTABILIZING TO PUMP ROTOR
