Improving Reliability Of Canned Motor Pumps in Refrigeration Service

King J. Molder

S. Dennis Fegan

24th International Pump Users Symposium

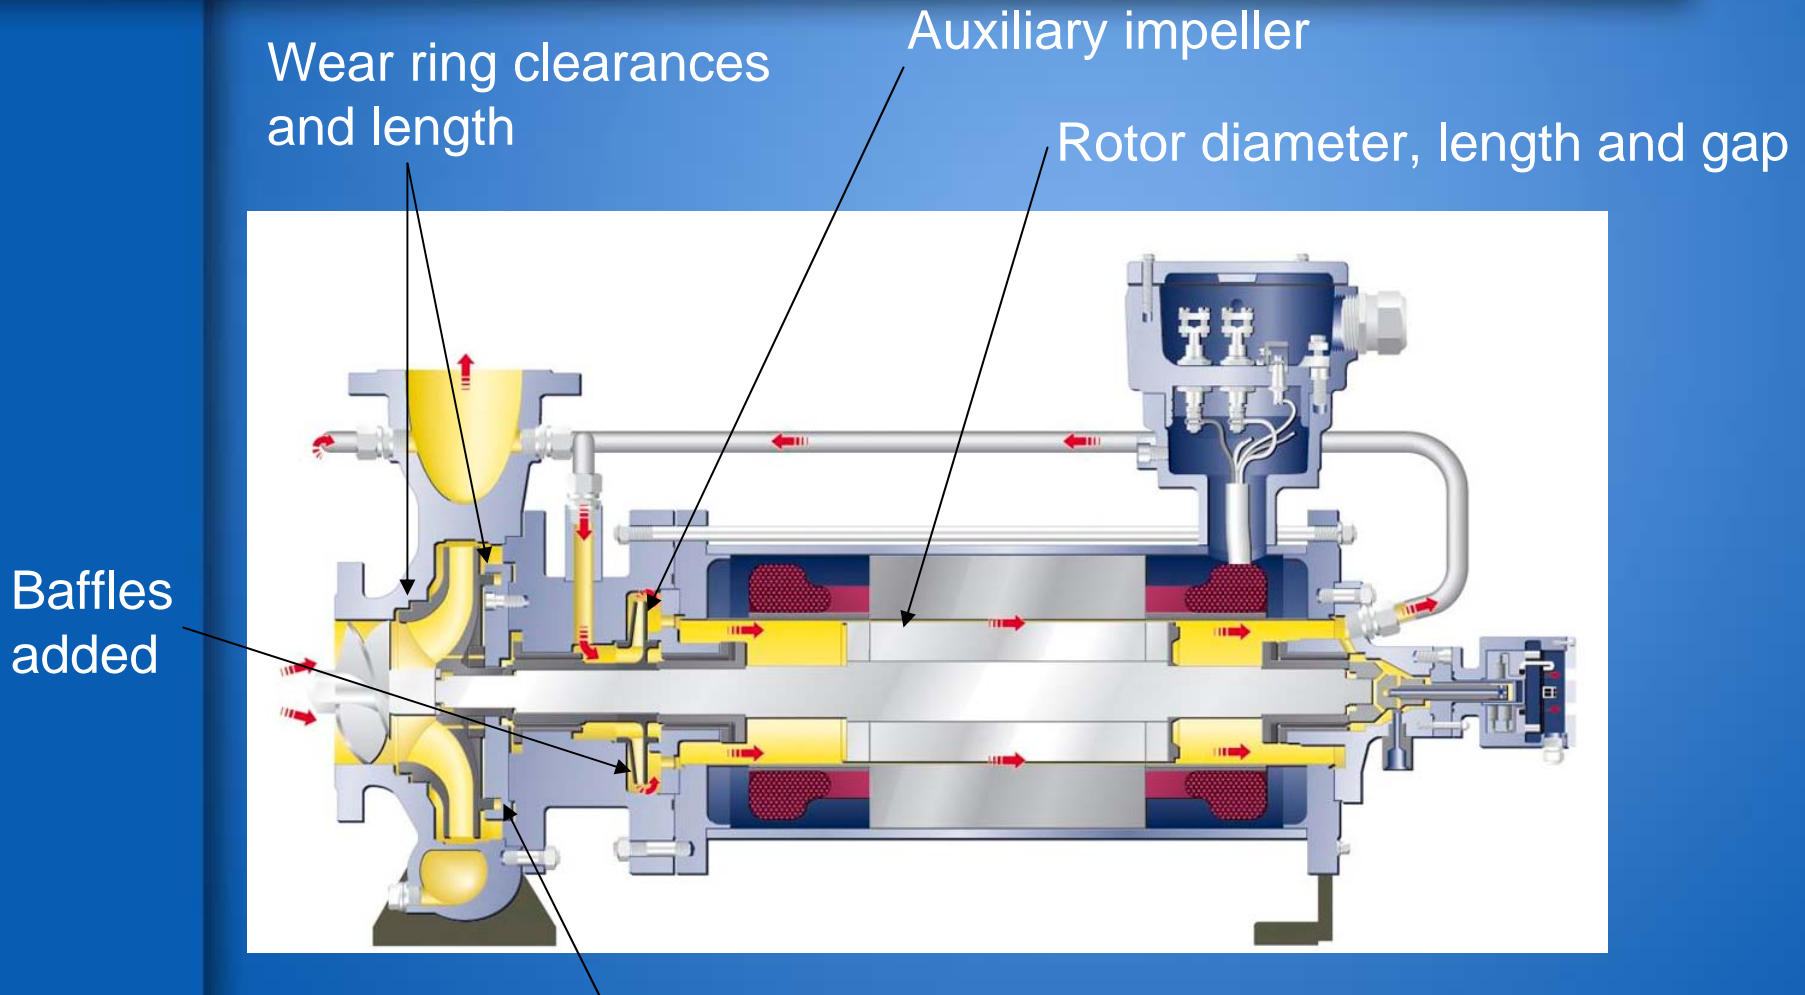
Factors That Affect Thrust Balance

- ❖ The initial axial thrust unbalance caused the rotor to move toward the front of the pump which is not as desirable as movement to the rear.
- ❖ The rear movement is more desirable as it allows the double rear wear rings on the back of the impeller to control the pressure behind the impeller.
- ❖ Several design changes were initiated to change the direction of the axial thrust including reducing the clearance of the double wear rings and adding baffles in front of the auxiliary impeller.

Double wear ring to control pressure behind the impeller and clearances reduced to produce rear thrust

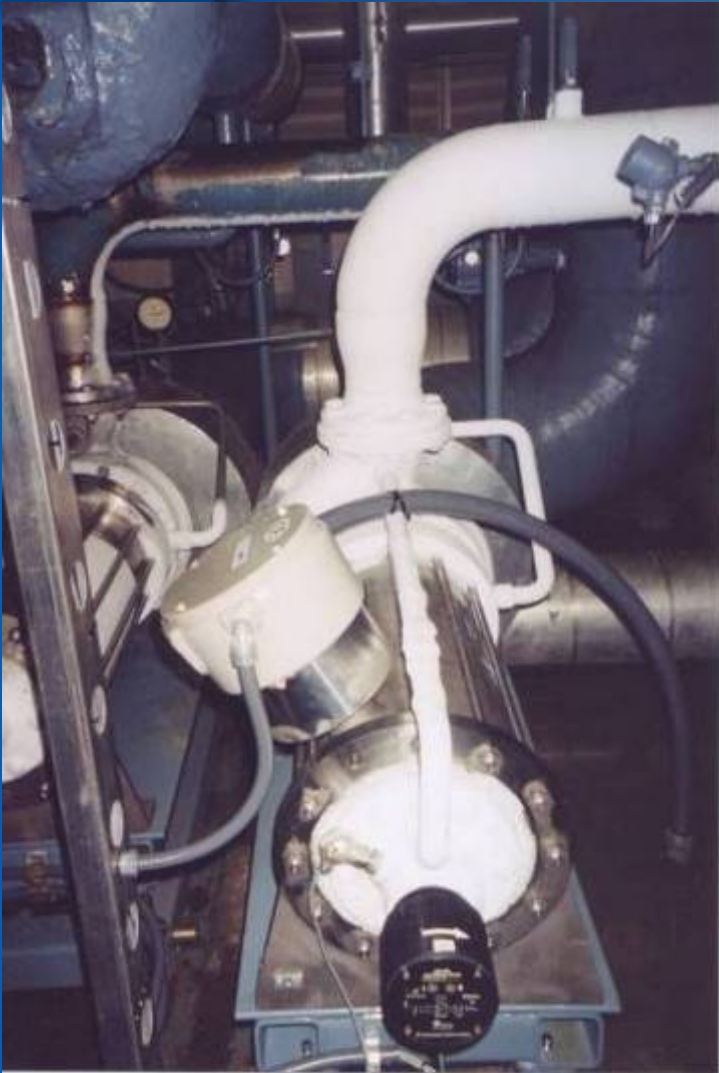
Pump in operation

- ❖ Root cause of the problem was ice in the system
- ❖ Ice was centrifuged in the pump case and pumped directly into the motor
- ❖ Ice upset the hydraulic balance of the pumps.
- ❖ Pumps are performing well and are allowing flow rates in excess of 1000 gpm depending on system head.
