ITT

Modification of BB1 pump vibration characteristics to meet ISO 13709 2nd edition (API 610 11th) limits

ITT Goulds Pumps

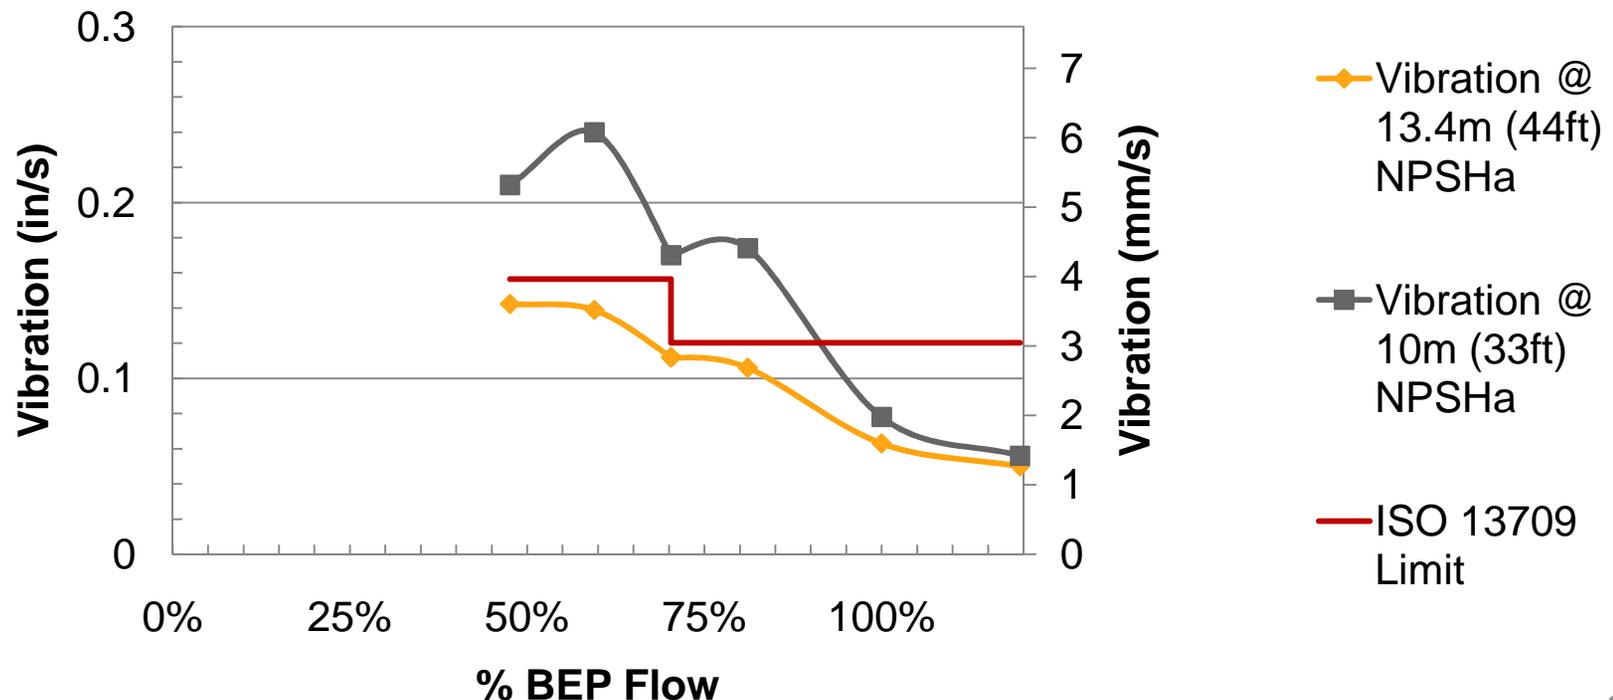
Initial testing results #1

The pump was retested at the rated NPSHa of 10m (33 ft) and vibration levels significantly exceeded the allowable vibration criteria

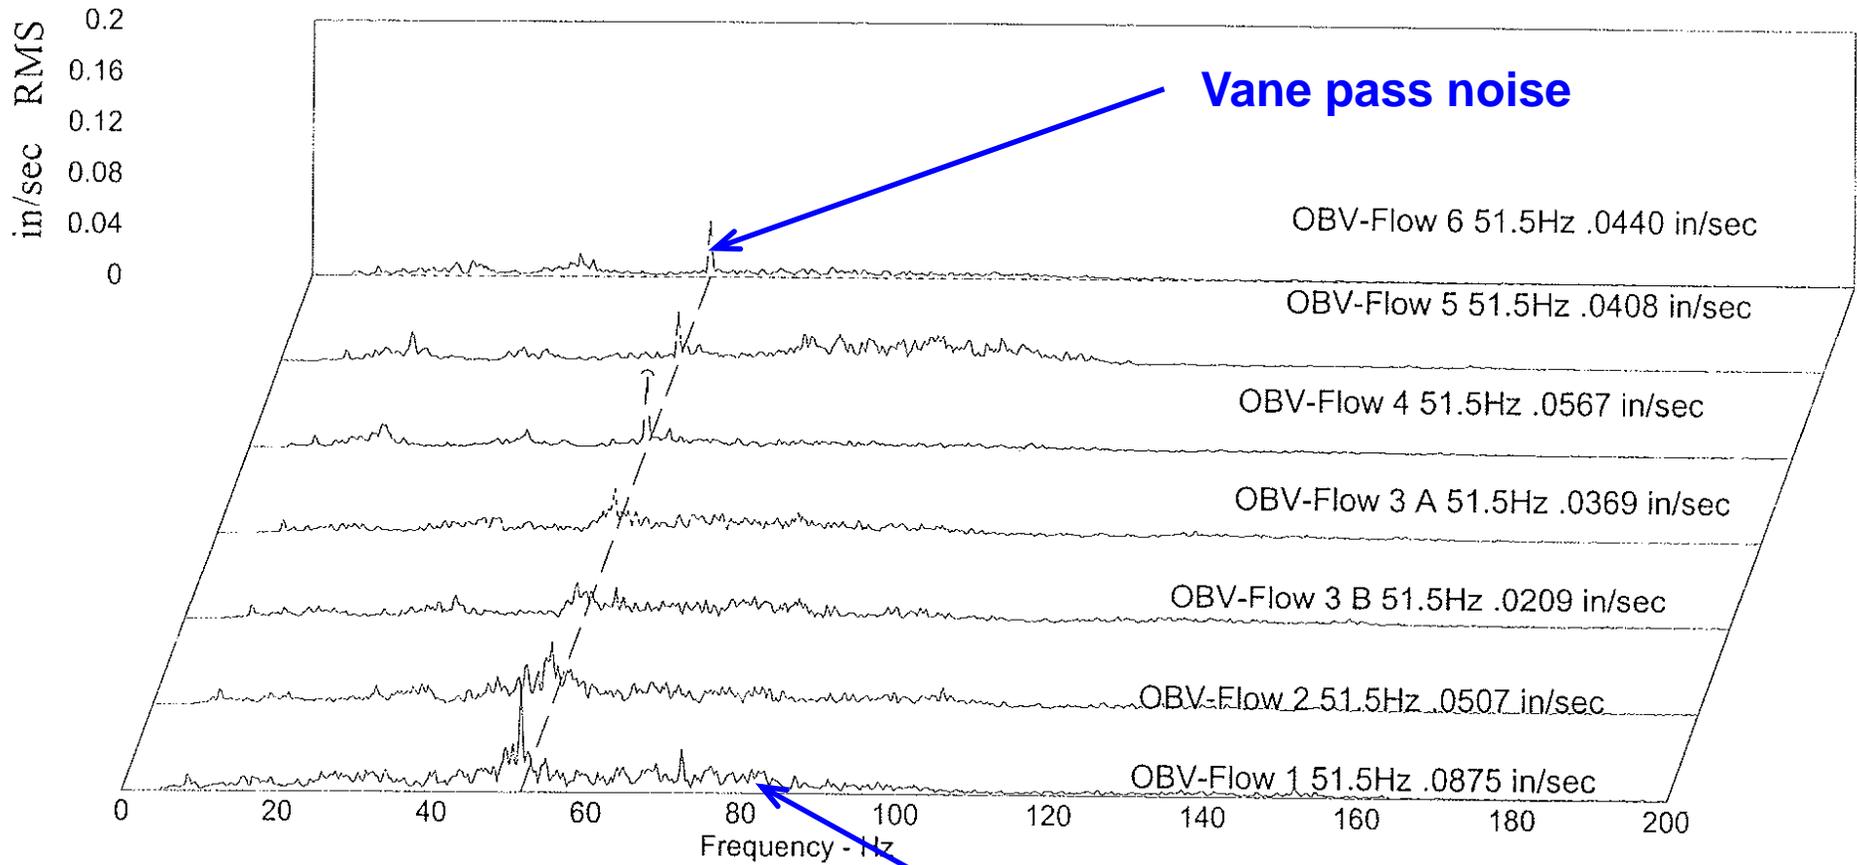
Waterfall
J-4302 B \ OBV

**Broadband
hydraulic noise**

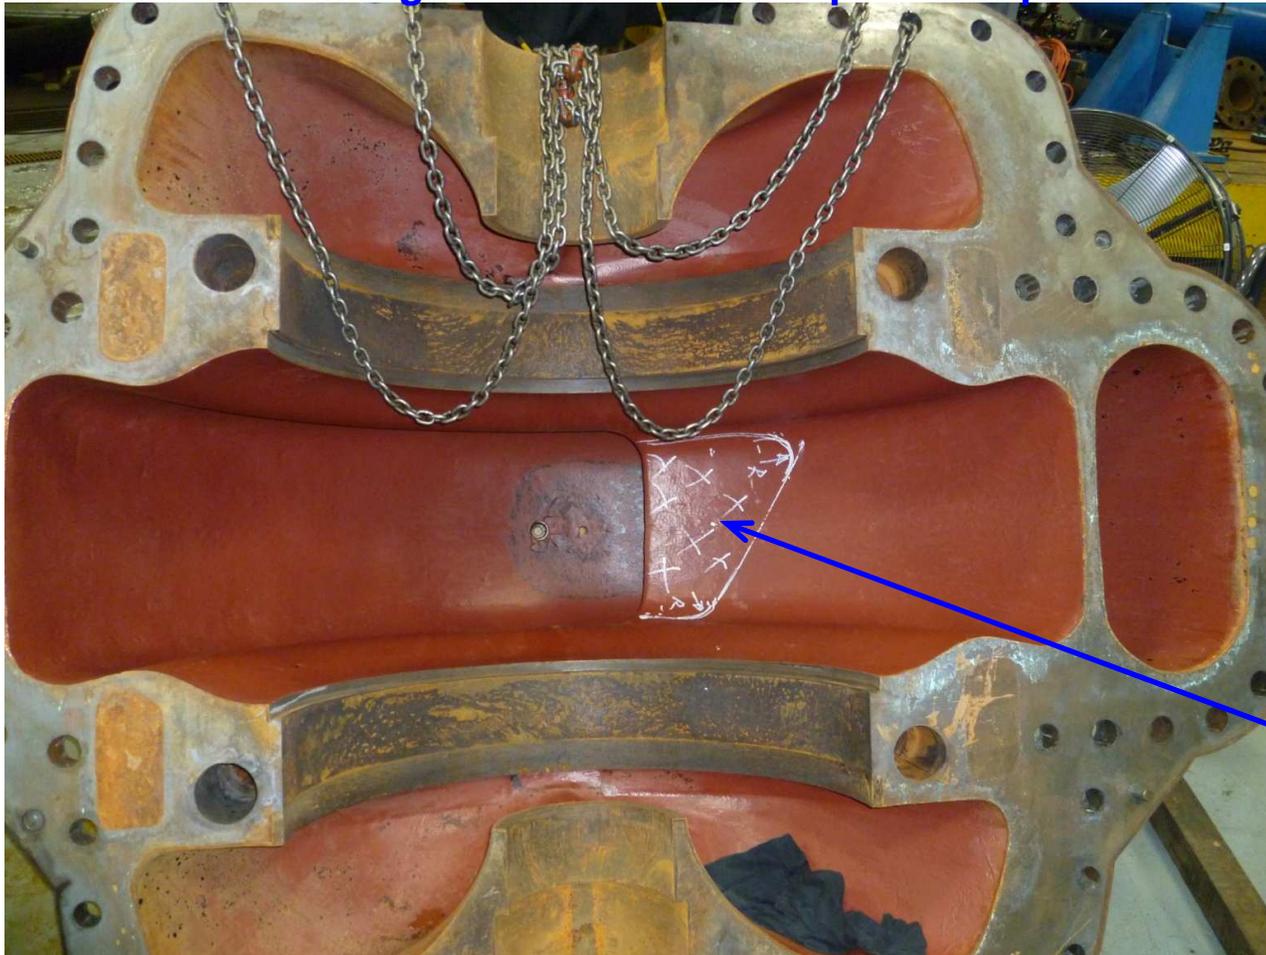
White marks
indicate material
removed

The top half casing volute lip was cutback to create an angle of 168° relative to the lower half volute lip.

The cutback was angled 30° to smear the pressure pulse in the time domain

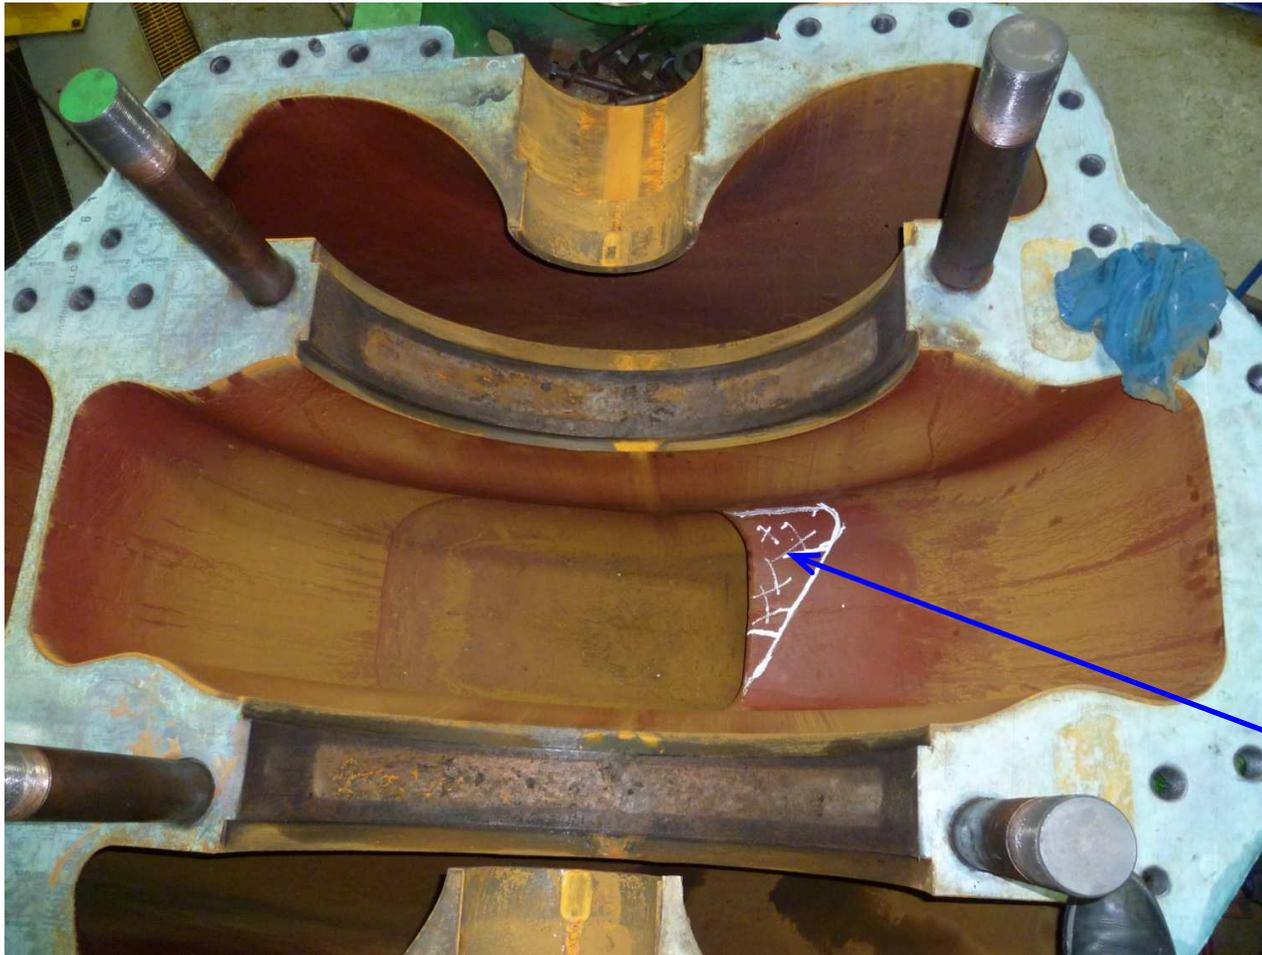
White marks
indicate material
removed

The bottom half casing volute lip was angled 30° to smear the pressure pulse in the time domain

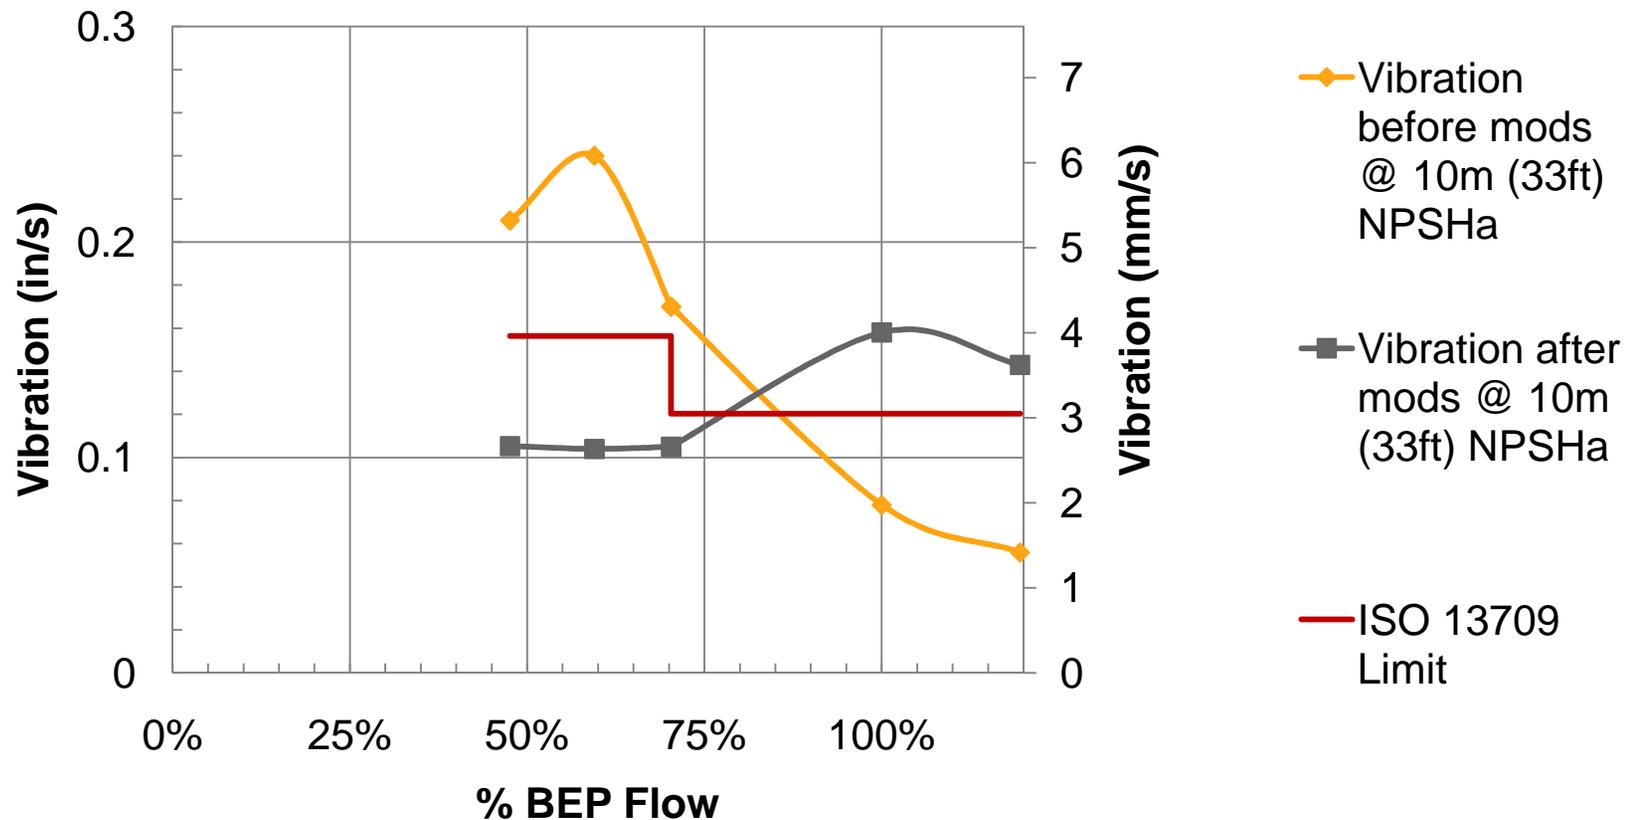
Testing confirmed the effectiveness of the modifications at suppressing low flow vibration behavior, but created a problem at higher flows.

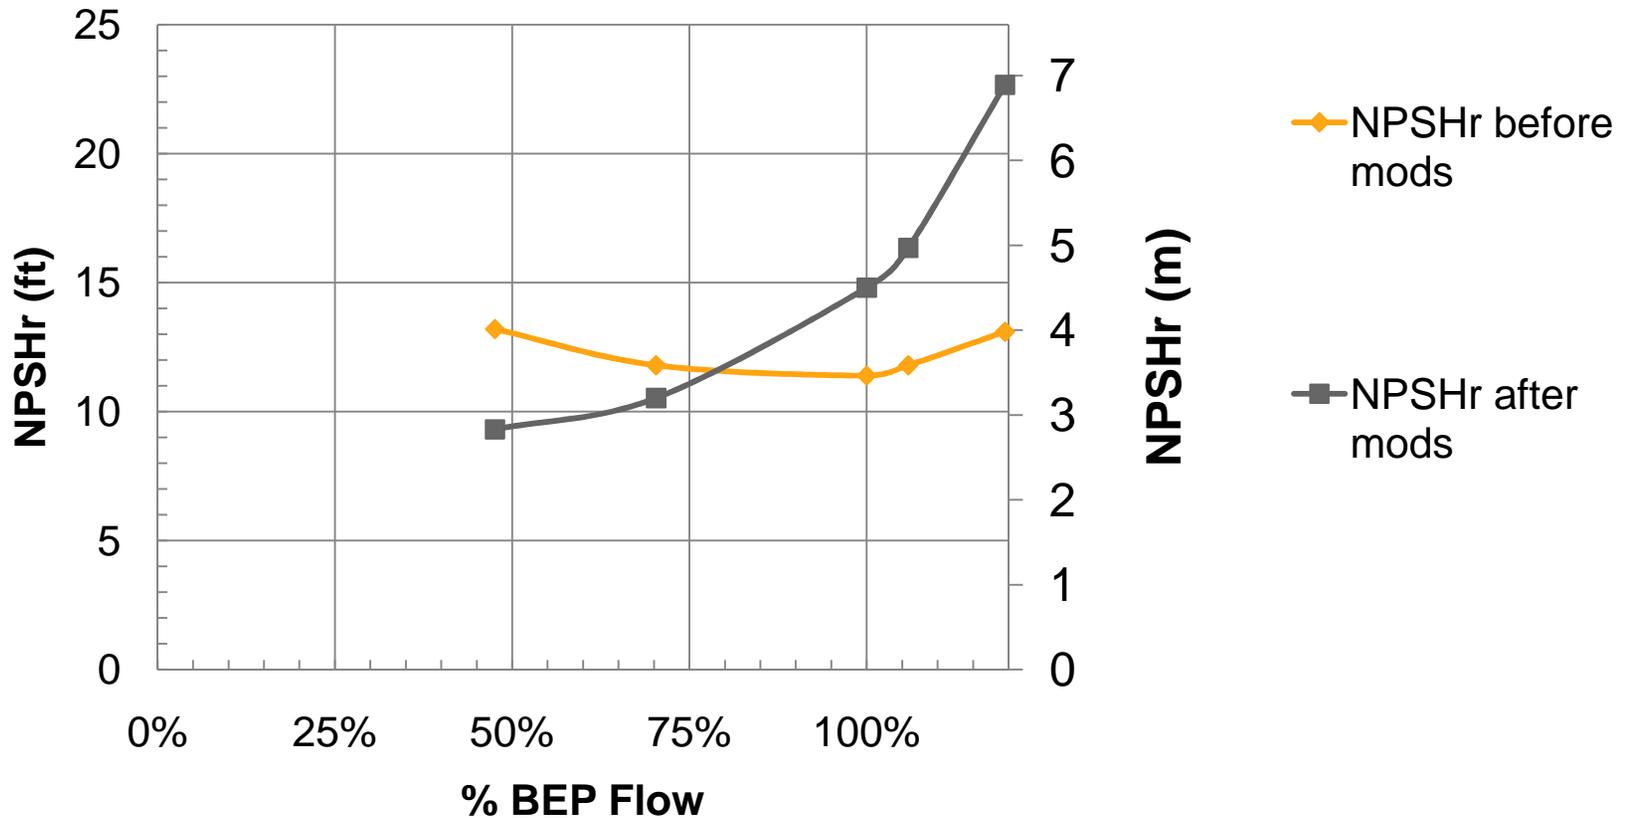
The bull ring was causing significant head loss at higher flows:

- Head loss = Broadband hydraulic noise = Extra vibration

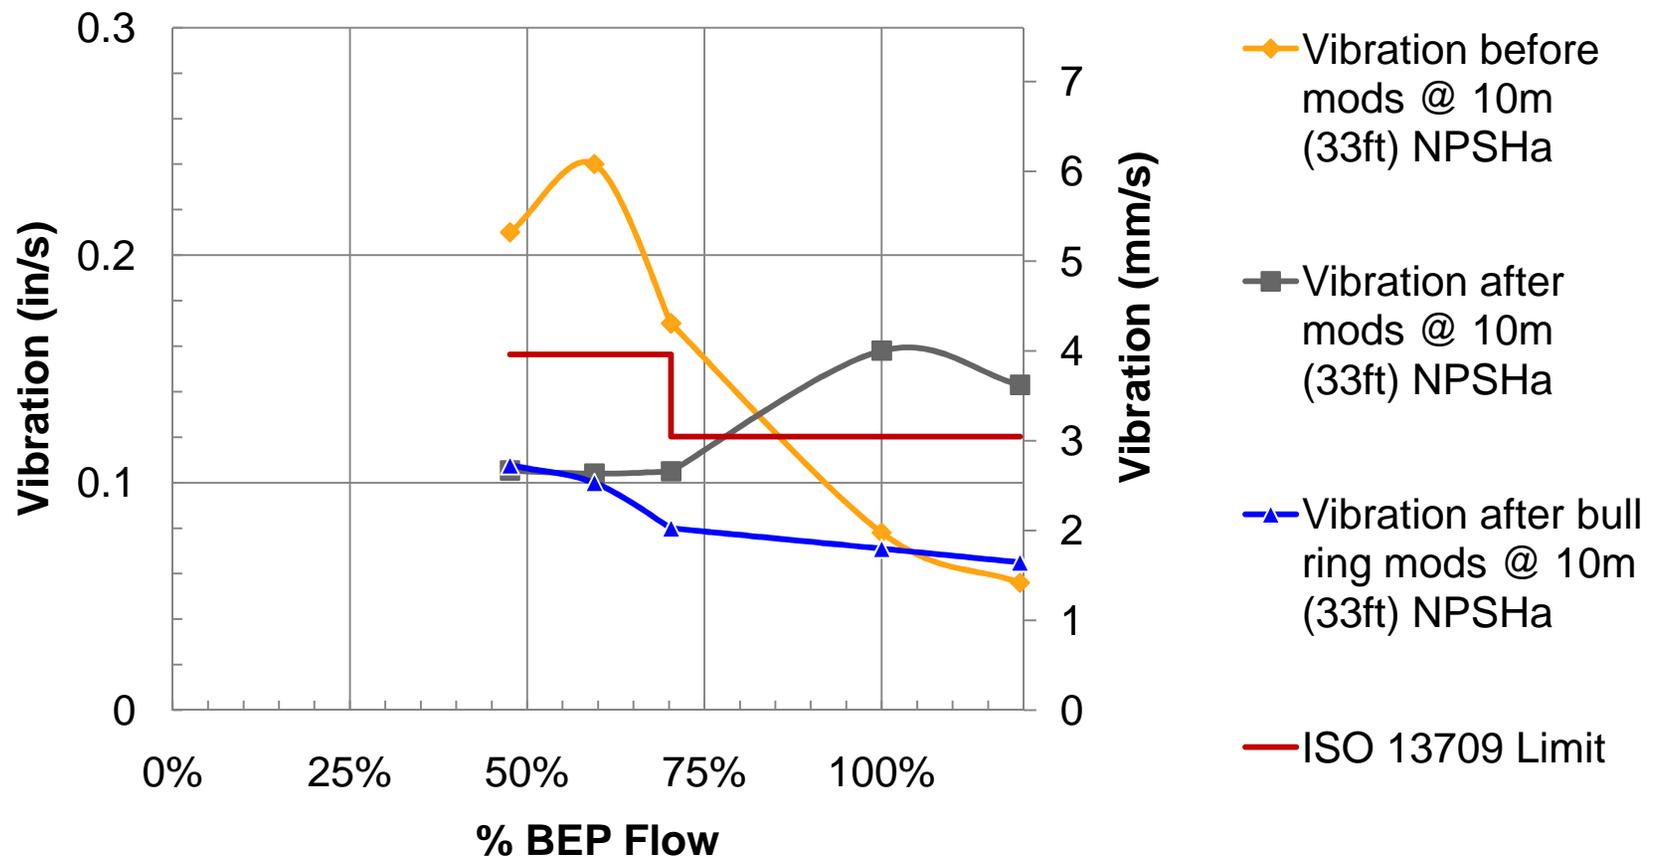
Testing confirmed the effectiveness of the changes to the bull ring

Vibration was now well controlled over the whole flow range

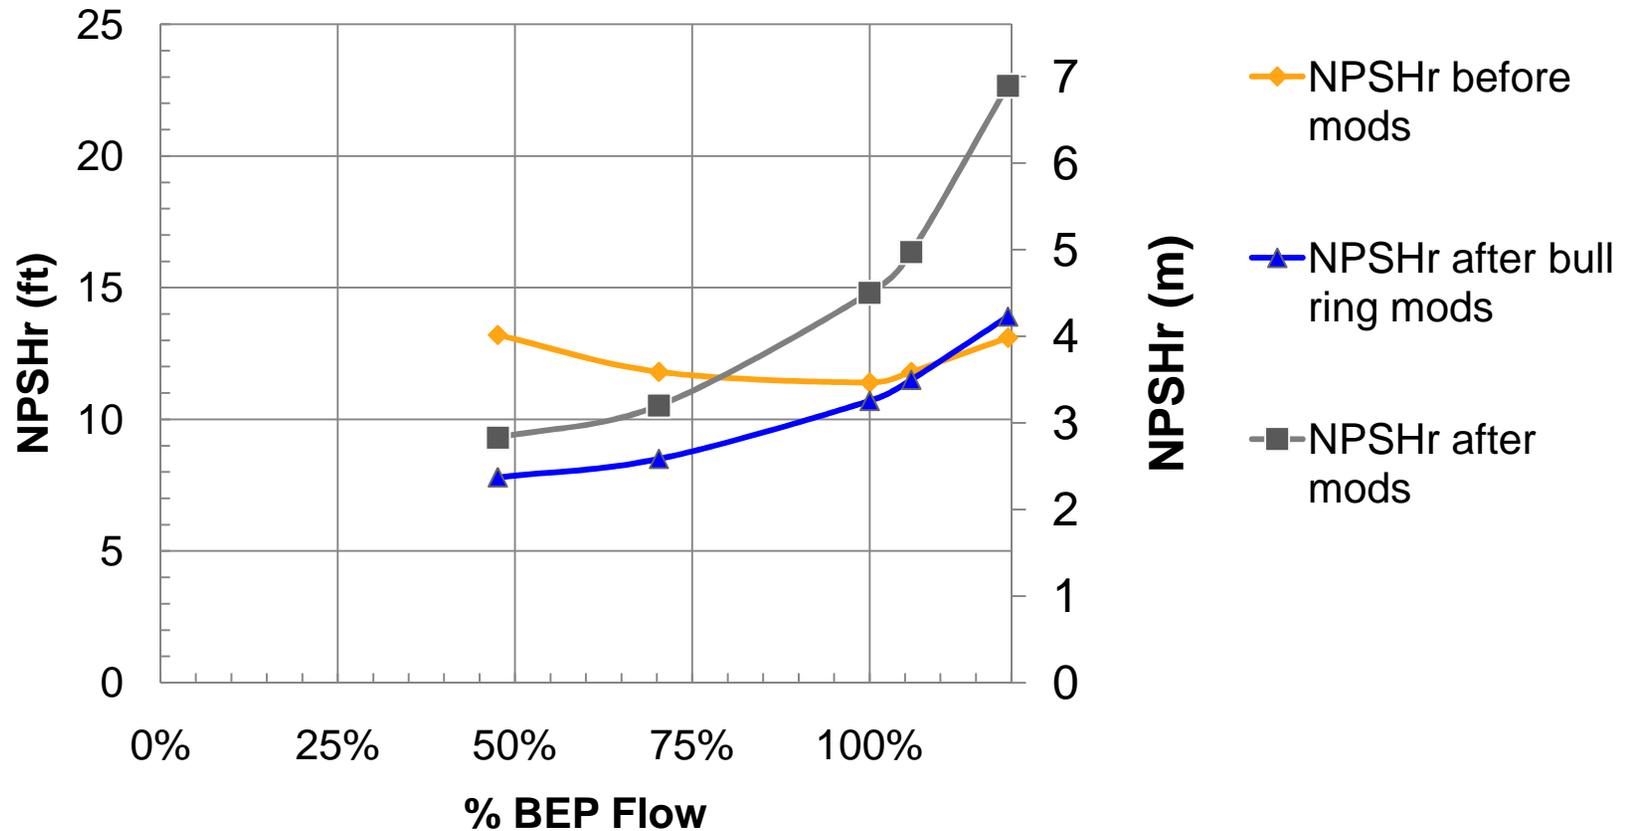
The NPSHr results also indicate the success of the final bull ring design
