# Pump Baseplate Resonance Responsible for Large Piping Vibration and Component Failures

José A Vázquez, Ph.D.

DuPont Company

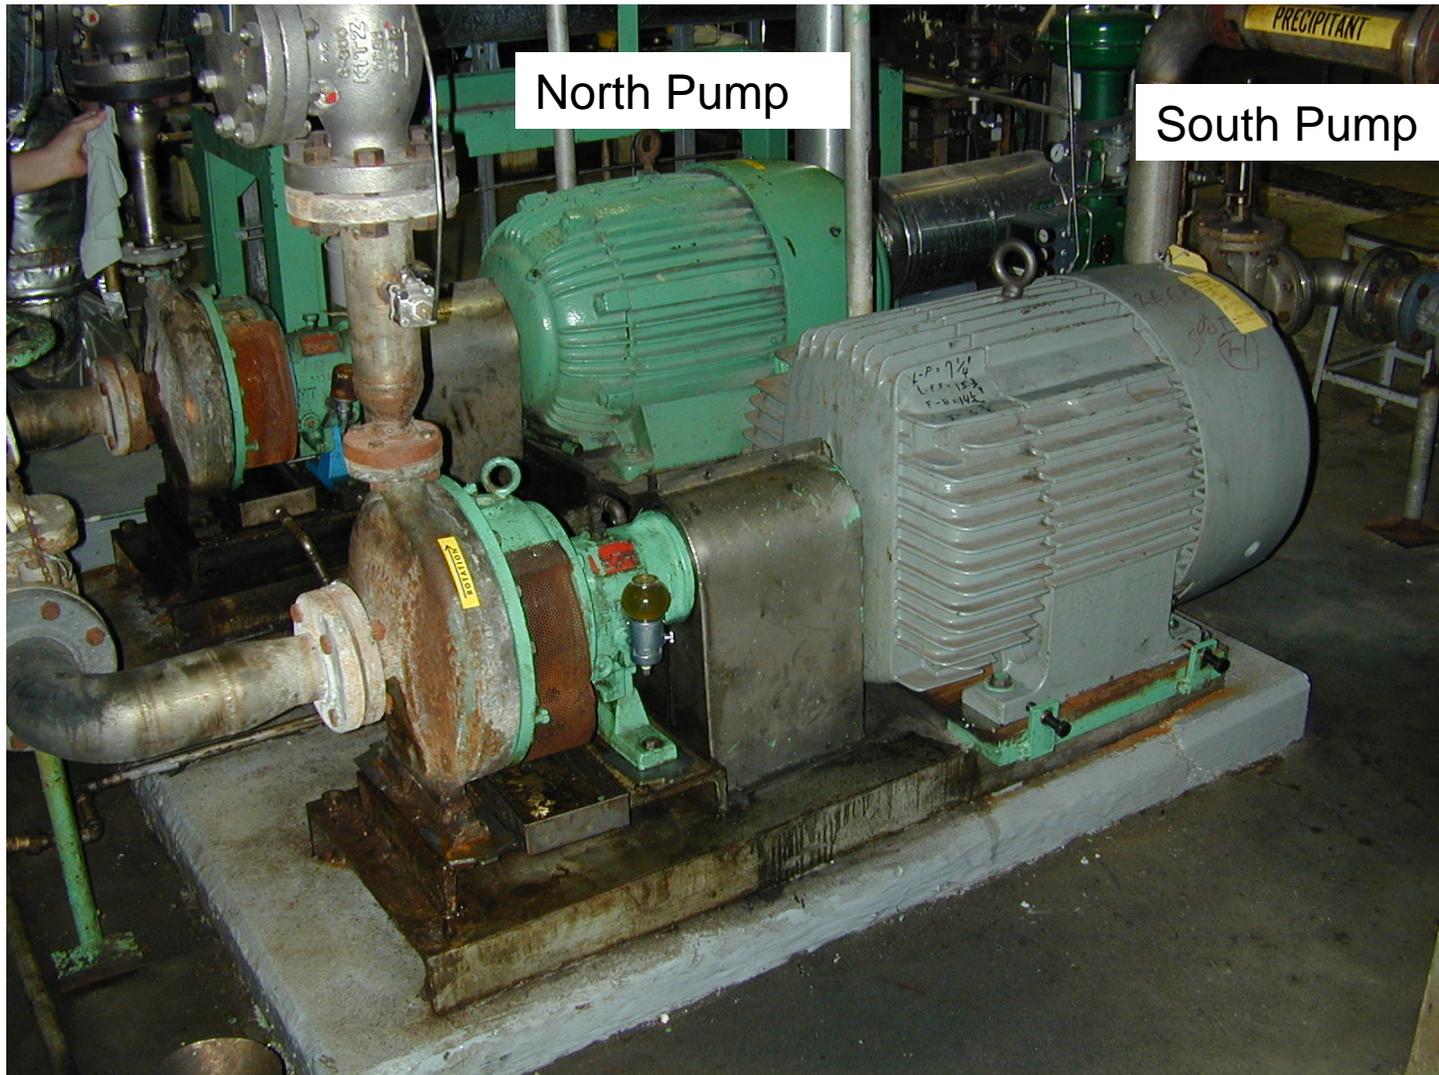
# Problem statement (cont.)

- Maintenance Personnel observed high vibration on the piping system where many of the failures occurred
- Initial thought was that piping resonance was excited and that shook the pump
- It had been a practice to tighten the pipe hanging supports to reduce vibration temporarily

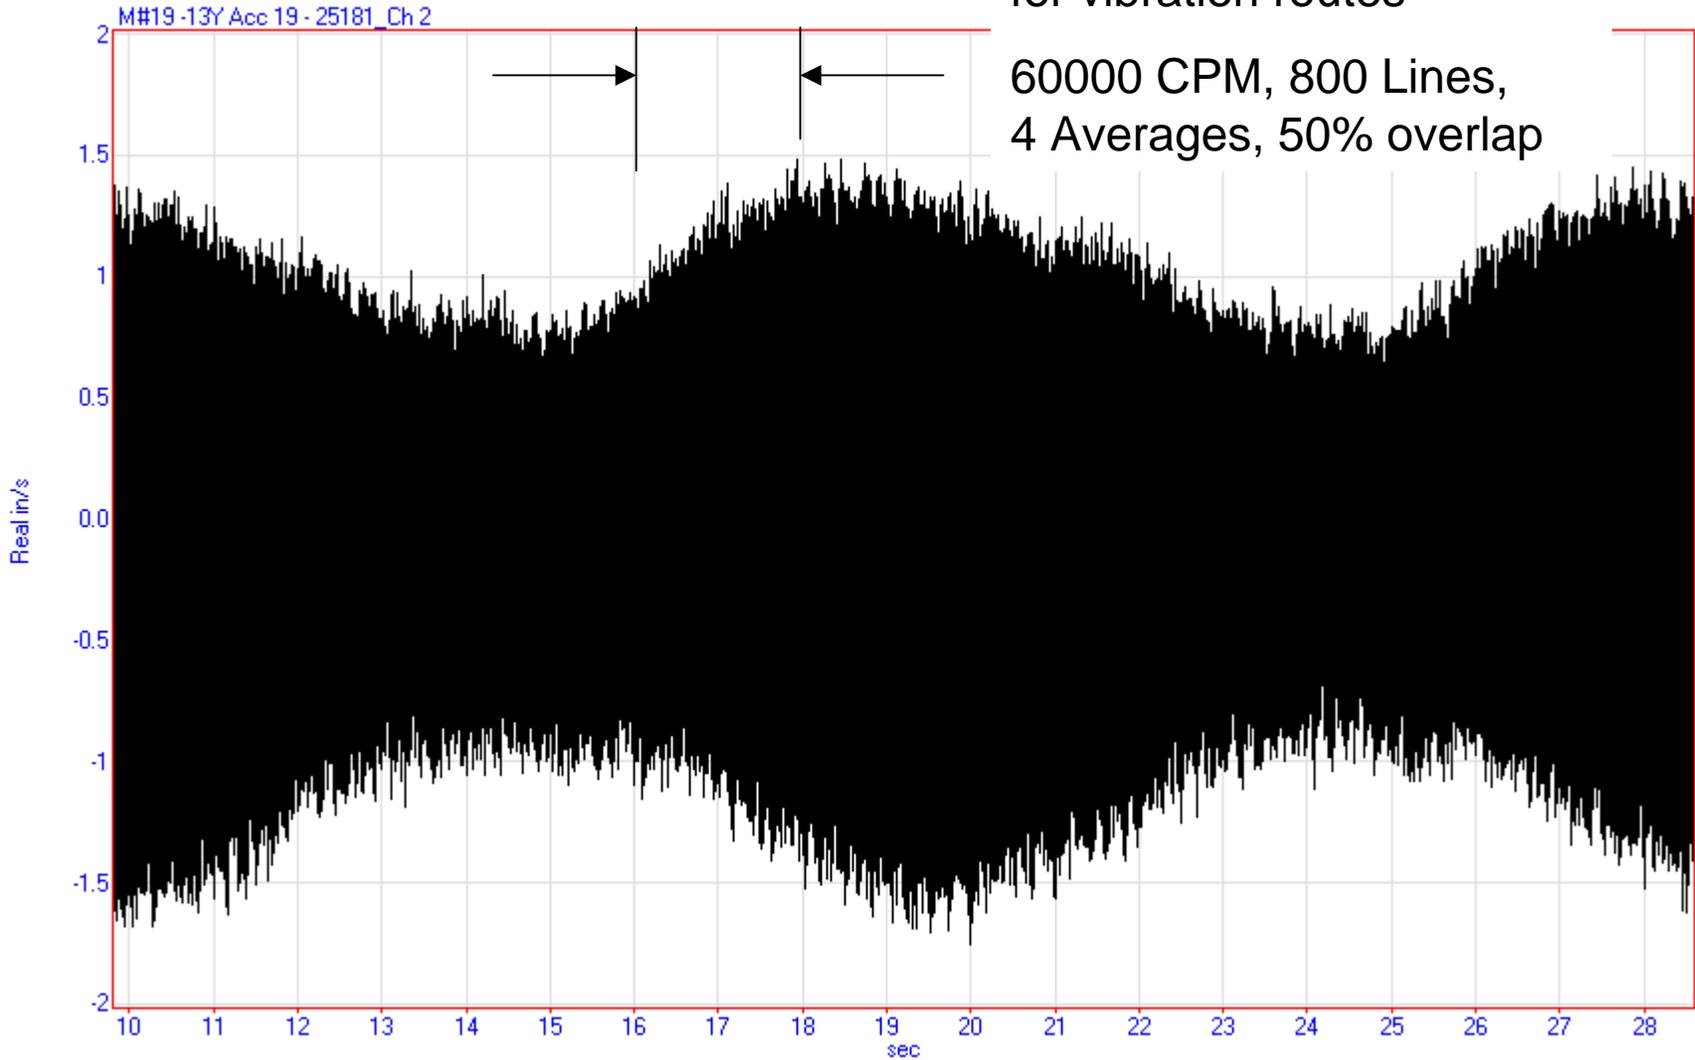
# Vibration Measurement on South Pump Bearing Housing, Coupling End Horizontal direction

Typical collection window for vibration routes

60000 CPM, 800 Lines, 4 Averages, 50% overlap

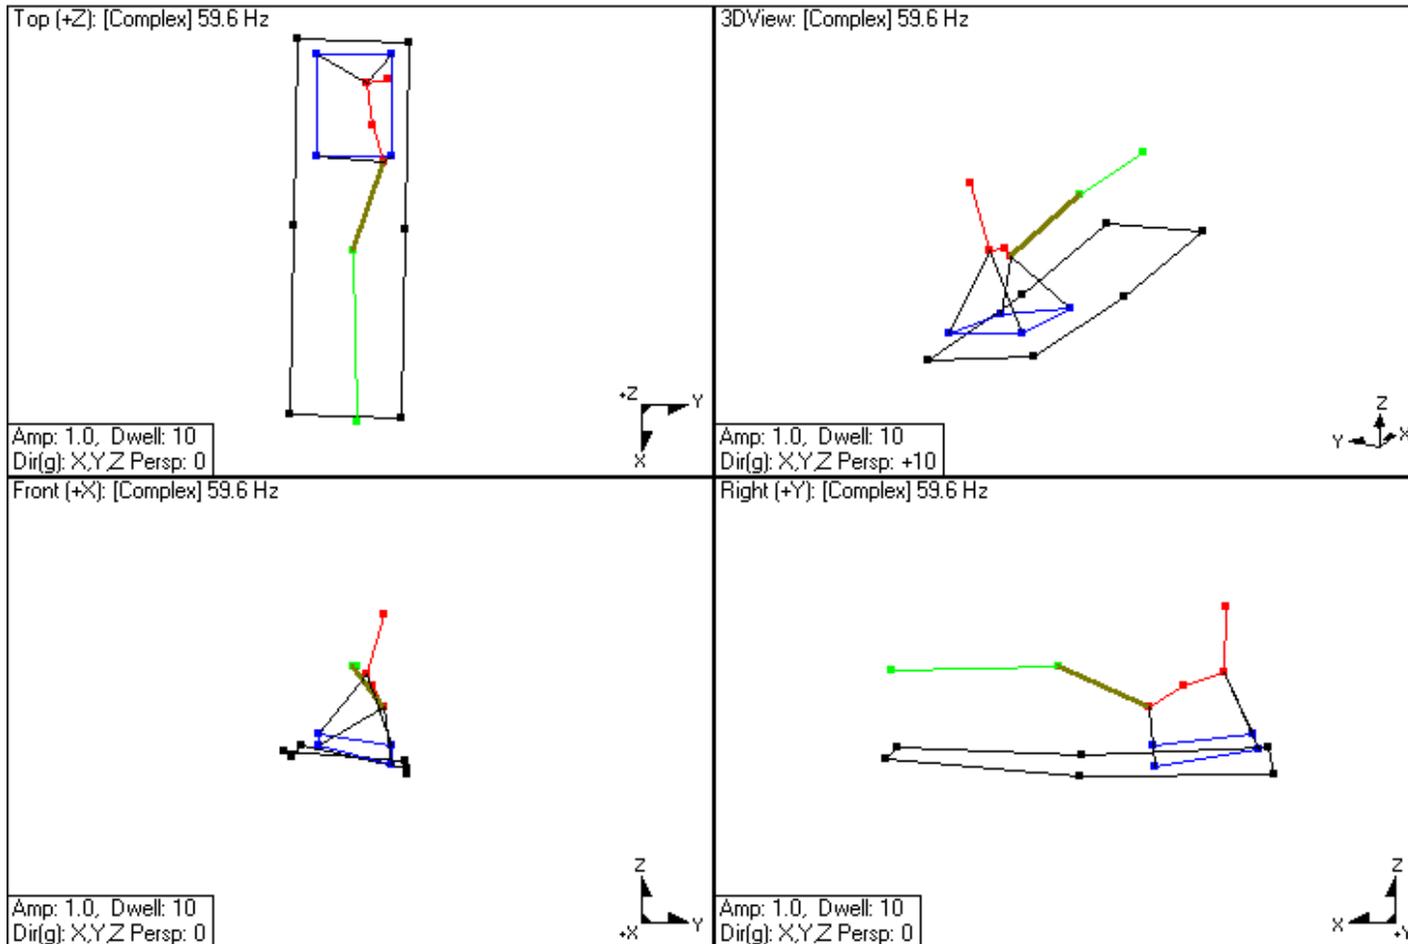
## North Pump

- Impact testing on the Inlet and discharge piping did not show any resonance in the vicinity of running speed
- Based on the evidence from the ODS, the baseplate was impacted in several directions. We found a natural frequency on the baseplate of the south pump at the running speed of that pump.

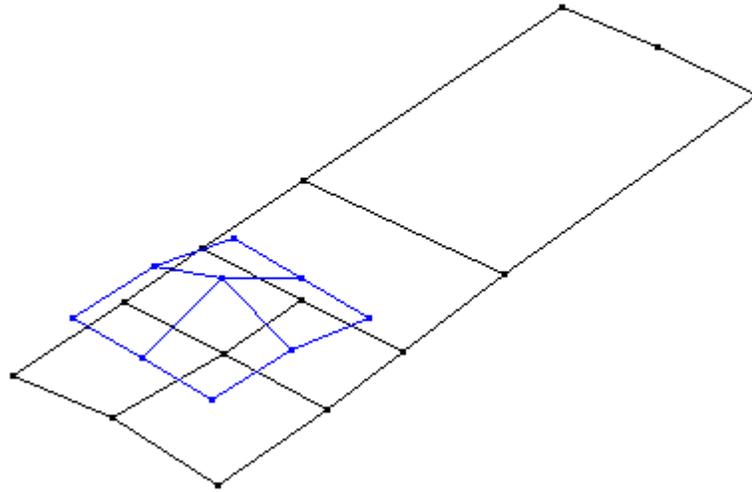
# South Pump Baseplate resonance

3DView: 59.7 Hz

- Repaired the pump pad that had some cracks
- Changed the in-house baseplate for a fabricated baseplate that could be grouted in
- Corrected the local practice of tightening the pipe hangers to control vibration
- The pumps have been in operation for 5 years without major issues
