Pump Performance and Energy Efficiency Improvement Through Pump Refurbishment and Internal Coatings of Horizontal Split Case (HSC) Pumps

Presented By: Paul Maier

Monroe County Water Authority (MCWA)

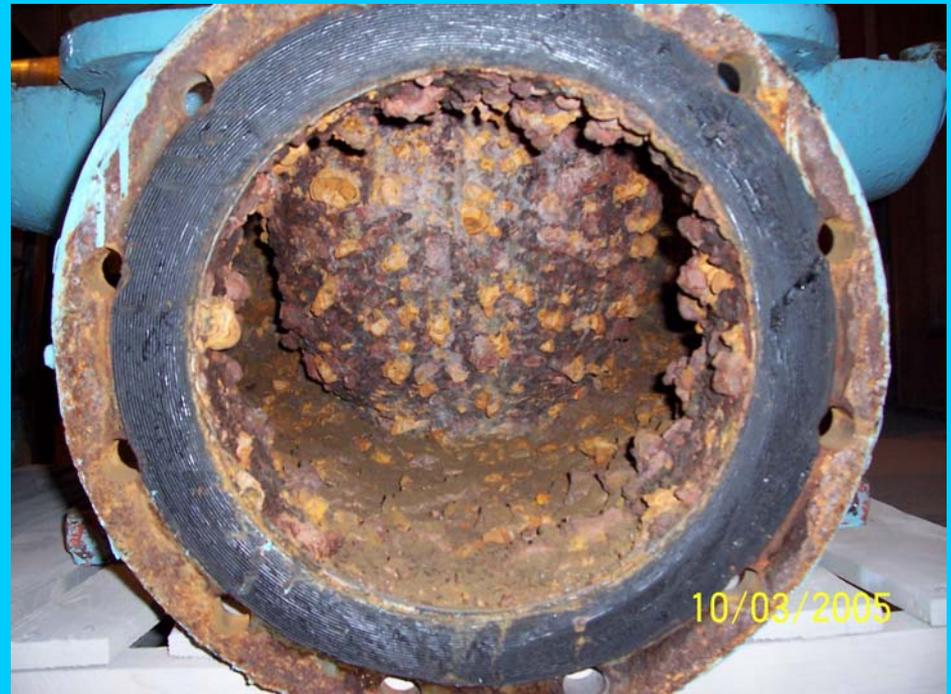
Not so well Documented - 400 HP, 12x16 HSC Pump Installed 1962

- Does the inside Tuberculation impact Pump Flow, Head, Efficiency and/or Energy Consumption and by how much?
- Can any Loss of Pump performance be restored and/or Energy Consumption reduced by cleaning and coating the interior of the pump casing?

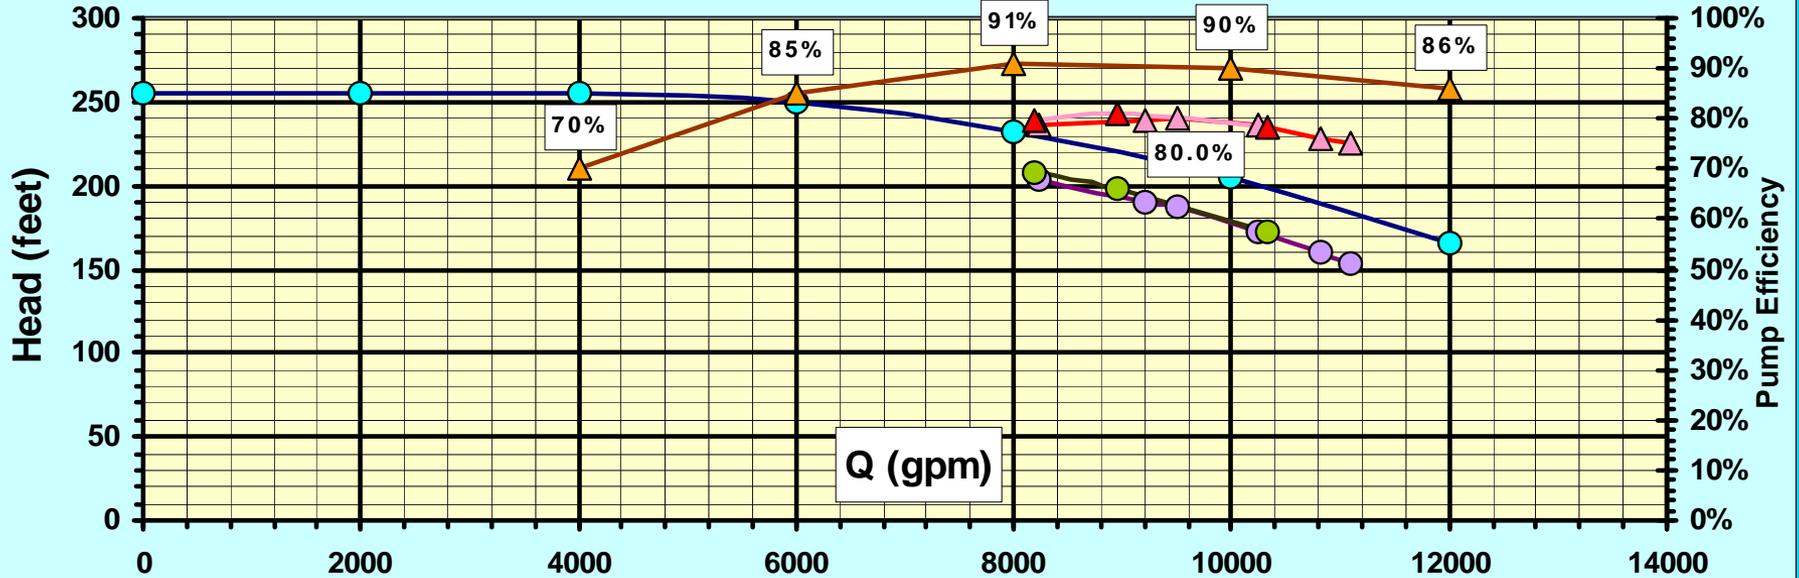
Echo Pump No. 2, 11/23/04 - 8/24/06

600 HP, 18x16 Bottom Suction HSC Pump, Installed 1990, Pre Rebuild/Pre Coating Performance Analysis (25' Loss of Head, 10% loss of Efficiency)

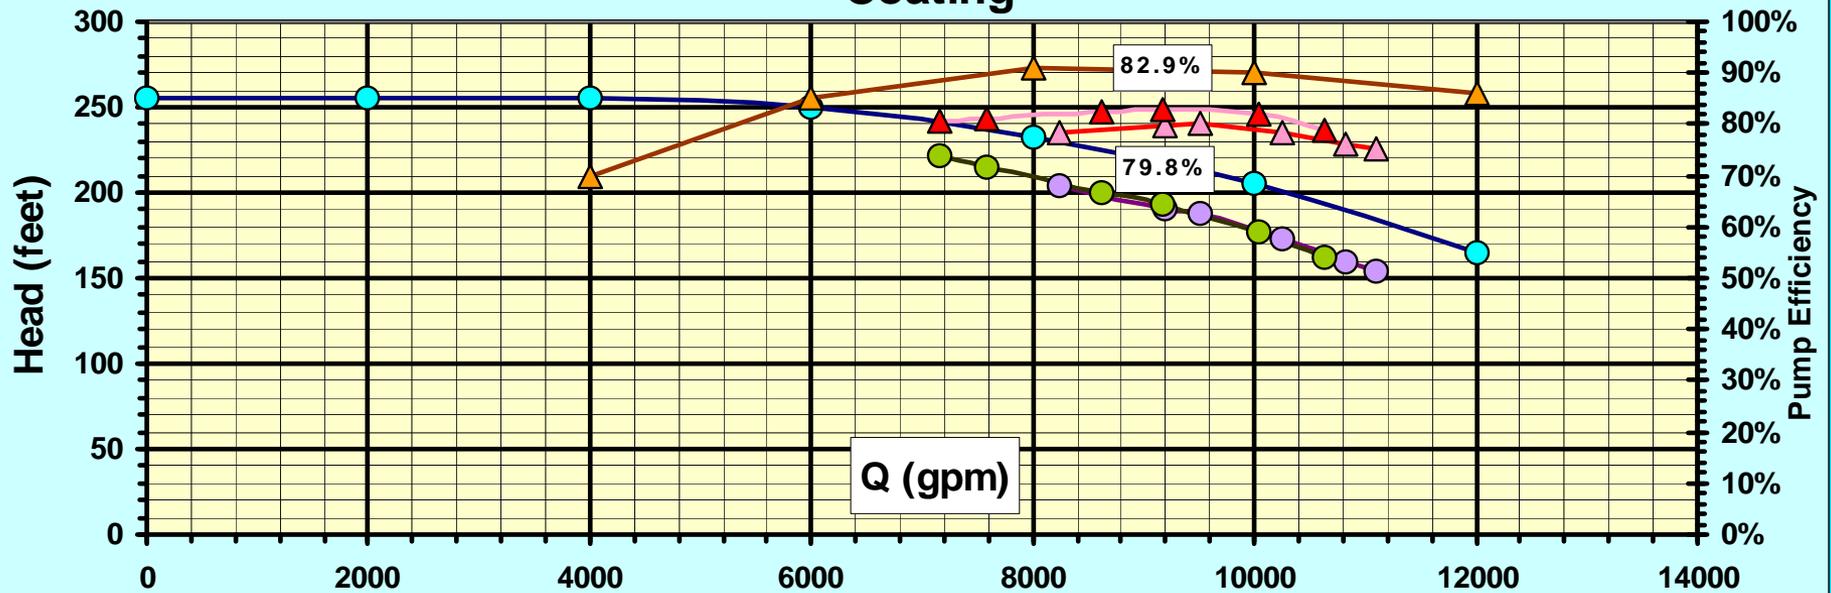
Echo Pump No. 2, 8/24/06 - 5/10/07 Post Mechanical & Impeller Coating

Pump Performance Post Mechanical Refurbishment

(Slight Increase in Head, Efficiency Increased 3.2%)

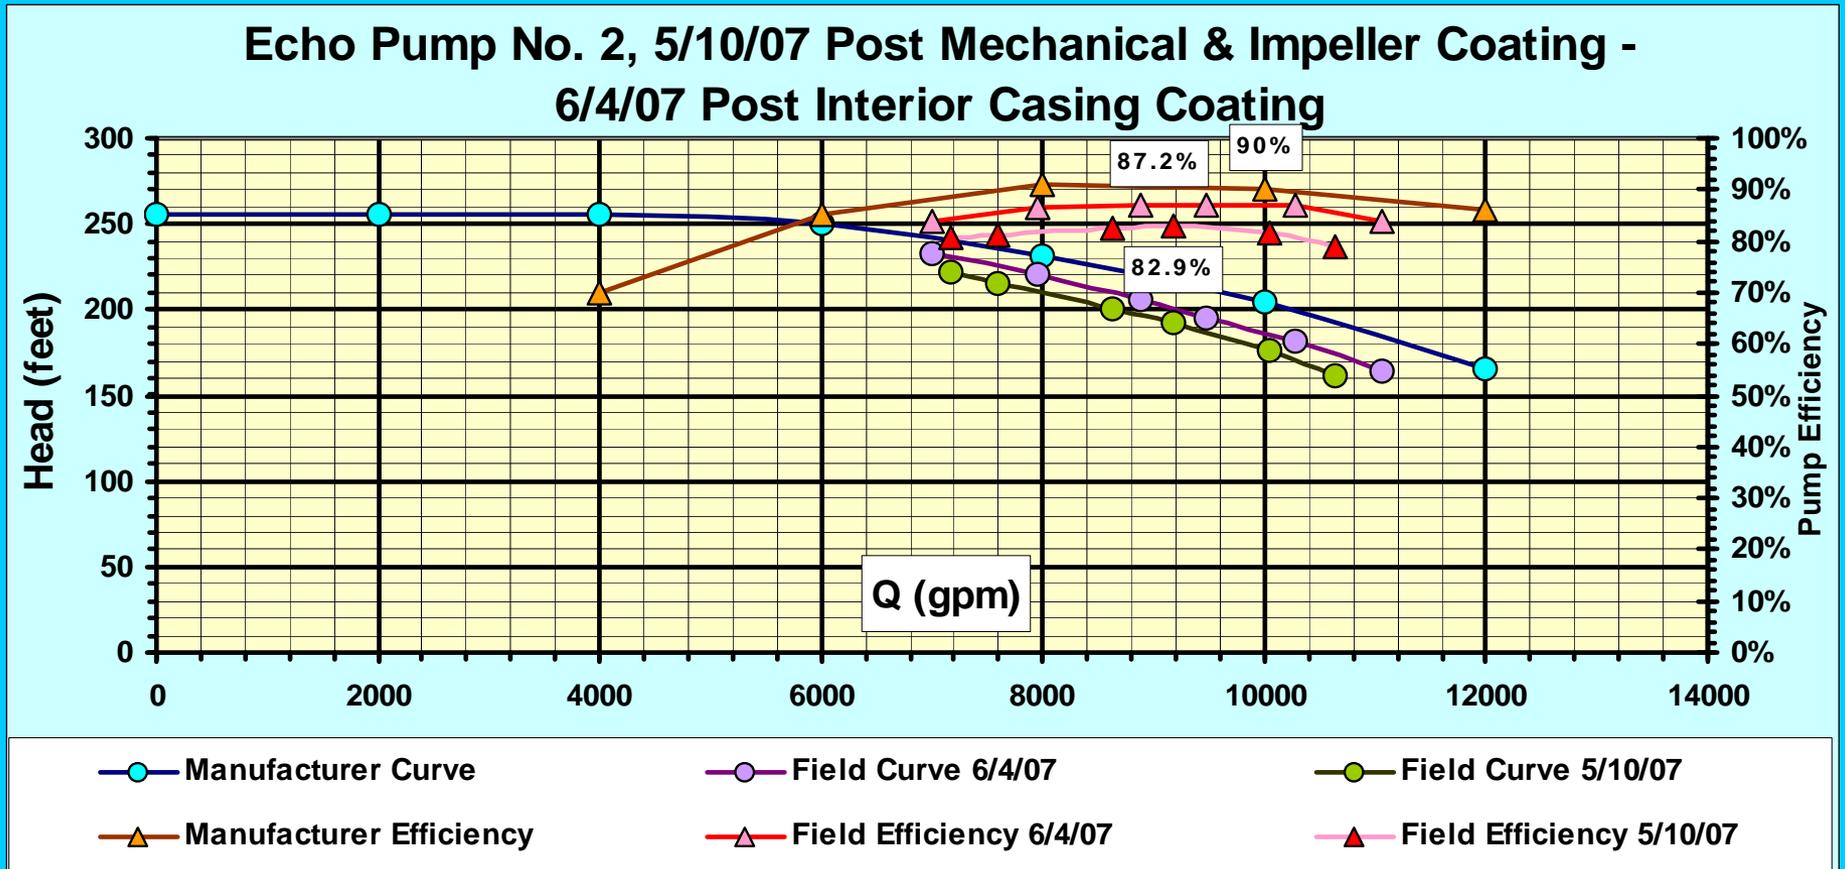
Echo Post Interior Coating vs. Post Mechanical Refurbishment Performance Comparison

Increase 10' of Head, Increase of 5% Efficiency
 Total Efficiency Increase from Mechanical & Coating 8.2%
