RELIABILITY IMPROVEMENTS TO A HIGH SPEED/HIGH ENERGY PUMP

Ed Wilcox

Lyondell Chemical Company

Channelview, Texas

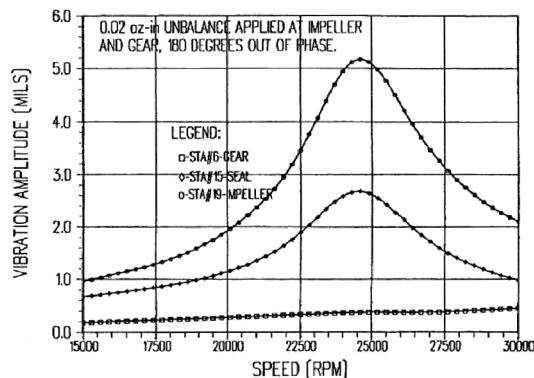
Figure 3. Revised OEM Unbalance Response Calculations with Steel Impeller/Inducer.

The pumps were originally installed with the original equipment manufacturer (OEM) standard stainless steel impeller and inducer. Typical synchronous vibration levels for the pumps were approximately 3 to 4 mils at an operating speed of 25,000 rpm. As could be expected, this was very detrimental to the reliability of the seals. The end-user questioned the OEM about the possibility of a resonance problem with the high speed output shaft and its first critical speed. Originally, the OEM had calculated that the first critical was above the operating speed. However, reverification of the calculations showed that the operating speed was nearly on top of the first critical, which was predicted at 24,500 cpm (Figure 3). Since, the overhung weight of the impeller greatly affected the critical speed, the impeller and inducer were changed to titanium. This raised the predicted critical speed to approximately 31,500 cpm (Figure 4). This lowered the measured vibration in the field to approximately 1.0 to 1.5 mils and greatly improved the reliability of the pumps.

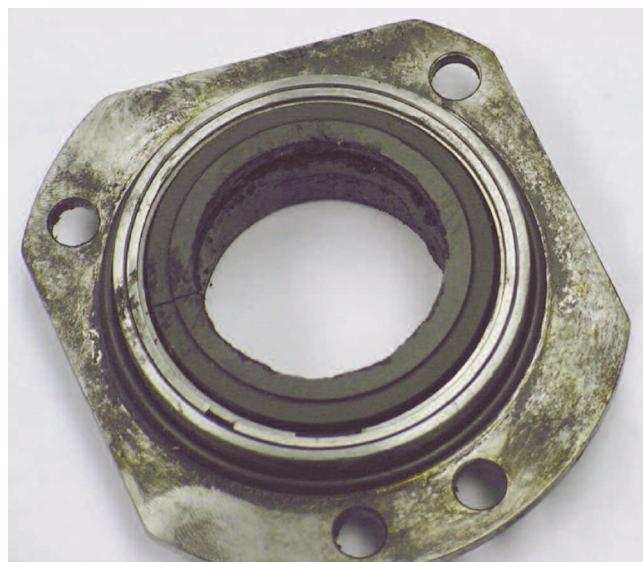
The pump was equipped with a tandem, pusher style seal arrangement, with an API plan 52 that was vented to flare. The primary process seal was normally found to be in excellent condition. However, the secondary seal would always show signs of dry running and excessive heat (Figure 5). This was evident as well from the buildup of burned oil on the output shaft (Figures 6 and 7). Likewise, this buildup on the shaft certainly contributed to the unbalance of the rotor. There were several factors that contributed to the failed secondary seal:

Figure 5. Secondary Seal Stationary Face, Evidence of Dry Running/Cracked Face.

To further improve the reliability of the secondary process seal, the one piece "top hat" design discussed above was replaced with a two piece design that incorporated a separate 17-4 PH sleeve and solid tungsten carbide rotating face (Figure 14). This increases the seals ability to conduct heat away from the faces as well as eliminates problems with the tungsten carbide coating on the steel face.

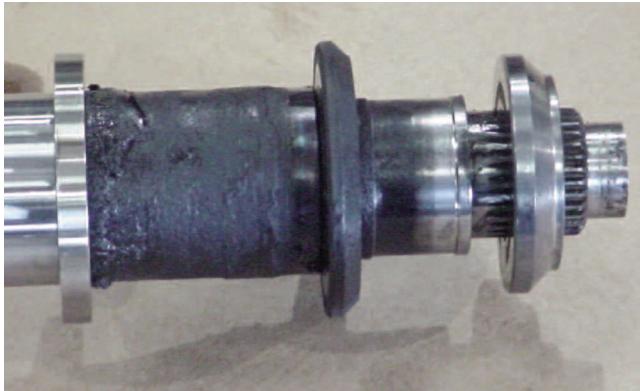
Figure 7. Closeup of Output Shaft Showing Burned Oil Around Secondary Seal.

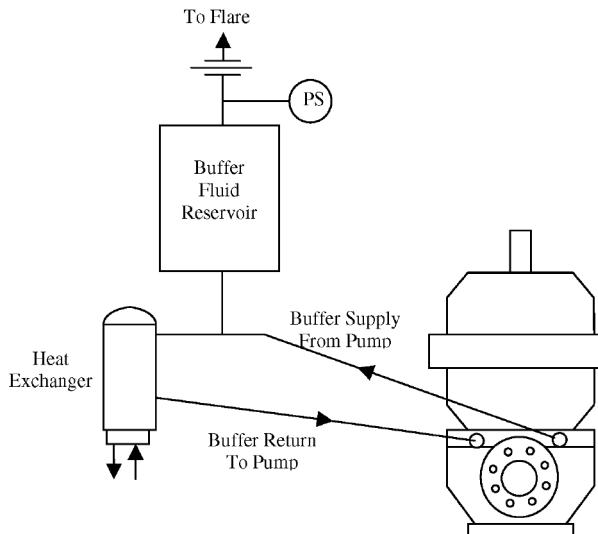
- Poor circulation of the buffer fluid—This was primarily due to the design of the original API plan 52, which incorporated a separate heat exchanger from the carbon steel seal oil reservoir (Figure 8). Additionally, the original three gallon reservoir was constructed from 8 inch pipe, which made it quite short in length. This, combined with the heat exchanger separate from the reservoir reduced the thermo-siphon effects in the system. There was no measurable temperature differential across the buffer fluid exchanger (i.e., no flow and no thermo-siphon). This caused the temperature of the buffer fluid around the secondary seal to rise considerably and possibly flash, which contributed to the heat buildup at the secondary seal.

Figure 8. Original API 52 Seal Flush Plan with Separate Heat Exchanger from Reservoir.

To improve the circulation of seal buffer fluid, the original reservoir and exchanger were replaced with a stainless reservoir (made from 6 inch pipe) with an internal cooling coil (Figure 13). This greatly reduced the restriction in the buffer fluid circulation loop because the pressure drop through the new reservoir is very small compared to the prior set up of passing through shell side of the small shell-and-tube heat exchanger. Likewise, this arrangement better utilizes the capacity of the seal reservoir to increase the effects of the thermo-siphon. Additionally, the small $\frac{1}{2}$ inch stainless steel tubing from the pump to the reservoir was replaced with new $\frac{3}{4}$ inch stainless steel tubing that sloped continuously down to the pump with large radius bends.

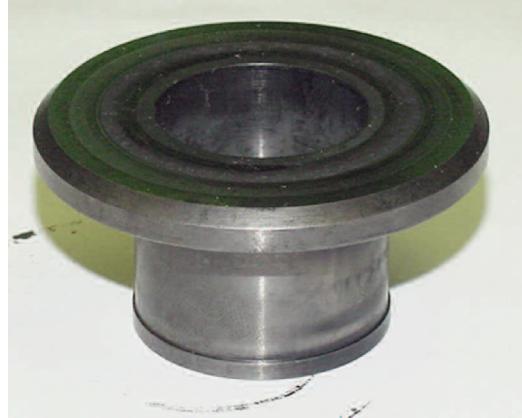
- Poor secondary seal rotating face design—The original secondary seal design incorporated a design where the sleeve and rotating face are one piece steel, with the face of the seal coated with tungsten carbide, similar to a “top hat” in appearance (Figures 9 and 10). At high surface speeds, this can create seal problems due to the bond between the coating and the steel, as well as the fact that the steel does not conduct away the heat produced by the seal as well as solid tungsten carbide.

Figure 10. Original “Top Hat” Secondary Seal Rotating Face/Sleeve.

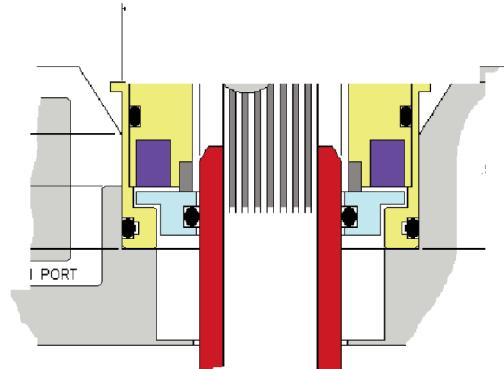
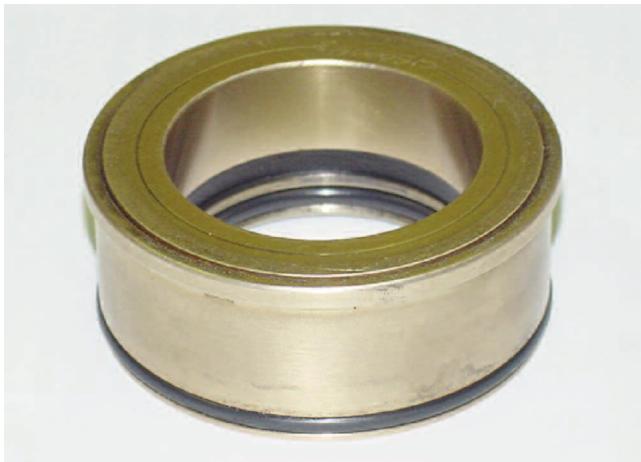
There were constant problems with upper gearbox seal leaks. The upper gearbox seal was originally a single lip seal. To reduce the leakage, another lip seal was installed on top of the original, but this did not reduce the leakage significantly. Even a slight gearbox oil leak could be a problem because the gearbox case was the lube oil reservoir, which gave it a small capacity.

As mentioned above, the upper gearbox lip seal leaked excessively, even if two lip seals were stacked on top of each other. The lip seals on the input shaft were replaced with a new magnetic seal to reduce oil leaks out the top of the gearbox (Figures 11 and 12).

Figure 11. New Upper Magnetic Gearbox Oil Seal.

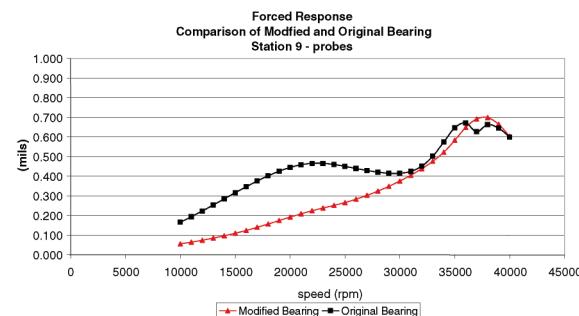
Figure 16. Predicted Unbalanced Response at Shaft Probes with Modified and Original Lower Bearing.

To reduce the vibration of the output shaft, a modified tilting-pad bearing was selected. The axial width of the bearing was increased from 0.6 inch to 0.9 inch, while maintaining the same radial clearance and preload (Table 1 and Figure 15). This was an alternate bearing design, provided by the OEM. This reduces the bearing load and increases the effective damping provided by the bearing because it reduces the stiffness for approximately the same damping. This lowers the predicted critical speed slightly, but also reduces the amplification factor as well. The vibration at the probes is reduced (Figure 16), which compares the predicted maximum amplitude at the shaft probes with both the modified and original bearing. Bode and polar plots for the pump with the original and modified bearings are shown in Figures 17 to 20. As can be seen the synchronous amplitude has been reduced from 0.6 to 0.15 mils, which is very close to the predicted change shown in Figure 16.
