ROOT CAUSE ANALYSIS OF FIVE COSTLY CENTRIFUGAL PUMP FAILURES

Heinz P. Bloch

ABSTRACT

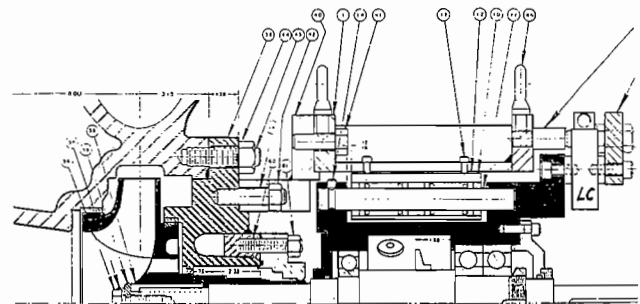
Pump owner and pump manufacturer agreed to perform a field test on this failure-prone pump. A special test rig, Figure 1, was designed and fabricated by the pump manufacturer. It consisted of means to allow the pump rotor-bearing assembly to move in the axial (impeller thrust) direction. The total axial movement was limited so as not to exceed permissible impeller travel. Also, the axial thrust value was measured by three load cells (Figure 1), whose connecting cables are visible in the field test setup shown in Figure 2.

Figure 1. Design Drawing of Centrifugal Pump Axial Thrust Test Rig.

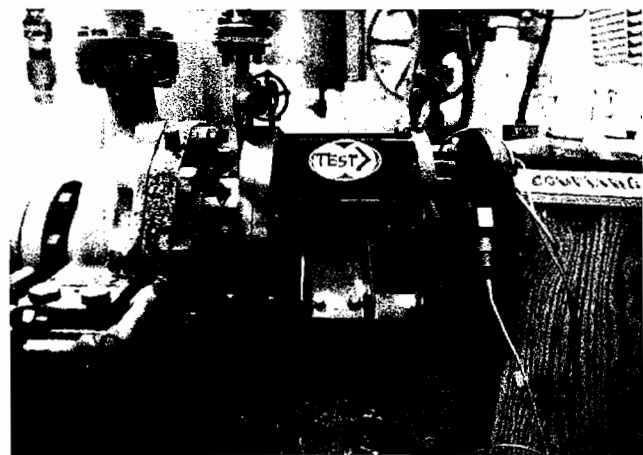
Figure 2. Field Installation of Special Bearing Housing Which Verified Centrifugal Pump Axial Thrust to be Excessive.

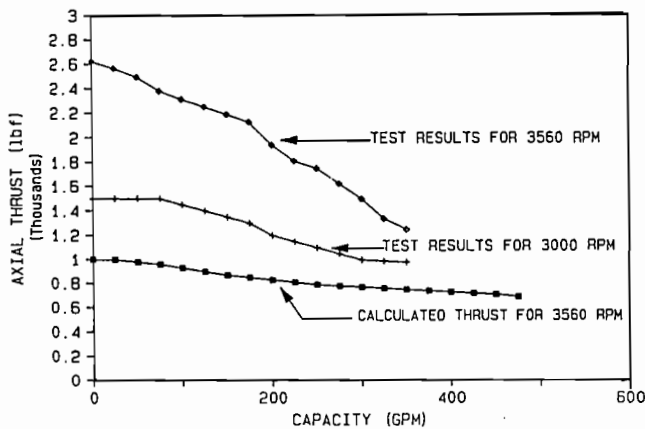
Test results were plotted and compared to the manufacturer's calculated and originally anticipated thrust values for this pump. As indicated in Figure 3, the experimentally verified thrust at shutoff was 2.6 times greater than anticipated. Since ball bearing life varies as the cube of the load changes, the life of the pump bearing would thus be reduced by a factor of 17.

Figure 3. Experimentally Verified (Actual) Rotor Thrust Exceeds Manufacturer's Anticipated Values by a Factor of 2.6.

The test results convinced both the operating company and the pump manufacturer that the pump internals had to be redesigned to limit hydraulically induced thrust values to more reasonable limits. Obviously, the basic agent of the bearing failure mechanism was excessive force.

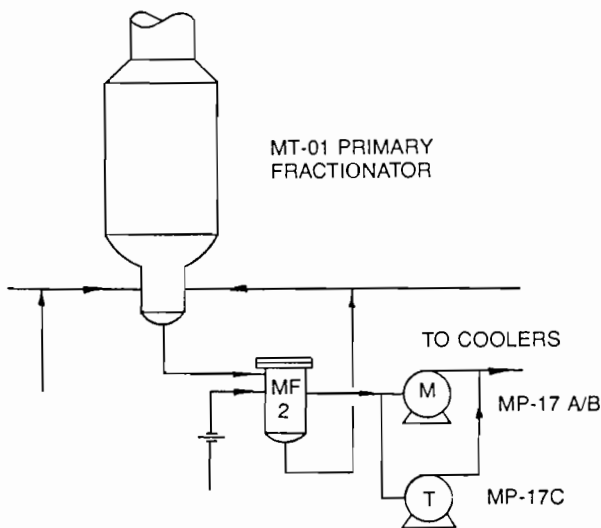
The pump in Figure 4 is identified as one of the MP-17 A or B sets feeding 320 gpm of tar at temperatures around 500°F from the primary fractionator tar boot and coke filter MF-2, through tar coolers and on to downstream process equipment. Pump design inlet and discharge pressure conditions were 10 psig and 300 psig, respectively.

Figure 4. Flow Schematic Showing Tar Pump (MP-17A) Involved in Fire Event.

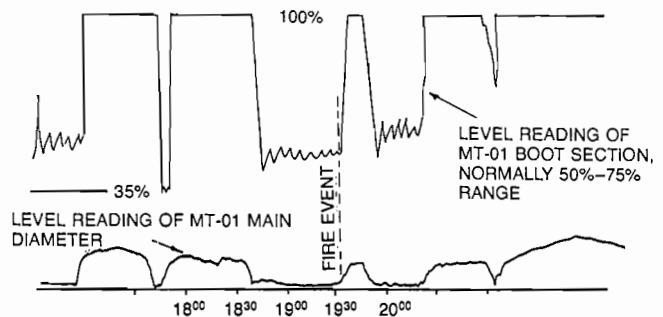
Satisfactory operation is graphically represented in Figure 5, the strip chart obtained from the trend recorder for fractionator boot and main vessel level. At 17:30, or 5:30 p.m., the chart shows the boot level to be 100 percent. About 10 minutes later, the boot level was reduced to 35 percent for approximately 5 to 10 minutes before finally returning to 100 percent. The chart verifies that the boot level never dropped below 35 percent on the day of the failure incident. Therefore, pump operation errors or off-design service conditions did not seem at fault and were ruled out.

Figure 5. Strip Chart Showing That Adequate Liquid Level Existed in Suction Drum at all Times.

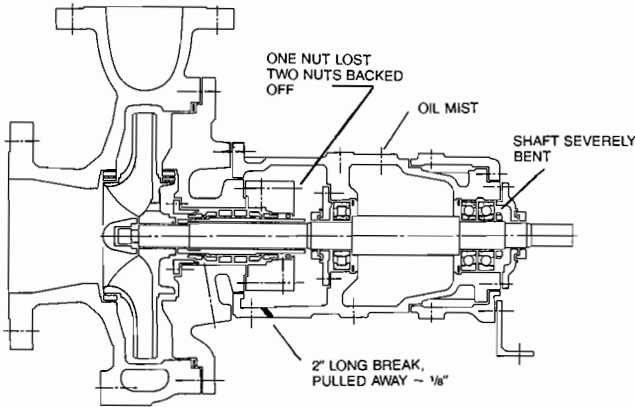
When the pump was dismantled, the seal area was found in clean and undamaged condition. Some solids were found in the impeller. Impeller wear rings and inboard bearing appeared satisfactory. The duplex thrust (outboard) bearings were totally destroyed. Severe metal loss was noted on virtually every bearing ball. Many balls were deeply embedded in the inner race; the ball separators had disintegrated. The shaft was severely bent in the region adjacent to the duplex bearing lock nut (Figure 6). Two of the four seal gland nuts had loosened, a third one had fallen off completely. A pedestal support bracket at point A had not been connected to the pump casing. The ductile iron bearing bracket was fractured at point B.

Figure 6. Schematic Cross-Sectional View of Centrifugal Pump.

fire. Excessive friction resulting from severe and near-instantaneous bearing failure could have caused the shaft to bend. Extreme vibration was certain to be generated and could have caused the less-than-optimally installed seal to release pumpage. By this time, the outboard bearing area was thought to have been red hot, causing spilled pumpage to ignite.

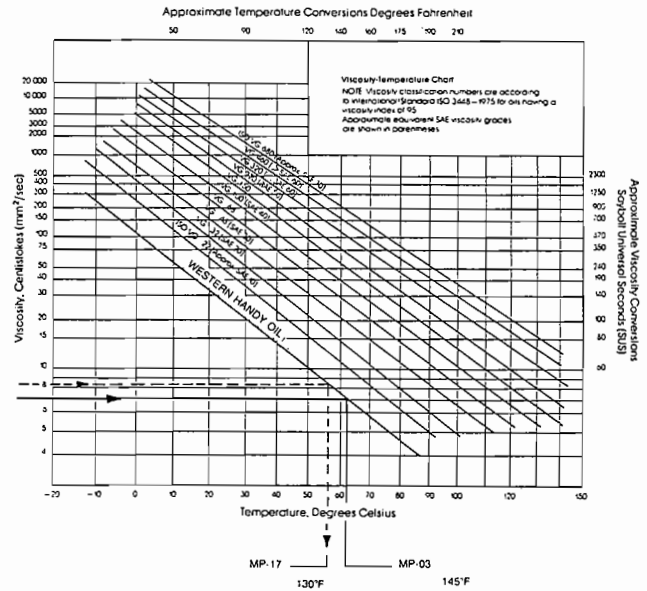
The chart in Figure 7 was used to determine the viscosity required to adequately lubricate the MP-17 bearings. At a mean diameter of 87.5 mm and a speed of 3570 rpm, a minimum lubricant viscosity of 8.3 cSt is required. As shown in Figure 8, maintaining this minimum viscosity is possible only if operating temperatures do not exceed 130°F. Newly installed duplex and double row thrust bearings will, however, experience temperatures well in excess of 130°F. Although a superior grade oil mist lubricant was supplied to these particular pump bearings, the mist lube could not overcome the diluting effect of the inferior low viscosity oil which was present in a “trough” formed by the bearing outer race at the six o’clock position. The existence of this “trough,” or minisump explains why oil mist lubricated bearings in horizontally arranged pumps and drivers generally survive for periods of eight or more hours after the oil mist supply has been turned off. Unfortunately, if the minisump is filled with a dilutant, the beneficial effects of applying highly viscous lubricants cannot come into play until the damage is done.

Figure 7. Temperature-Viscosity Chart Illustrates that Excessively Low Viscosity Lubricants Will Not Support Oil Film at Temperatures Typically Encountered by Process Pumps.

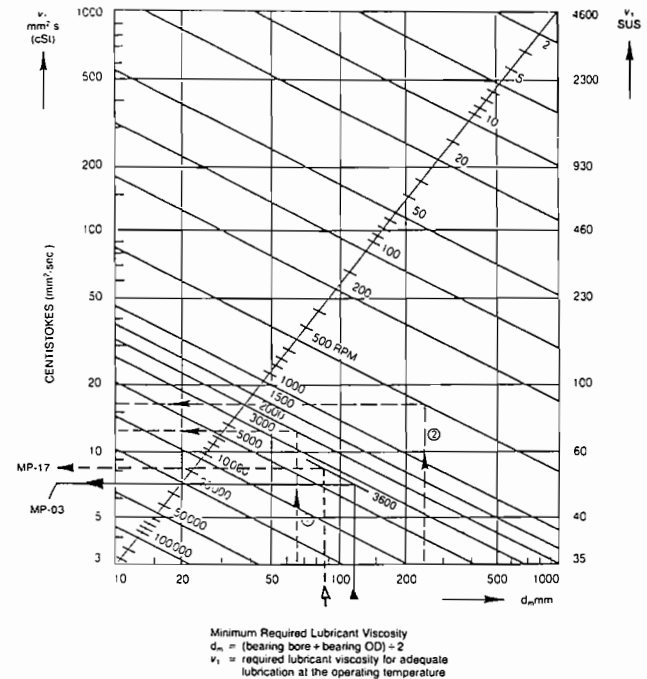
In conclusion, prelubrication with an inadequate lubricant was proven to be the root cause of this and other serious pump failures which had preceded this particular event. Had the reviewer allowed himself to be distracted by additional but, in the final analysis, minor deviations such as the out-of-perpendicularity of seal faces, defective sleeve gasket, and a missing support brack-

Figure 8. Oil Viscosity Requirements Plotted vs Mean Bearing Diameter and Shaft Speed.

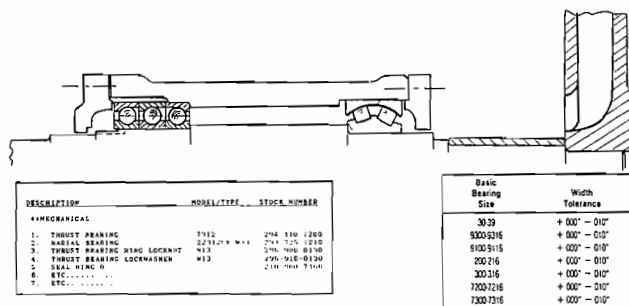
The analysis strategy consisted of a review of the vibration records, repair history, spare parts consumption, and physical examination of bearing and impeller wear patterns. Since the pumps had been designed and manufactured by an experienced company and were generally running quite well, the cause categories "Faulty Design," "Fabrication or Processing Errors," and "Assembly or Installation Defects" were not considered high on the list of probable failure initiators. There did not appear to be any material defects on either the badly worn bottom bearing or the slightly cavitation-eroded impeller vanes. Accordingly,

Figure 9. Bearing Housing Showing Ball Thrust Bearings Which Failed Frequently.

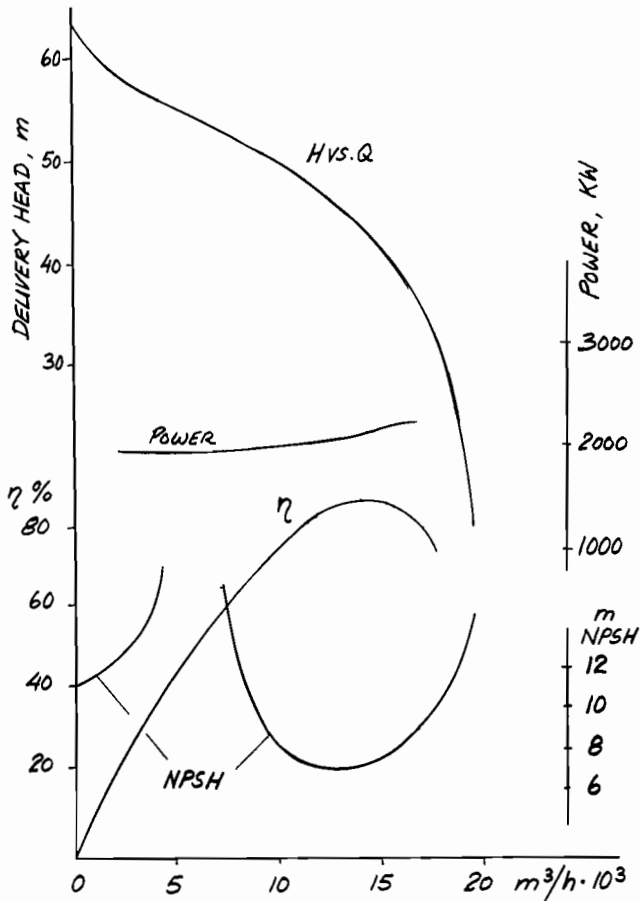
Figure 10. Performance Chart for Vertical Pumps in Seawater Intake Service. Note NPSH trace.

When operating at throughputs in the vicinity of 5,000 cubic meters per hour, the required NPSH (net positive suction head, largely a measure of inlet pressure) would be exceedingly high, certainly twice the NPSH required at 10,000 cubic meters per hour. With the available NPSH for each seawater intake pump essentially fixed at roughly 12 meters, reductions in throughput flow from the customary 8,000 cubic meters per hour per pump could rapidly drive the pump performance into the cavitation range where high vibration would be encountered. The equipment owner was advised to consider installing an automatically controlled low flow bypass loop or a combination of supervisory instrumentation and seawater consumer-to-pump-operator communication link (audio-visual electronic interface). This would give the utility crew sufficient time to always have only that number of pumps on line which would be needed by the downstream processes while at the same time satisfying the flow requirements of each individual vertical pump.

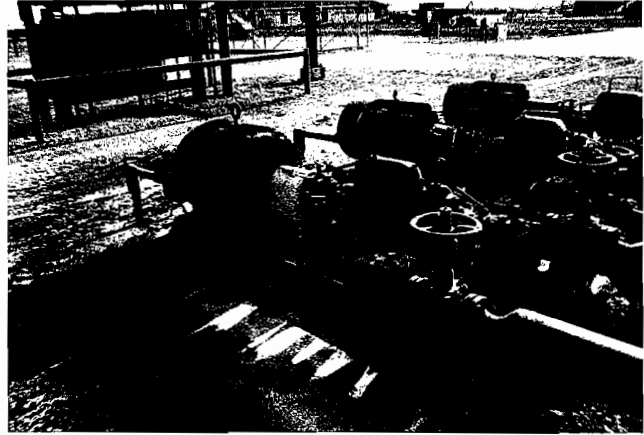
One of the more tragic pump failure incidents occurred at a hydrocarbon processing plant in the U.S. Gulf Coast area in 1982 (Figure 11). It involved the pump shown in the foreground of Figure 12.

Figure 11. Propane Pumps Involved in a Disastrous Flash Fire.

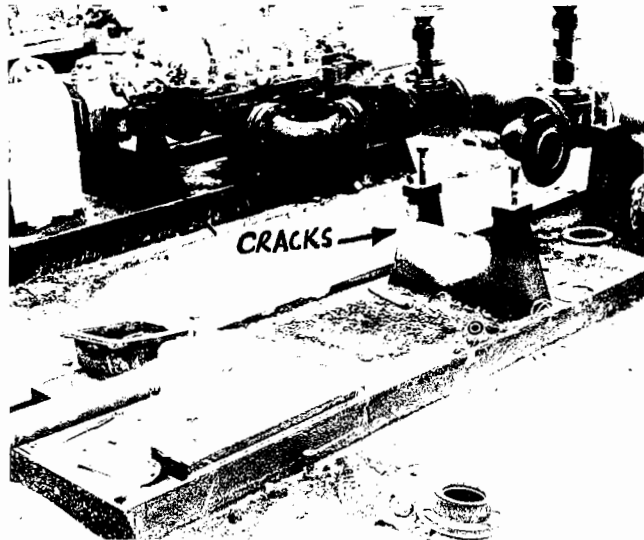
Figure 12. Broader View of Pumps in 1982 Hydrocarbon Processing Plant Accident.

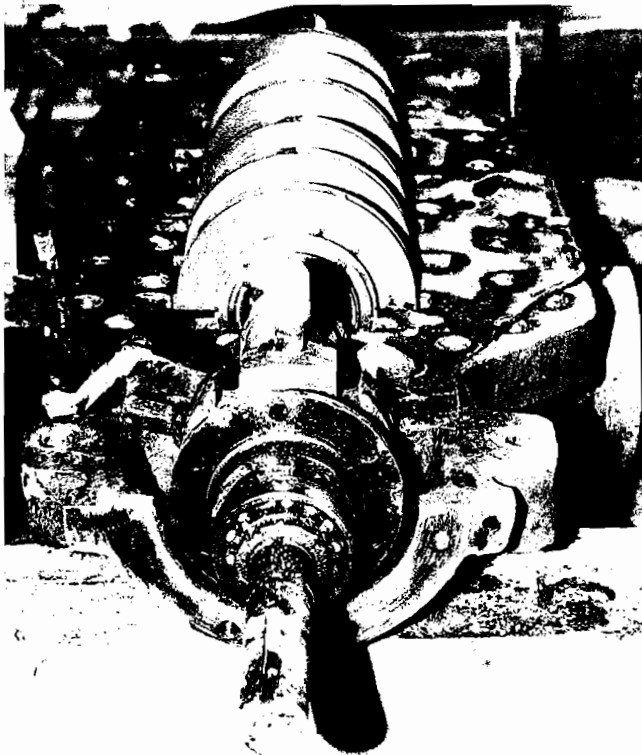
Figure 13. Pumps Internals Immediately After the Fire.

- Severe internal misalignment now caused the ball separator on the radial bearing (near drive end) to disintegrate (Figure 13).

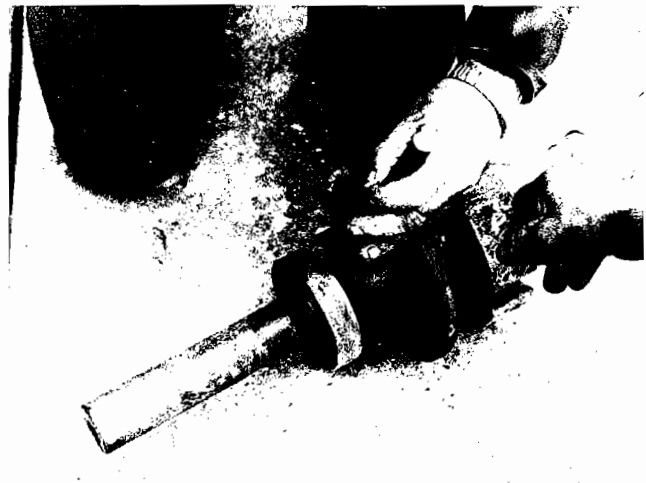
Figure 15. Questionable Procedure for Removing Rolling Element Bearings (Pump Inboard Side).

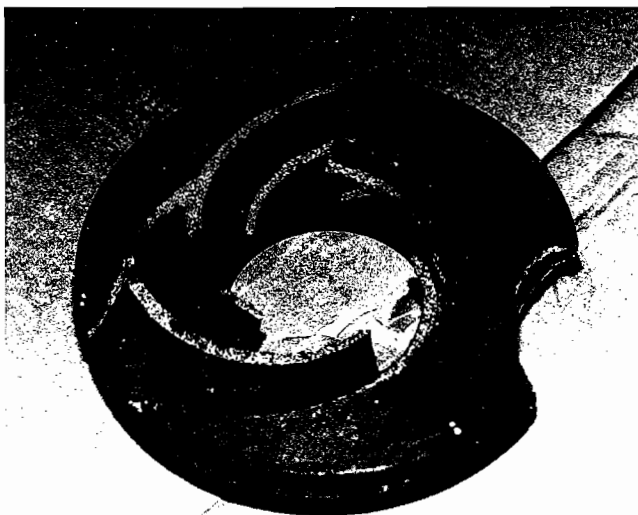
Figure 17. Impeller Destroyed at Disassembly.

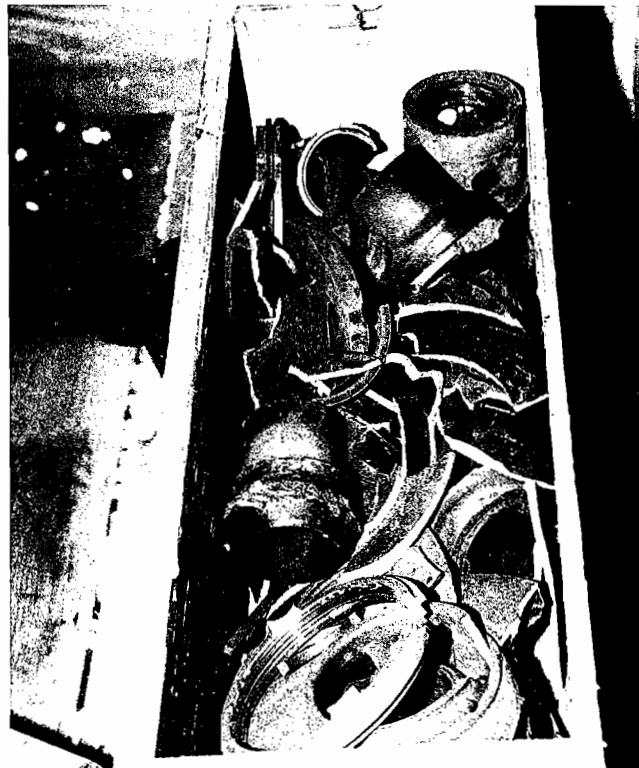
Figure 18. More Components Destroyed at Disassembly.

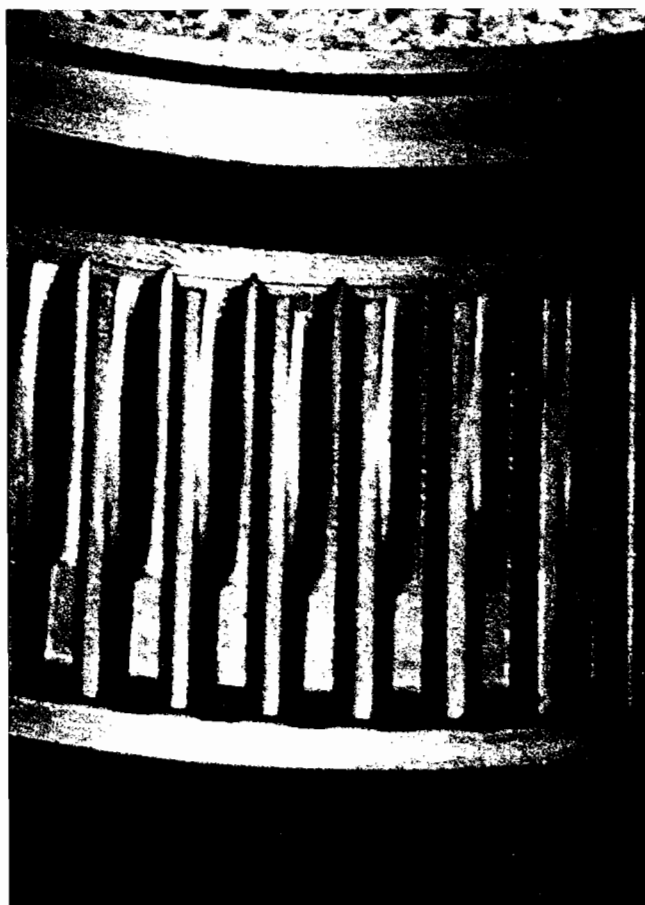
Points of evidence: severe ridges were visible in the softer of the two mating gears; no traces of lubricant were found in the drive-side coupling on the failed pump set; also, no traces were found of lubricant in the couplings of both adjacent identical pump sets.

Figure 20. Closeup of Worn Gear Coupling.
