SEAL RELIABILITY AND PERFORMANCE IMPROVEMENTS IN A LARGE, HIGH-PRESSURE, HIGH-TEMPERATURE BARREL PUMP

by
Ed Wilcox
Senior Staff Engineer
Conoco, Inc.
Westlake, Louisiana

Modifications to a high-pressure, high-temperature barrel pump to increase seal reliability and throughput are discussed. The pump is in unsparred hydrodewaxer (HDW) feed service. The original seal design included nonpressurized dual seals to provide an additional level of reliability. However, due to the heavy-oil/high-temperature nature of the service, the dual seals produced less than desirable run times. Substantial modifications to the dual seals were made to improve their reliability, but this also proved to be disappointing. Finally, the dual seals were replaced with single seals of a different design resulting in much more favorable results. The paper provides a detailed description of both seal modifications and their results. After approximately two years of service the capacity of the pump became the unit limit. The throughput of the pump was increased by approximately 25 percent without substantial capital outlays. This performance increase was accomplished by modifying the impeller diameter, the impe

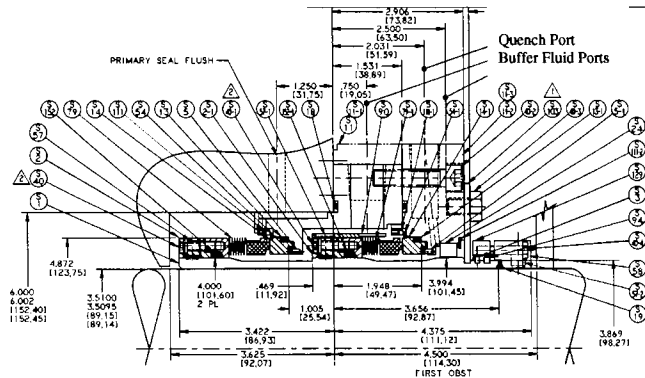
Figure 3. Dual Seal with Rotating Metal Bellows, Original Design.

- Leakage from the seal pot into the pump (i.e., past the primary seal) may have been a result of poor fluid circulation under the primary bellows (even though the seal sleeve was relieved under the bellows), which could have caused excessive temperature. This was supported by the large amount of coking found under the primary bellows. Because of the tandem arrangement, there is only a 0.125 inch clearance between the back of the primary seal and the front of the secondary seal (Figure 3).

A single, stationary metal bellows seal was selected to replace the dual seals (Figure 15). Because more axial space was available with a single seal, an anti-coking device could be incorporated in the design and a thicker bellows was used. Likewise, the seal flush that had been used to fill the seal pots was now used as an external flush on the seals, i.e., API Plan 32. The seal flush was routed through the seal gland instead of the gland tap to ensure adequate flow past the seal faces. Likewise, the Plan 11 flush from the

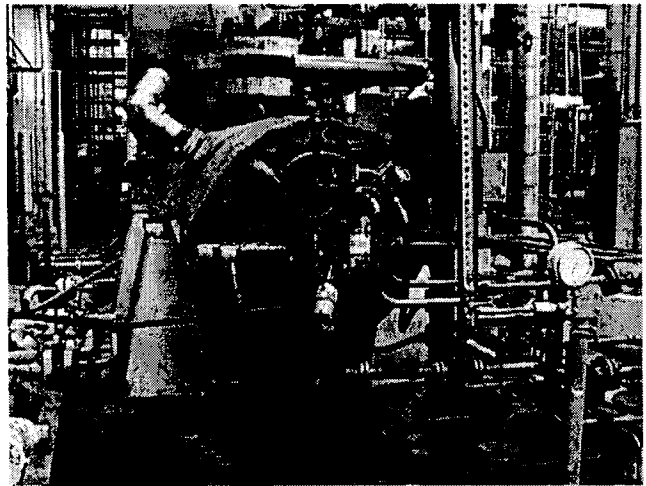
Figure 5. Oil Vapor Blowing Out of Secondary Seal and Accumulating on Baseplate.

This caused the seal pot to pressure up to approximately 30 psig, which blew out the secondary seal. Inspection of the seal revealed a large amount of coking on the outside of the secondary seal and excessive wear on the secondary seal faces (Figures 6 and 7).

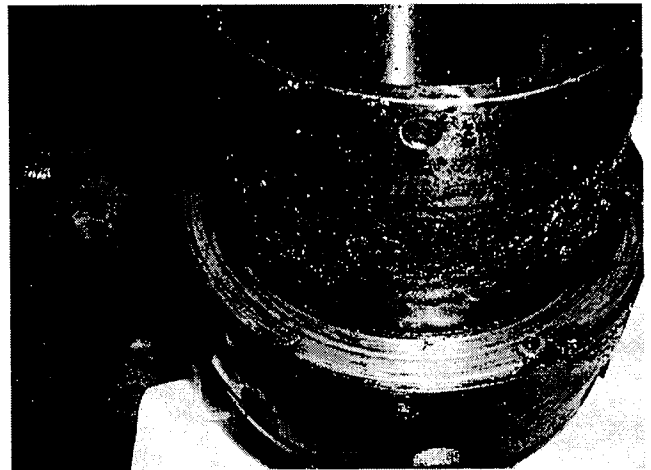
Figure 6. Wax and Coke Buildup Under Primary Bellows (Back of Secondary Seal).

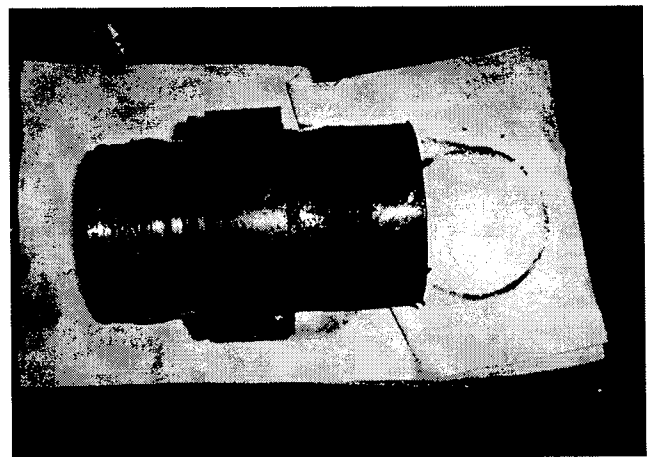
Figure 7. Coke Buildup on Sleeve (Secondary Seal Is Still on the Sleeve).

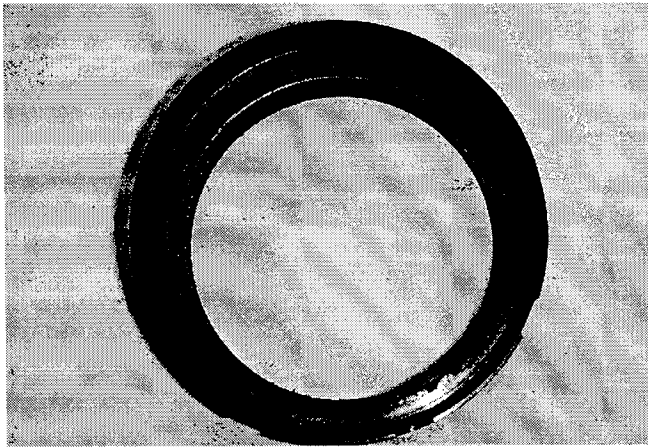
It was thought that the waxy gas oil was eventually contaminating the seal oil pot to the point that the secondary seal was running dry, which resulted in the excessive face wear. Likewise, because of the high surface velocity and low fluid pressure on the secondary seal (1 psig), it was thought that the secondary seal was not being properly lubricated (i.e., the centrifugal effects on the oil were overcoming the hydrodynamic pumping action of the seal). This was confirmed by the evidence on the secondary seal carbon face that the seal was running hot and contacting on the inside diameter (Figures 8 and 9). A hydrodynamic/thermal model (Lebeck, 1991) of the seal faces confirmed that there was a large amount of thermal deflection of the rotating seal face. This produces a highly convergent face profile resulting in contact on the inside diameter of the seal faces (Figure 10).

Figure 8. Secondary Seal Face Showing Evidence of Excessive Heat/Lack of Lubrication.

The seal design was changed to a pressurized tandem. This would keep the waxy gas oil out of the seal pot and also provide

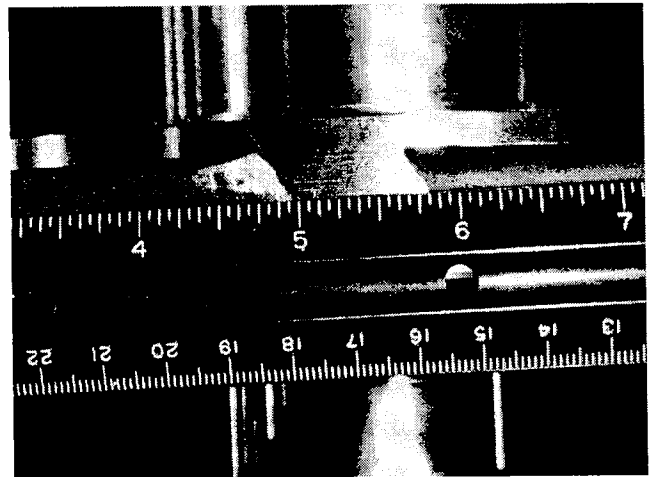
Figure 22. Impeller Vane Before Underfiling.

The impeller vane thickness at the tip was reduced from 13/16 inch to 3/16 inch (Figures 21, 22, and 23). This reduced the exit area in the impeller by approximately 3 to 4 percent. It was estimated that the underfiling would increase the capacity of the pump by at least 2 percent. Underfiling the vanes has the added benefit of reducing the pulsation produced by the vanes as they pass by the volute tip. This was especially a concern since the volute to vane tip clearance had been reduced as mentioned above. Angle cutting the impeller vanes and volute tips to reduce the pulsation was considered; however, it was not performed because it might have reduced the performance of the pump. It was believed that the other changes would reduce the pulsation to an acceptable level.

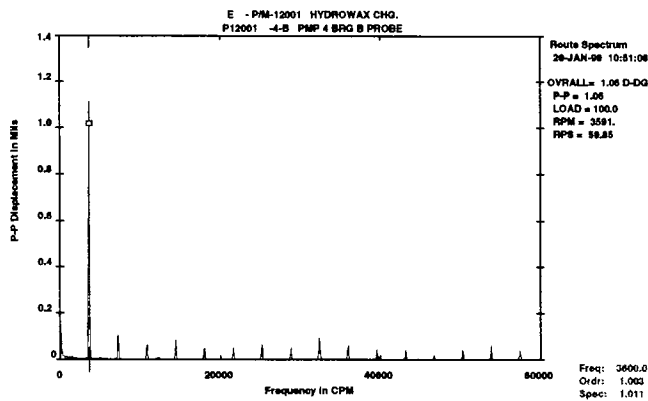
Figure 36. Shaft Vibration Before Upgrade.

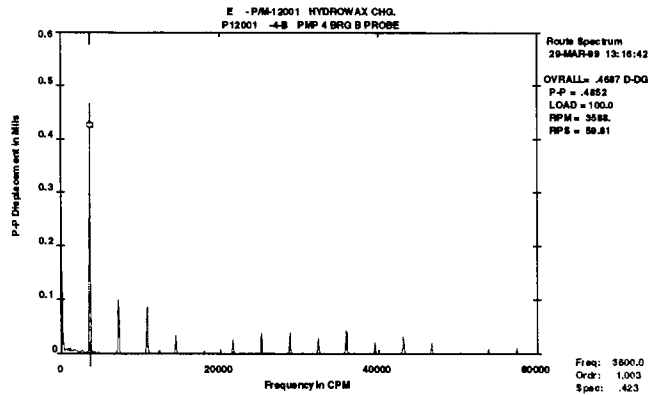
The modified rotor and bushings were installed in the HDW charge pump in February of 1999. The performance was measured immediately after startup and was found to be above the predicted values (Figure 35). This was probably a result of improvements in efficiency caused by the reduced vane-to-volute clearance that was not taken into account. Since then, the performance has been checked several times and has shown no decrease. The overall vibration of the HDW charge pump has been less than 1.0 mil of shaft displacement since the modification. Figures 36 and 37 are shaft vibration spectra from before and after the modification.

Figure 37. Shaft Vibration After Upgrade.
