The Effect of Foundation Piers on the Natural Frequencies of a Vertically Mounted Sewage Pump in Resonance with Vane Pass Excitations

27th International Pump Users Symposium
George R. Brown Convention Center
Houston, TX
September 12 - 15, 2011

Paul A. Boyadjis

Mechanical Solutions, Inc.

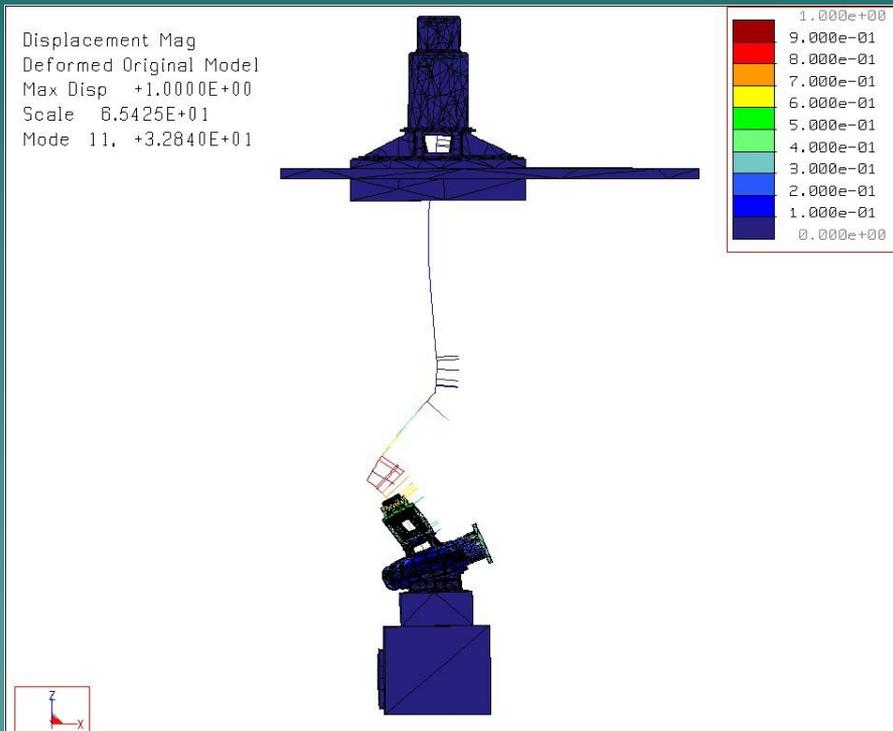
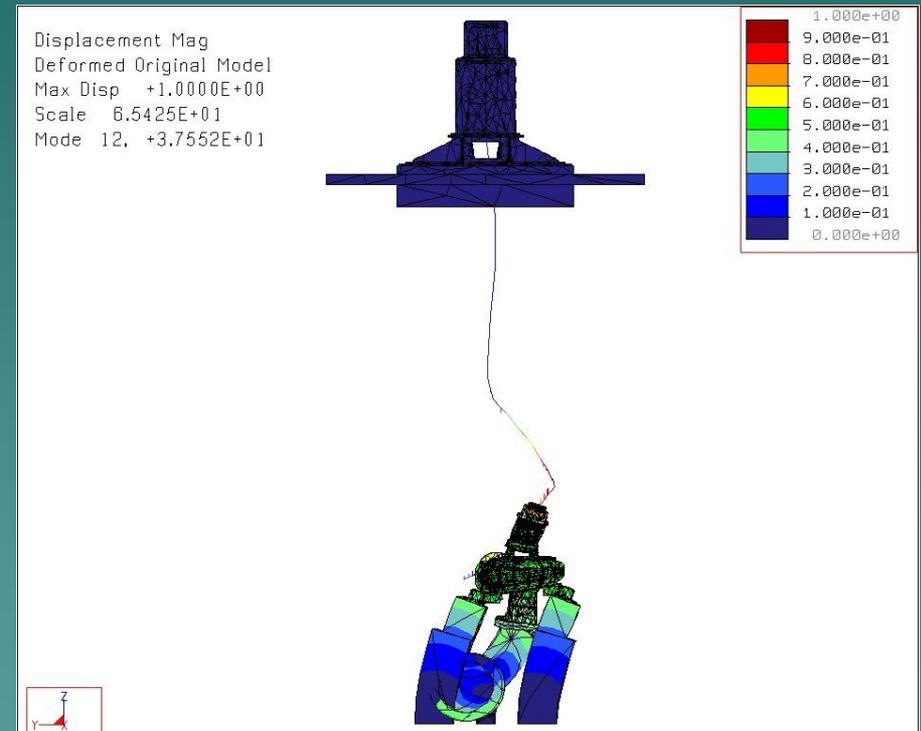
Figure 1

- ◆ Preliminary analysis found that the entire pump volute casing mounted on two 10 ft. high vertical concrete piers predicted rocking modes that fell within 4x running speed of the pump (36.8 Hz-39.7 Hz) and the $\pm 20\%$ separation margin range of 29.4 Hz to 47.6 Hz

Casing Rocking Modes @ 32.8 Hz and 37.6 Hz

- ◆ Modifications to the model were made prior to the pump's installation which consisted of supports for the suction and discharge nozzles as well as joining the two vertical piers on the discharge side to form a horseshoe support. These modifications were predicted to raise the offending casing rocking mode natural frequencies to 20% above 4x running speed (vane pass) to ~ 48 Hz.

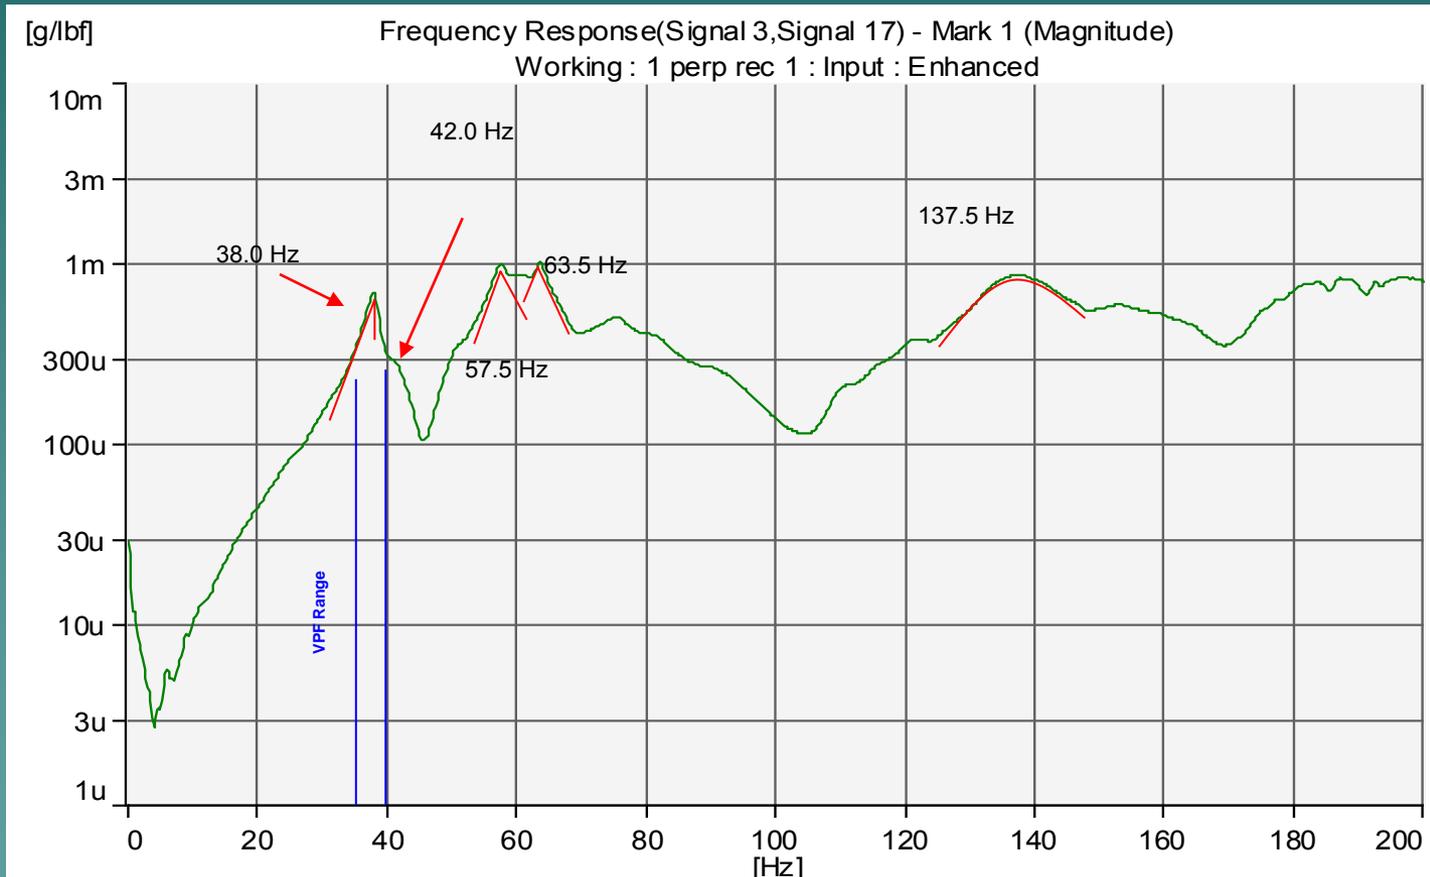
Figure 5

Hammer Impact Modal Response at Bearing Tower

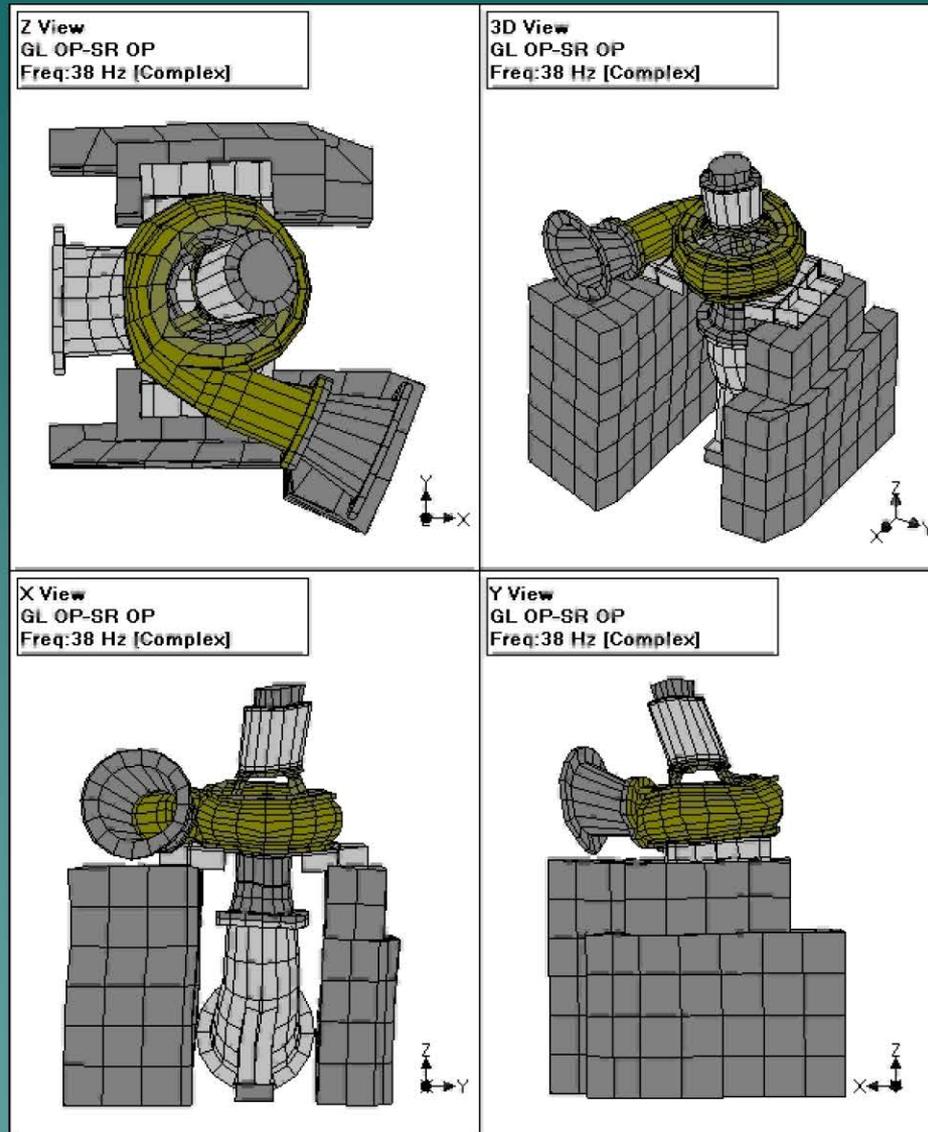
Figure 6

Modal Test Animation at 38 Hz

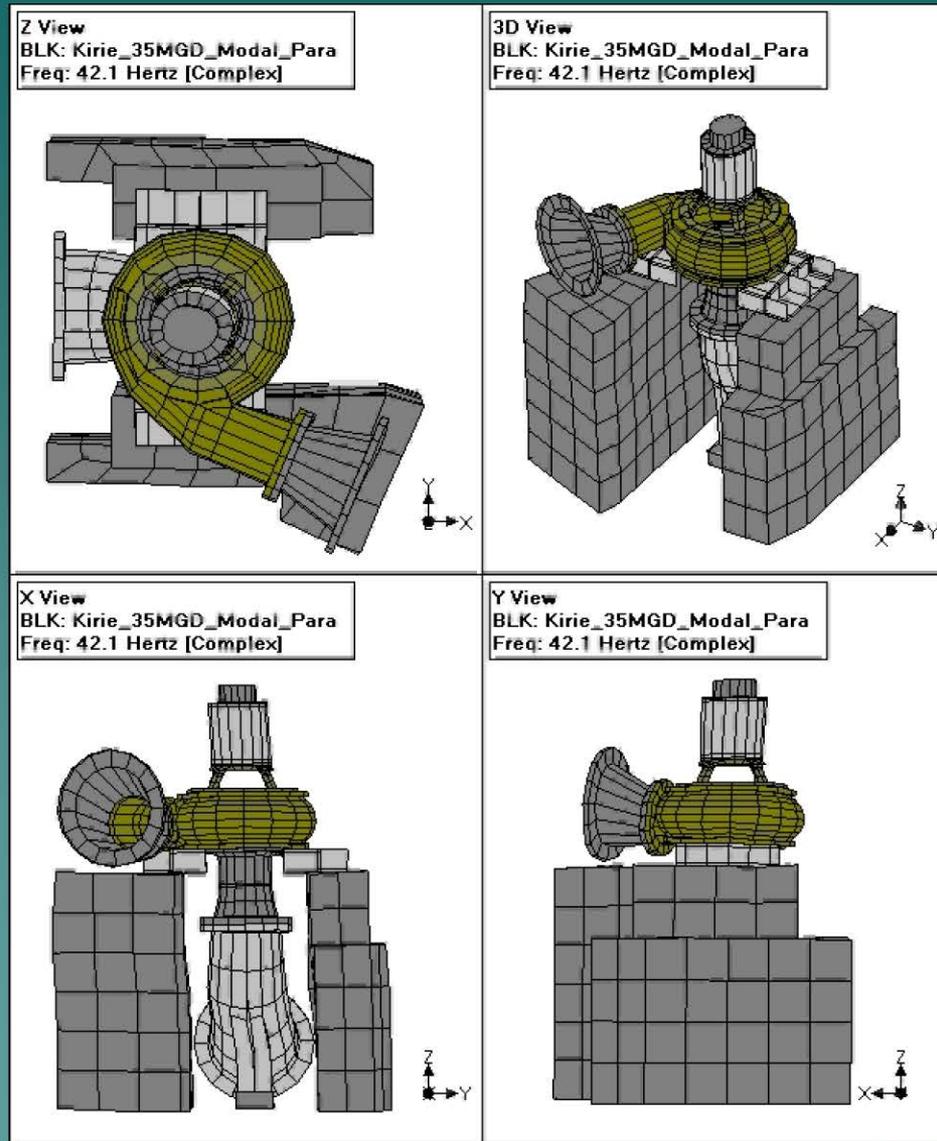
Figure 7

Modal Test Animation at 42 Hz

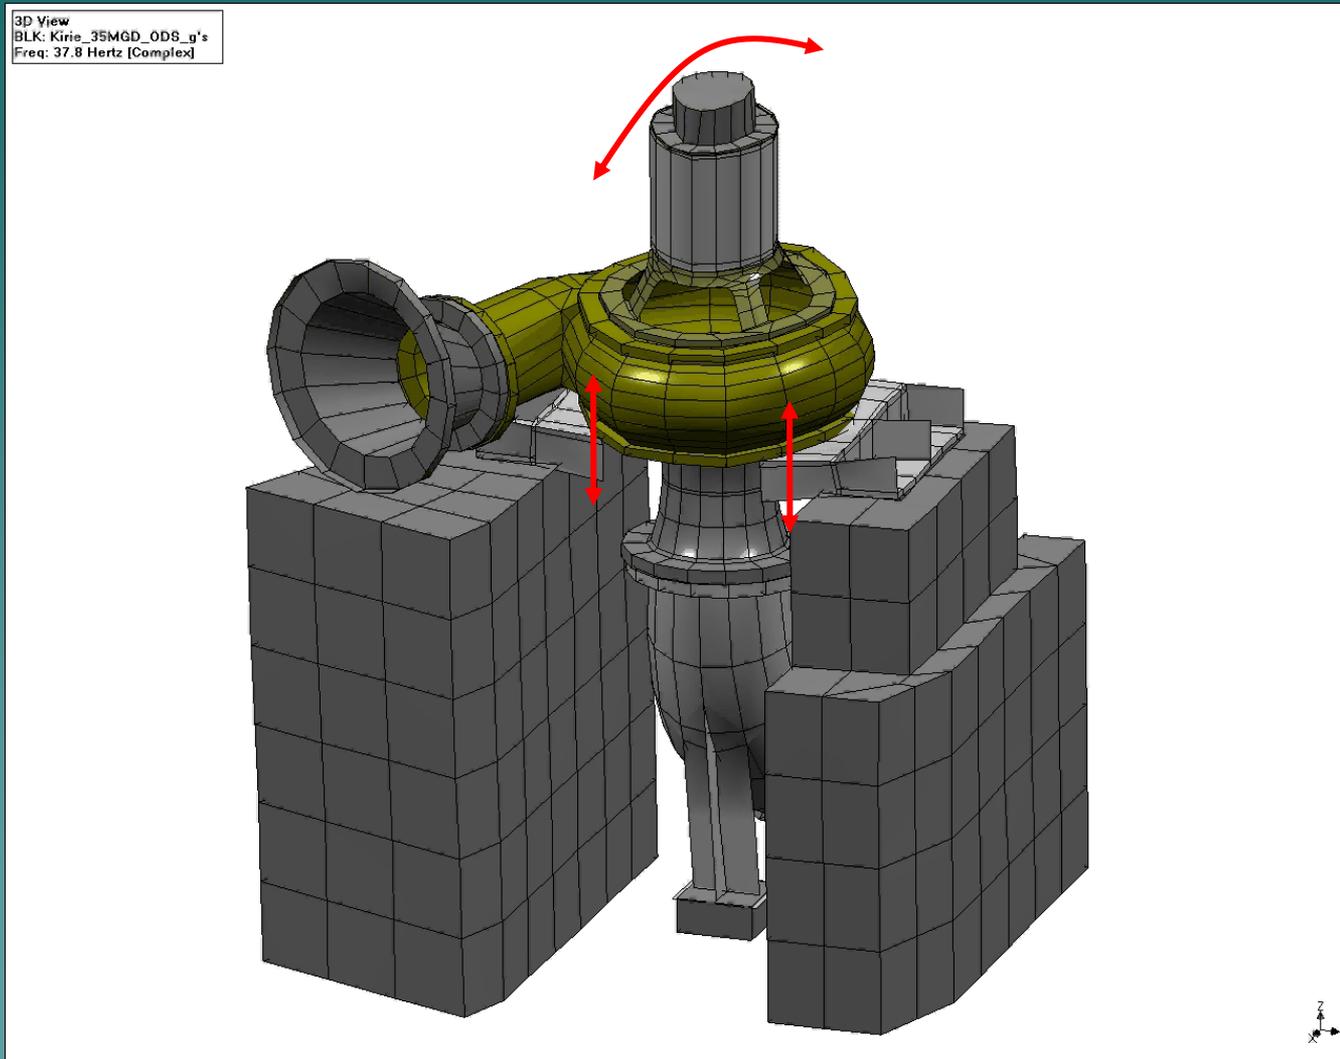
ODS Animation at VPF (38.0 Hz)

- ◆ Clearly the high vibration was due to the casing rocking natural frequency in the vane pass operating range at 38 Hz.
- ◆ Apparently due to access issues the two piers were never connected together, but this information was never communicated back for evaluation.
- ◆ Although the model had originally predicted modes interfering with vane pass, the discharge nozzle being supported should have raised the natural frequency to just outside of the operating range albeit not with sufficient separation margin.

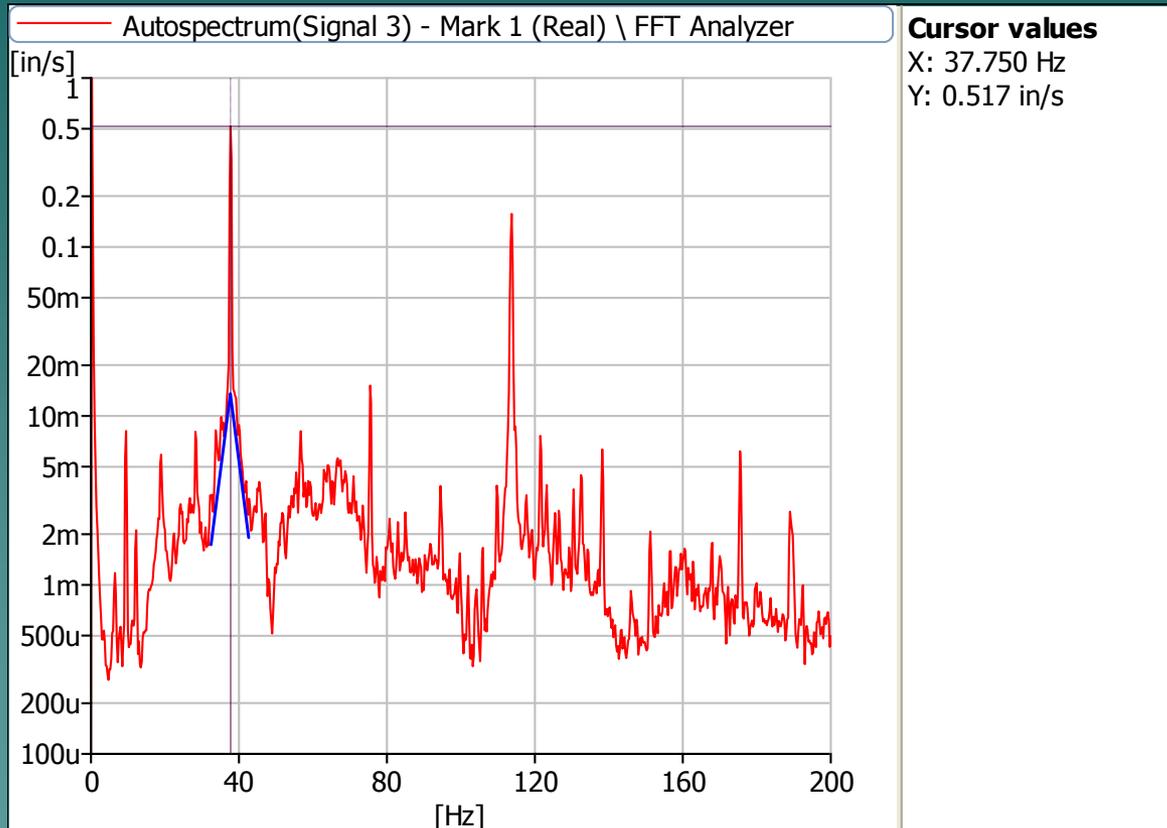
Figure 9

- ◆ When the pump was finally installed, high vibrations were being measured on the pump bearing tower of 0.6 in/s RMS at 4x running speed (vane pass). ***But Why? Hadn't the analysis provided guidance to avoid this???***
- ◆ The task now was to determine the source of the vibration via field trouble shooting methods and propose a suitable solution without costly trial and error field fixes using the existing FEA model.

Spectrum measured at the top of the bearing tower in the parallel (top) direction to the discharge pipe while the pump was running at 570 rpm

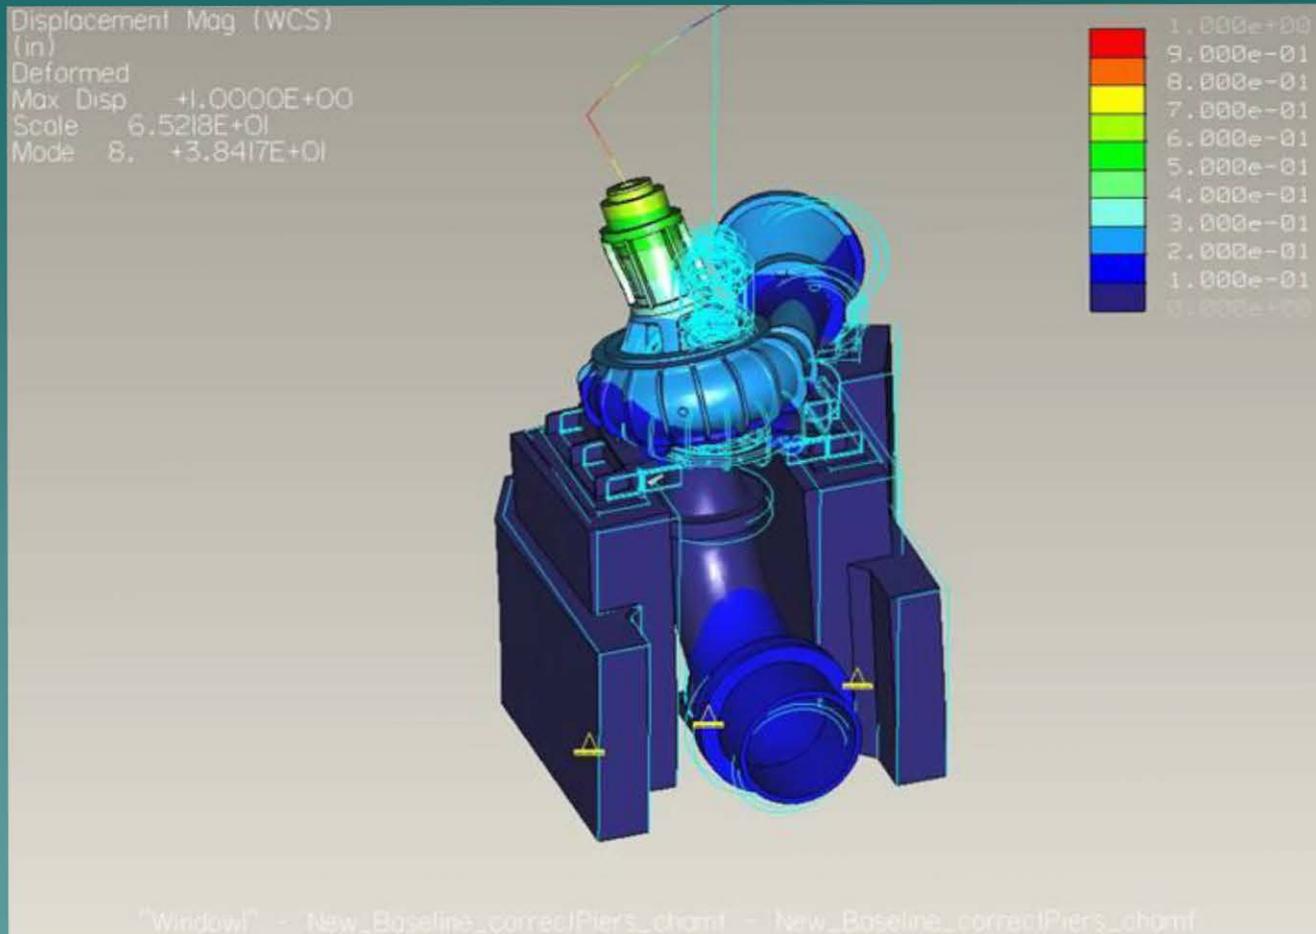
Baseline results with soft mounting at the pump support brackets – 38.4 Hz
Figure 11

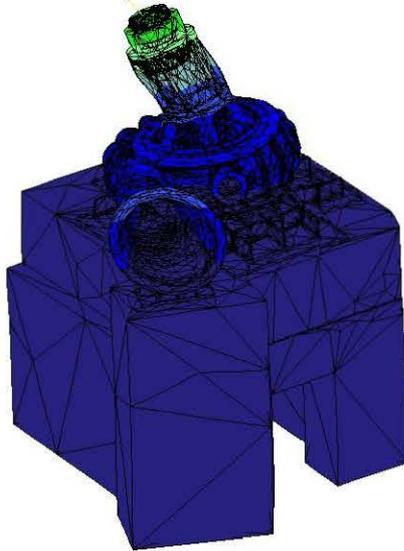
Chamfer cutout from suction beam (soft mount)

Mode 1 – 49.0 Hz

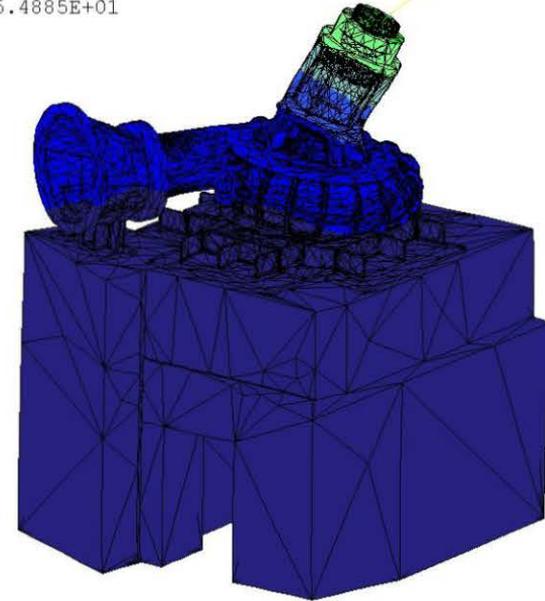
Chamfer cutout from suction beam (soft mount)

Mode 2 – 54.9 Hz

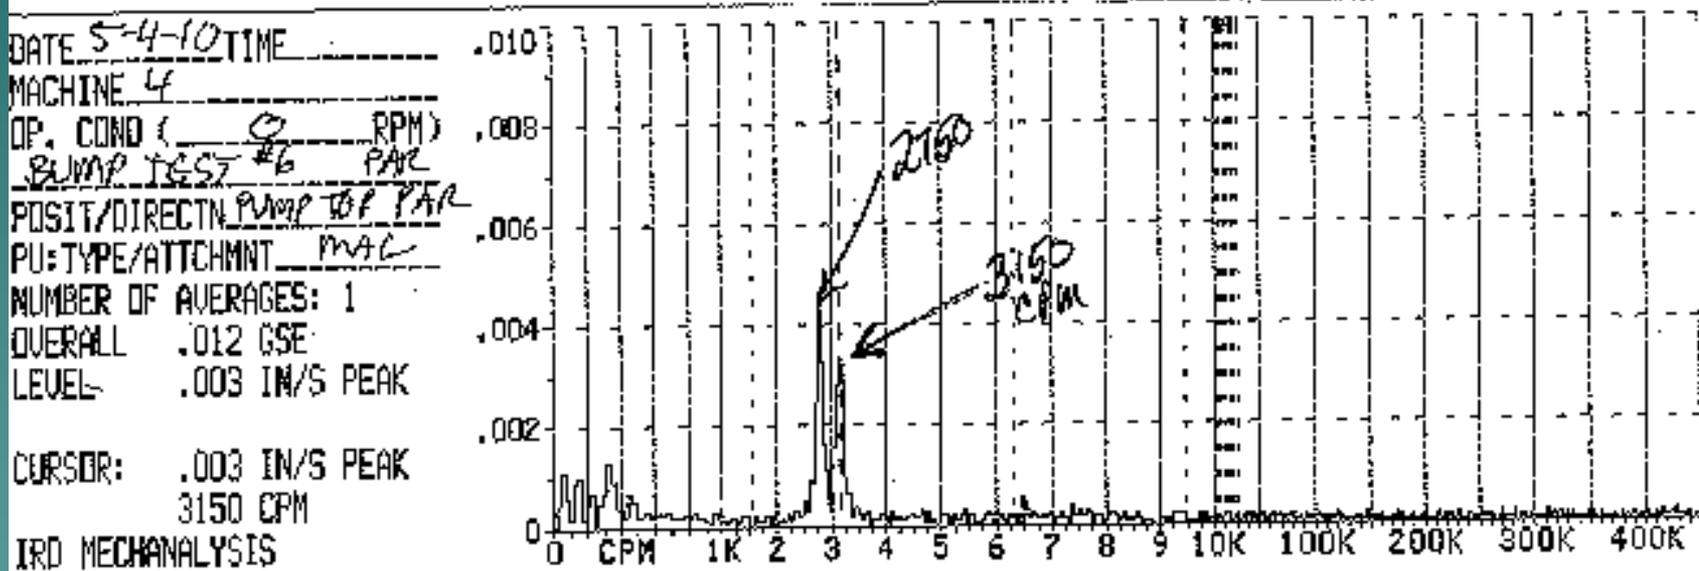
Figure 15

- ◆ After the recommended fixes were implemented, the vibration levels decreased from 0.6 in/s RMS to less than 0.2 in/s RMS at the bearing tower.
- ◆ Follow up field test by others showed that the frequencies that were at 38 Hz had shifted to 46Hz and 52.5Hz, close to analysis predictions.
