A CASE STUDY: UNUSUAL PROBLEMS DISCOVERED DURING THE RERATE OF 2800 HP BOILER FEEDWATER PUMPS AND TURBINES

John P. Henderson

Novacor Chemicals (Canada) Ltd.

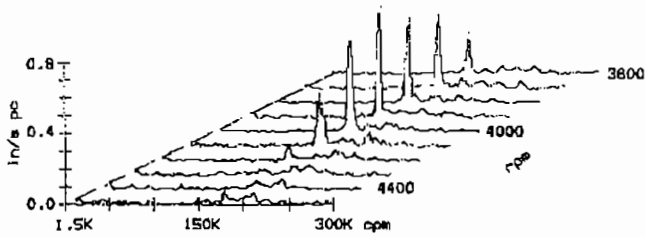
Just before Christmas, an operator happened to be passing by and heard an unusual squeal emanating from the turbine. By the time the engineers arrived with vibration instruments, everything was quiet and vibrations were normal. They decided to do some testing. The "B" pump was put on manual and the speed was varied through the operating range. The "A" pump was left on automatic and adjusted its speed to provide the required flowrates. A dual channel analyzer was programmed for automatic data capture every 100 rpm. A resonance was discovered around 4000 rpm and reproduced the squeal. The vibration energy was fluctuating but extremely high, and was occurring with a specific spike around 162,000 cpm (Figure 3). It was measurable all over the turbine but was highest around the governor valve area (in the 3.0 in/sec and 10 g range). When operating at the resonance speed, they could visibly see the vibrations causing the trip lever to walk off the knife edges. They concluded that this resonance was the root cause of the mysterious trips and the broken governor valve stems. The knife edges were not in particularly good condition. They were replaced and the turbine placed on manual at 4200 rpm where vibration levels were normal and more analysis began. Note that similar vibration resonance patterns were noticed on the "A" pump, but with much reduced vibration amplitudes.

Figure 3. Waterfall Spectrum of OB Turbine Bearing Before Modifications (Vertical Direction).

The analysis pointed to problems with the nozzle ring-governor valve combination. The manufacturer's rerate calculations consist of a simple table showing maximum power, plus a margin, vs flow passing capabilities of various nozzle ring and valve/seat combinations. The horsepower requirements nudged them into the biggest valve/nozzle ring combination available for this turbine. However, further investigations revealed that this table was based on standard mechanical governor data with a maximum valve travel of 0.6 in. The new electronic governor utilized a control valve actuator with a permissible travel of 1.0 in. The company had awarded the governor conversion to the turbine manufacturer specifically to avoid this sort of confusion, but it happened anyway.

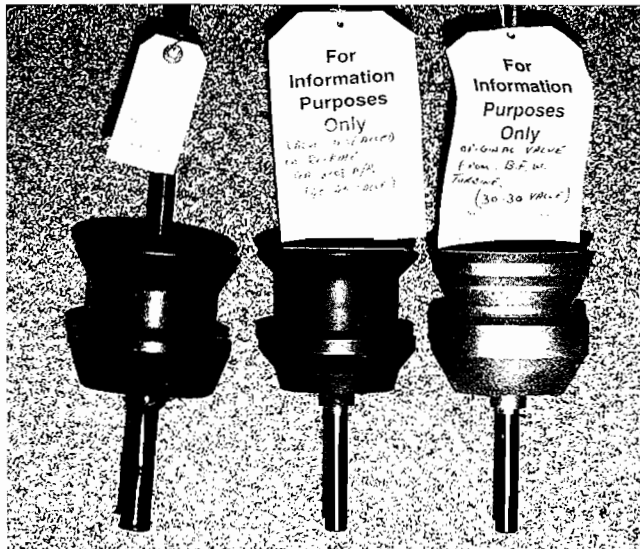
Another test was performed measuring inlet and outlet pressures and temperatures, steam chest pressures, valve stroke, vibration levels and speed in an attempt to correlate stroke to critical pressures. It was unsuccessful. It appeared that they had to put the turbine on manual away from the resonance and forgo the energy saving benefits and the major justification of the electronic governor conversion. But, having progressed so far, the engineers decided to try one more time and install the "more stable" 20-30 degree valve that had finally arrived on site. Note that the physical appearance of the 20-30 valve is identical to the 40-45 valve, except for the machining of the valve angle. The 30-30 valve is a different design and casting (Figure 4).

Figure 4. Turbine Governor Valves Left 20-30, Center 40-45, Right 30-30.

After the fiasco with the performance of the previous valve, their enthusiasm was somewhat dampened. The 20-30 valve was installed and a complete test was performed throughout the speed range. They were very pleasantly surprised to find that all traces of

the problem disappeared. Vibration levels were 0.1 in/sec and were without any signs of resonance. The unit was turned over to Operations without restrictions.

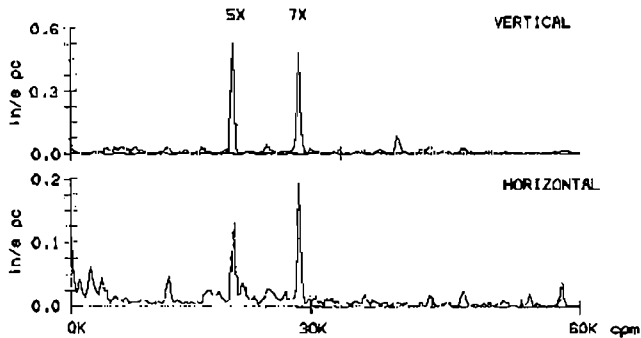
flows were established, overall vibration readings were 0.4 to 0.6 in/sec. When analyzed, all the energy was coming from peaks that were at 5x and 7x running speed (Figure 5). Note that the new pump internals had a seven vane impeller on stages 5 and 6, and five vane impellers on the other stages. The "B" pump had higher vibration levels while the "A" pump also exhibited lesser energy peaks at 3x, 4x and 6x of running speed indicating some kind of looseness (Figure 6). Note that there was little vibration concerns on the outboard bearing. This could be explained by the stabilizing effect of the throttle bushing to that end of the pump.

Figure 5. Typical Frequency Spectrum Of "B" Pump Before Modifications.

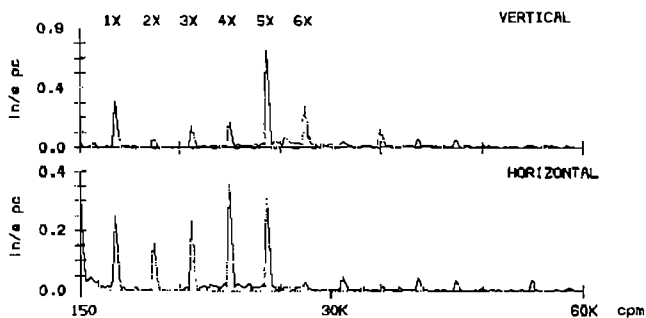
Figure 6. Typical Frequency Spectrum Of "A" Pump Just Before Modifications.

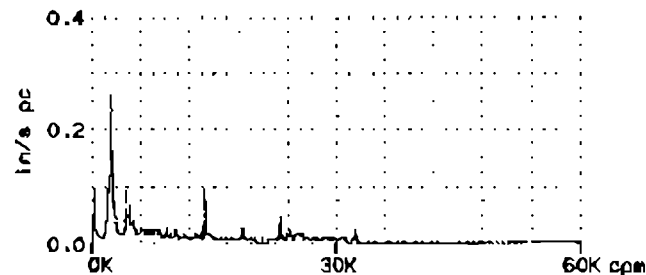
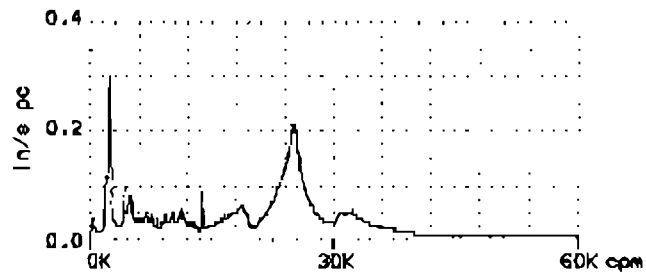
The "B" pump was shut down. A vibration probe was placed on the I/B bearing housing in the vertical plane. A baseline signature was recorded. Then the housing was struck with a rubber mallet numerous times. The frequency analysis showed a definite spike occurring at 25,200 cpm (Figure 7). The process was repeated with the vibration probe in the horizontal direction. A spike was also noticed at 23,175 cpm, but at half the amplitude. This correlated with the field vibration measurements that always showed higher readings in the vertical direction. For our operating speed range of 3700 rpm to 4500 rpm, the 5x range is 18,500 cpm to 22,500 and the 7x range is 25,900 cpm to 31,500 cpm. This could explain the strange variance of the 5x and 7x spikes in our field testing.

A - BASELINE SPECTRUM

B - NUMEROUS IMPACTS WITH RUBBER Mallet - 32 AVGS

Figure 7. Results of Resonance Testing Of IB Pump Bearing Housing (Vertical Direction).

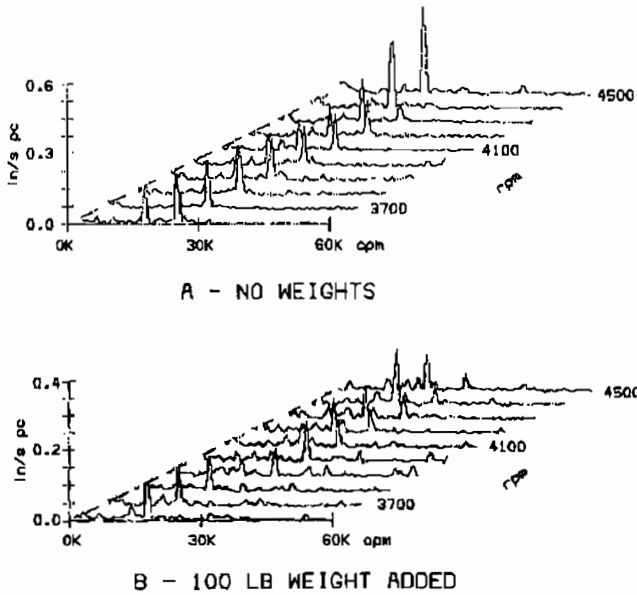
Then weights were added to the bearing housing in an attempt to alter its natural frequency. A long threaded rod was installed in the bearing housing lifting eyebolt tap and first 65 lb and then 100 lb of lead weights were bolted in place. The pumps were run through the operating speed range and vibration levels were compared to the baseline. The engineers discovered that 100 lb of weight significantly changed the overall vibration levels and the magnitude of the 5x and 7x frequency spikes as the speed varied (Figure 8).

Figure 8. Waterfall Spectrum Showing Effects of Adding Weights to Pump IB Bearing Housing (Vertical Direction).

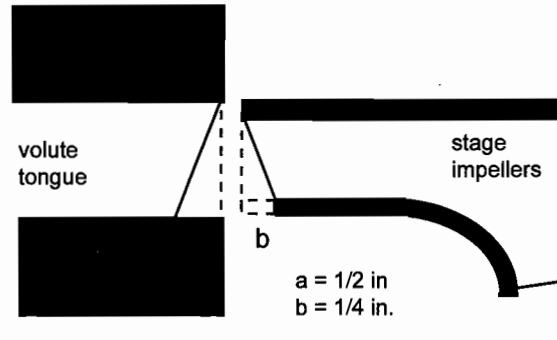
cy vibrations and specify that the gap shall be "at least six percent." The "as built" gap of 6.8 percent was marginally acceptable. The manufacturer developed a repair recommendation to increase this gap in very creative fashion. Instead of just trimming the impellers and underfiling to restore the head, they trimmed the impellers at an angle. And the angle cuts were in the opposite direction of the volute trims. The theory was to create a "scissoring" action that would not only increase the effective gap, but would change the energy distribution over the volute tongue to lessen the magnitude of the pulsations. The eye side of the impeller tips were cut back about 1/4 in and the volute tongues 1/2 in in the opposite direction. The first stage was a double suction and the same theory was used resulting in "V" cuts (Figures 9 and 10).

Figure 9. Impeller/Volute Trim Detail.

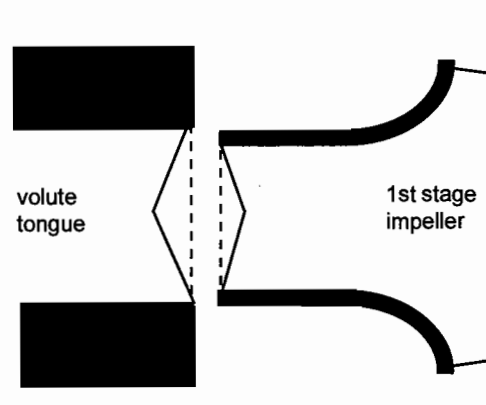
Figure 10. Impeller/Volute Trim Detail.

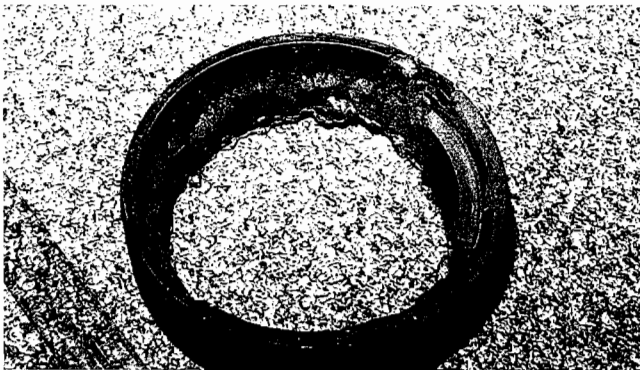
When the pump O/B end cover was removed, severe cavitation damage was discovered. The throttle bushing and sleeve are overlaid with welded stellite material. The sleeve on the shaft had contacted the stationary bushing. They had welded themselves together and spun in the support. This had opened a leak path and the interstage pressure of 1000 psi had cavitated the 3/4 in housing almost to failure (Figure 11). The investigators did experience some system upsets during start up that might have caused excessive rotor movement and contact. Another plausible explanation was improper installation. They discovered that the bearing housings had not been realigned after the new internals were fitted. Note that the company did not employ the services of the manufacturer's service representative during the original installation to reduce costs. The company did have them onsite for all the rebuilds.

Figure 11. Cavitation Damage to Throttle Bushing Holder (Cut Off End Cover).

The end cover was shipped to the manufacturer's repair center to have the washed out holder cut off and a new ring welded on. A new throttle bushing was installed and the repaired end cover was back onsite within three days. The new suction end cover with the heavier bearing supports was installed (Figure 12) and the bearing housings were carefully aligned. The new pump bundle was fitted without incident.

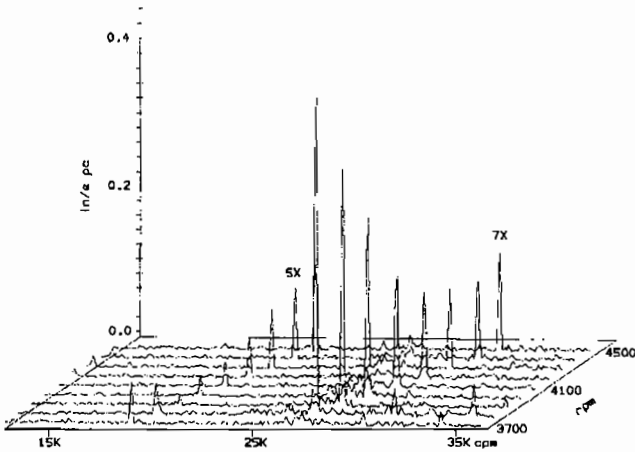
Complete success was almost achieved. Overall vibration levels were way down to acceptable levels. However, the spectrum analysis showed that the vibration energy was still coming from 5 \times and 7 \times peaks, albeit at much lower levels. As speeds were lowered and the pump was pushed back on the curve, the 5 \times spike dropped off but the 7 \times peak increased to 0.4 in/sec at 3900 rpm indicating that there was still some sort of resonance (Figure 13). Also, the repaired "B" pump now operated at 85 rpm faster than the "A" pump indicating that the underfilling did not restore the head expected. It was a little disappointing to the perfectionists but the unit was turned over to Operations without restrictions. Shortly after, the pump was shut down for a minor turbine repair and the bearing housing resonance test was repeated. The previous vertical resonance had all but disappeared.

Figure 13. Waterfall Spectrum Of "B Pump 1B Bearing After Modifications (Vertical Direction).
