A VERY HIGH HEAD PUMP

by
J.T. McGuire
Director, Special Products
and
Vahe Hayrapetian
Engineering Consultant
Flowsolve Corporation
Pump Division
Vernon, California

ABSTRACT

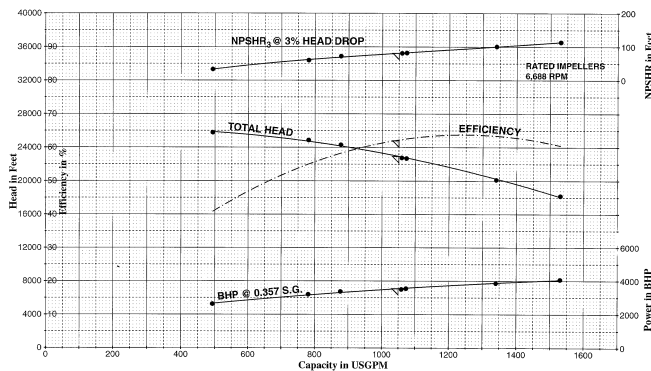
- Element -02, May 19. Impellers and balancing device sized for rated conditions based on the test results of pump A (element -01). The pump was then tested with new clearances at 4650 rpm (Figure 7). Total head and power were within contract tolerance of the rated values and consistent with the performance of pump A. The residual axial thrust of pump B was not consistent with that of pump A, being about 9000 lb (40 kN) higher over the operating flow range.

Figure 7. Shop Test Performance, Pump B, New Clearances, Final Impeller Diameter.

Since both pumps had their rotor set in the same axial position, the cause of the higher axial thrust in pump B was thought to be a discrepancy in its element’s internal dimensions. The element was dismantled and all relevant components inspected. No dimensional discrepancy that would account for the higher thrust was found, so the variation was attributed to the effect of minor stage and impeller dimensional variations in a low Ns design developing a high pressure rise.

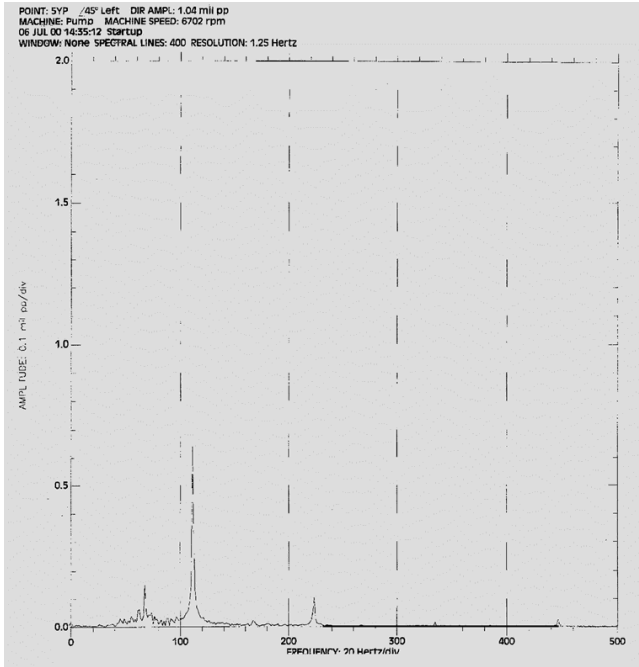
During operation on July 2, the fluctuating characteristic of the subsynchronous component of rotor vibration manifested itself. At 12:23 hours, the whole rotor developed high vibration, which then subsided. The reason for this was not determined. Shortly after this excursion in rotor vibration, the pump tripped on high rotor vibration (both probes at one location above 3.8 mil [96 μm] for more than three seconds). Vibration spectra showed high subsynchronous vibration caused the trip. The frequency of the subsynchronous vibration had risen from 69 Hz to 74 Hz.

Figure 9. Vibration Spectrum, Pump A, July 6, 2000, 14:35:12, Startup, 5YP, 6702 RPM.

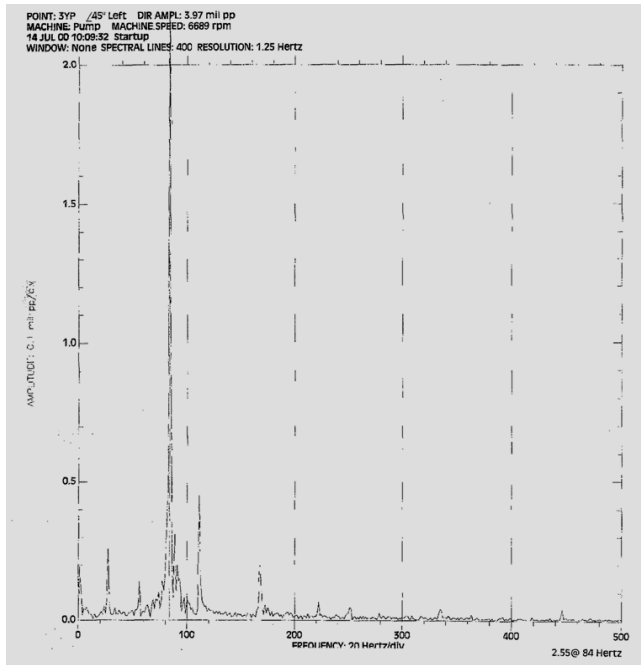
Inspection of the dismantled element July 17 showed:

- Running clearances worn 10 to 39 percent of “as-built,” with the greatest wear at rotor midspan (stages 4 to 8), least wear in stages 1 to 3, 9, and the balancing device.
 - Rub marks throughout the bottom of the stator, i.e., the bores of the casing wearing rings and diffuser bushings.
- Drawing on the plan for element modification and the results of inspecting the dismantled element’s components, the final restoration and modification plan was:
- Impeller front and back hubs: change from reverse spiral serrations to plain surface, by welding and remachining.

Figure 10. Vibration Spectrum, Pump B, July 14, 2000, 10:09:32, Startup, 3YP, 6689 RPM.

- Wearing rings: smaller bore for 15 percent less running clearance, normal serrations in the bore, antiswirl grooves in the high-pressure face.
- Diffuser bushings: smaller bore for 12 percent less running clearance, normal serrations in the bore.
- Balancing drum: reverse spiral serrations with narrower grooves.
- Balancing bushing: no change in clearance, plain bore, antiswirl grooves in the high-pressure face.

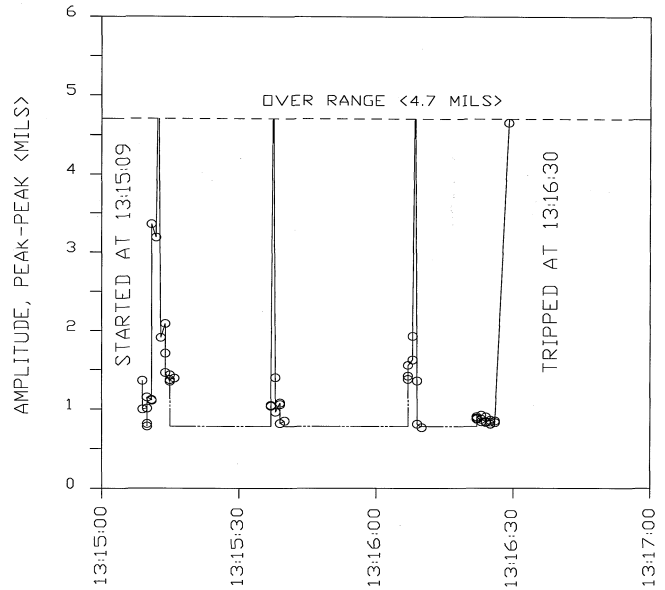
Figure 11. Plot of Startup Vibration, Pump B, August 24, 2000, 6XP.

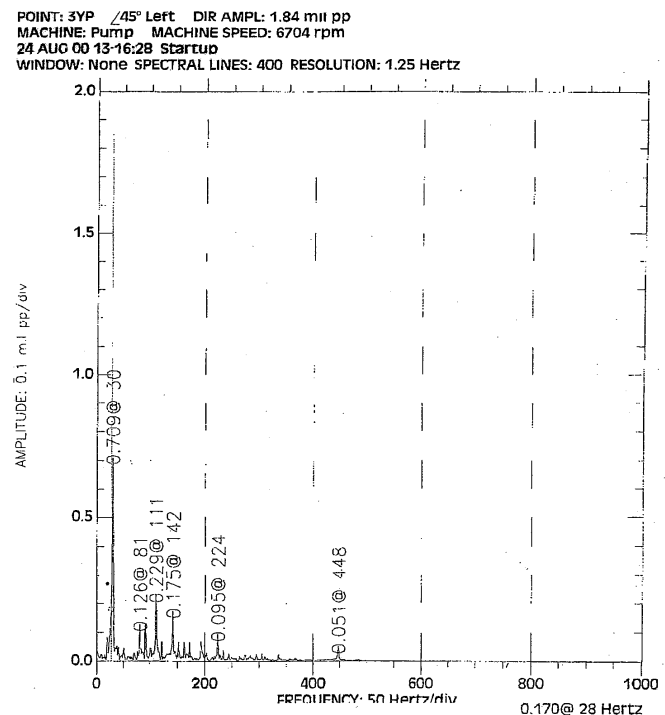
| Time | Probe | Speed | Vibration |
|---|---|---|---|
| 13.16.28 | 3YP | 6,704 | Direct 1.8 mil (46 μm), dominant component at 0.27X, others at 0.73X, 1.0X, 1.3X, 2X. |
| | 4XP | | Direct 1.3 mil (33 μm), dominant component at 0.27X, others at 1X, 1.3X, 2X. |

Figure 12. Vibration Spectrum, Pump B, August 24, 2000, 13:16:28, 3YP, 6704 RPM.

As with the July 17 “as-found” dimensions, rub marks in the bottom of the stator pointed to a rotor set low in its clearances. That was carefully checked when the element was reinstalled, so was not likely to be the cause of the repeated damage. Adams (2000), who examined the element, suggested the following alternative explanation:

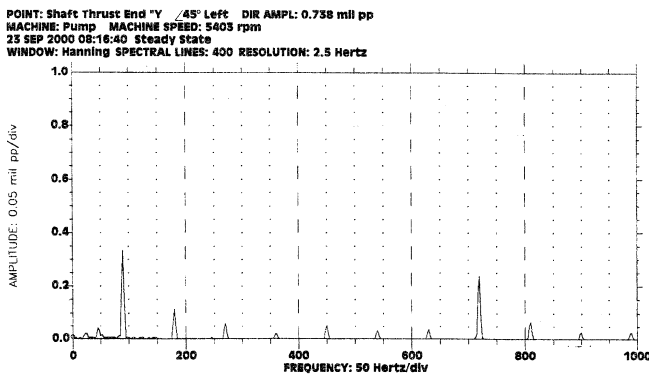
- Rotor lift about 2 mil (51 μm) on startup.
- Running at 5400 rpm (nominal), rotor vibration did not exceed 0.82 mil (21 μm), was predominantly at 1 \times with minor components at 0.25 \times , 0.52 \times , and 2 \times (Figure 13).

Figure 13. Vibration Spectrum, Pump B, September 23, 2000, 6XP, 08:16:40, Shop Test, 5403 RPM.

In the shop test on water, the pump had a higher pressure rise than in operation (about 5680 psi [392 bar] at BEP, 62 percent higher than rated) and higher damping. Evidently one or both of these acted to effectively restrain the rotor’s motion.

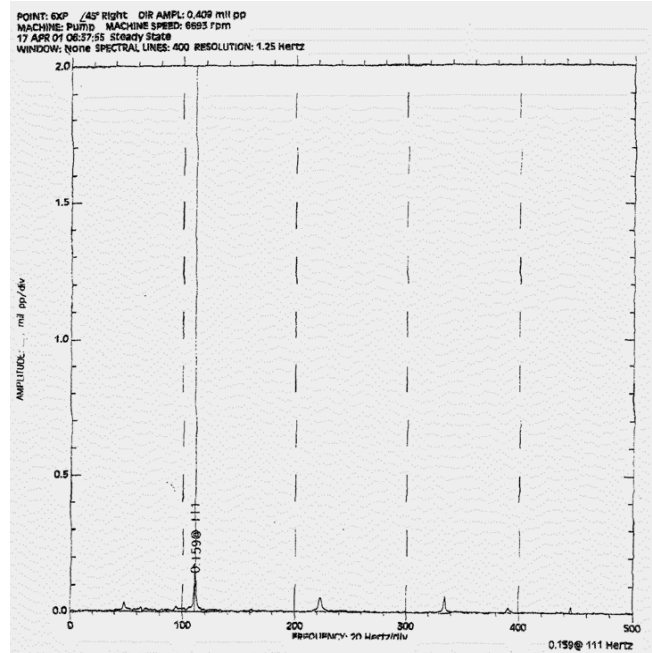
Spectra of rotor vibration during operation in the field April 17, 2001, showed the rotor was now very well behaved indeed (Figure 14 and Table 10).

Figure 14. Vibration Spectrum, Pump B, April 17, 2001, 6XP, 08:37:55, Steady-State, 6693 RPM.

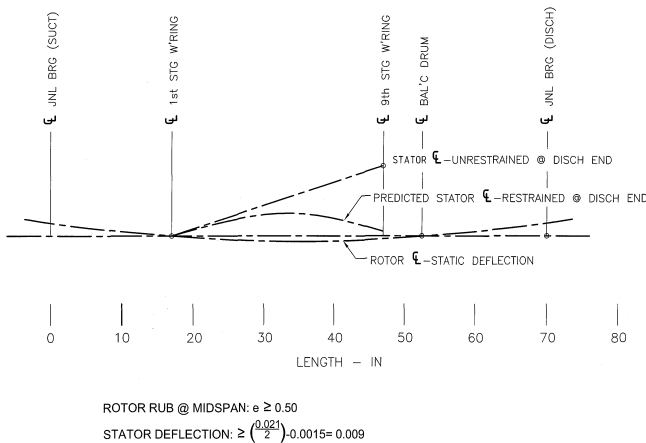
pump's differential pressure rose. The element would bow between the centering fit at the suction end of the barrel and the similar fit between the discharge stage piece and discharge head (Figure 15).

Figure 15. Diagram of Deflected Rotor and Stator Centerlines.

- The effect of the upward bow in the element would be compounded by the deflected shape of the rotor, with the net result being high eccentricity in the running clearances between rotor and stator in the region of rotor midspan.

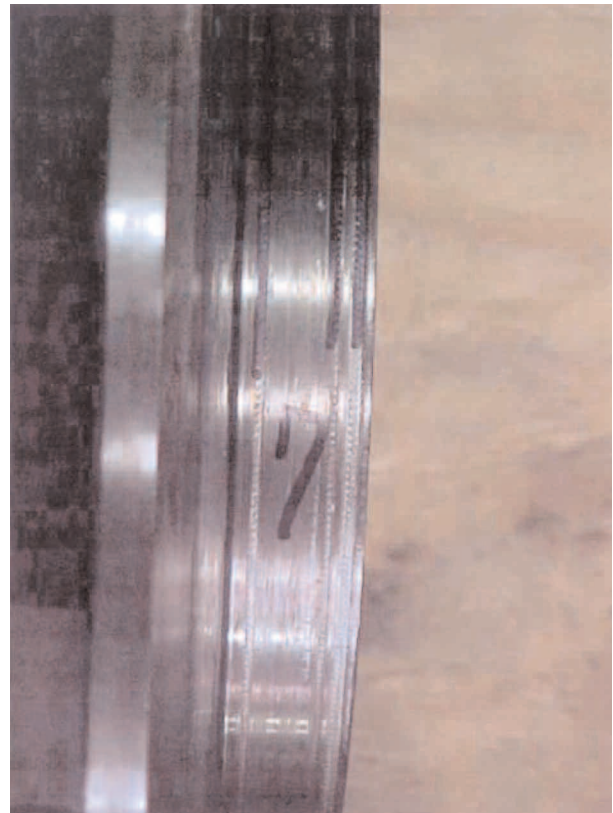
Dismantling pump B showed rubbing in the clearances including chatter marks caused by the antiswirl slots in the wearing rings (Figure 16) and a small piece of foreign metal in the first stage. A review of the events surrounding the start attempt found that the pump had sat idle for about three hours after being cooled down. The ambient temperature that day was 90°F (32°C).

Figure 16. Rub Marks (Chatter) Front Hub of Seventh Stage Impeller, Pump B, June 7, 2001.

The conclusion reached was that the most likely cause of the problem was the combined effect of a small piece of foreign metal lodging in one of the running clearances plus a bow in the casing from thermal distortion of the uninsulated casing. Without insulation, the temperature of a portion of the outer surface of the upper side could have been as high as 174°F (79°C) after three hours of solar heating (red body; radiation ratio 0.82).

The correction was to rebuild the element with standard running clearances but retaining normal serrations in the wearing rings and bushings rather than reverting to helical serrations on the impeller hubs.
