Investigation and Resolution of Intermittent Loss of Flow in a Diaphragm Metering Pump

Gregory Frantz

DuPont

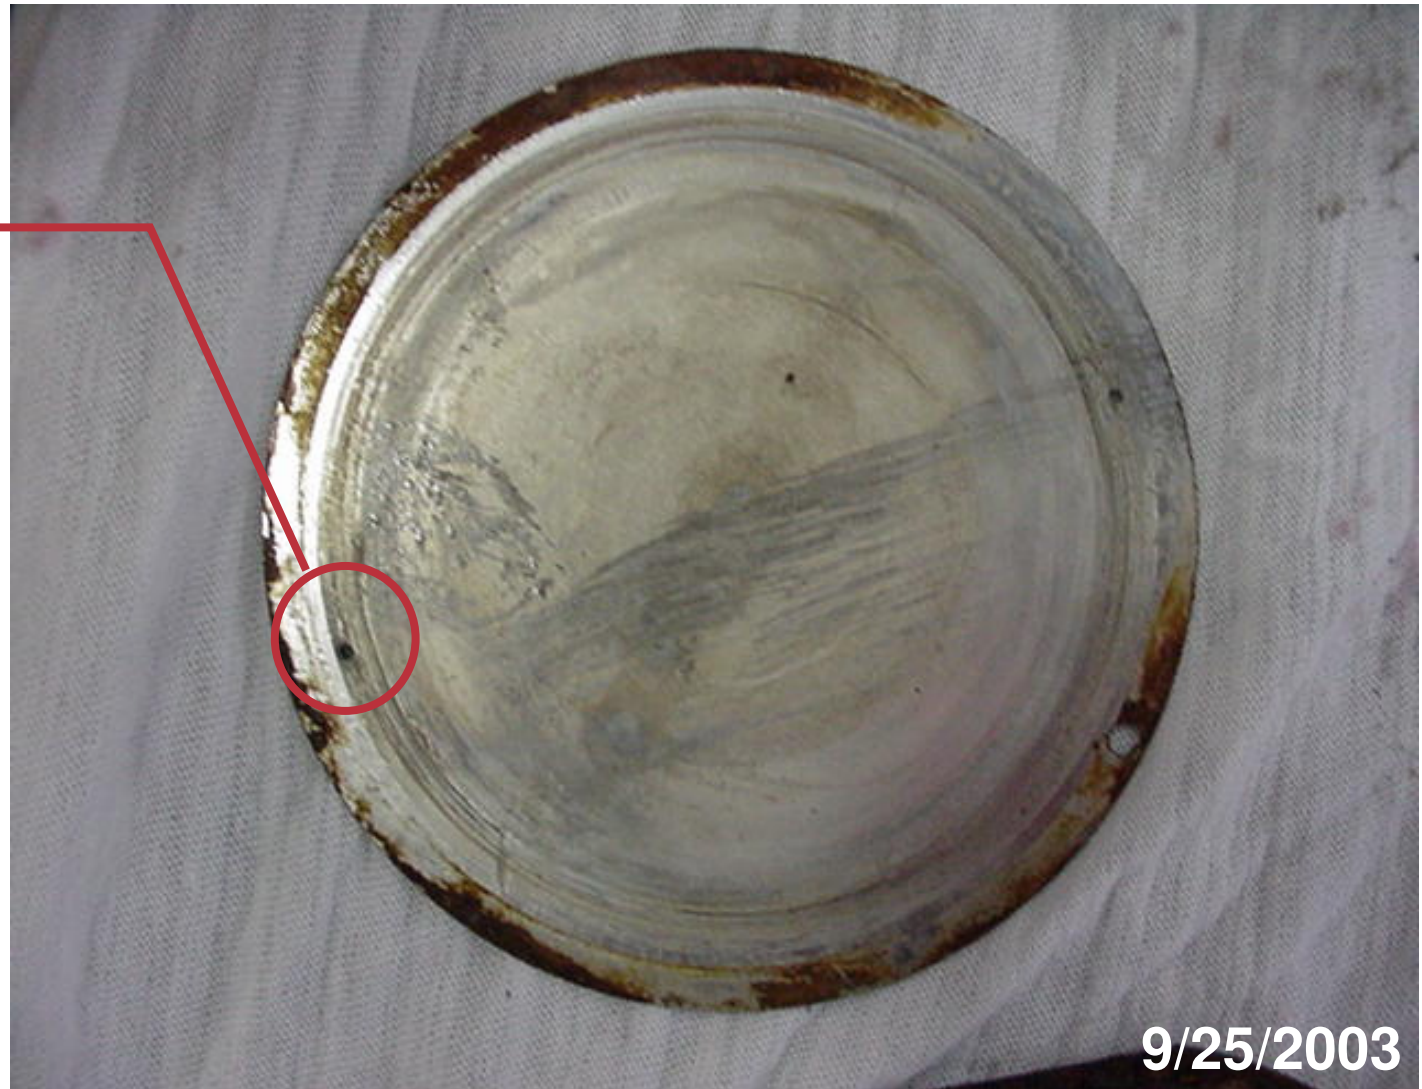
Cover Diaphragm – Process Side

Port for communication between leak detection system and intermediate diaphragm.

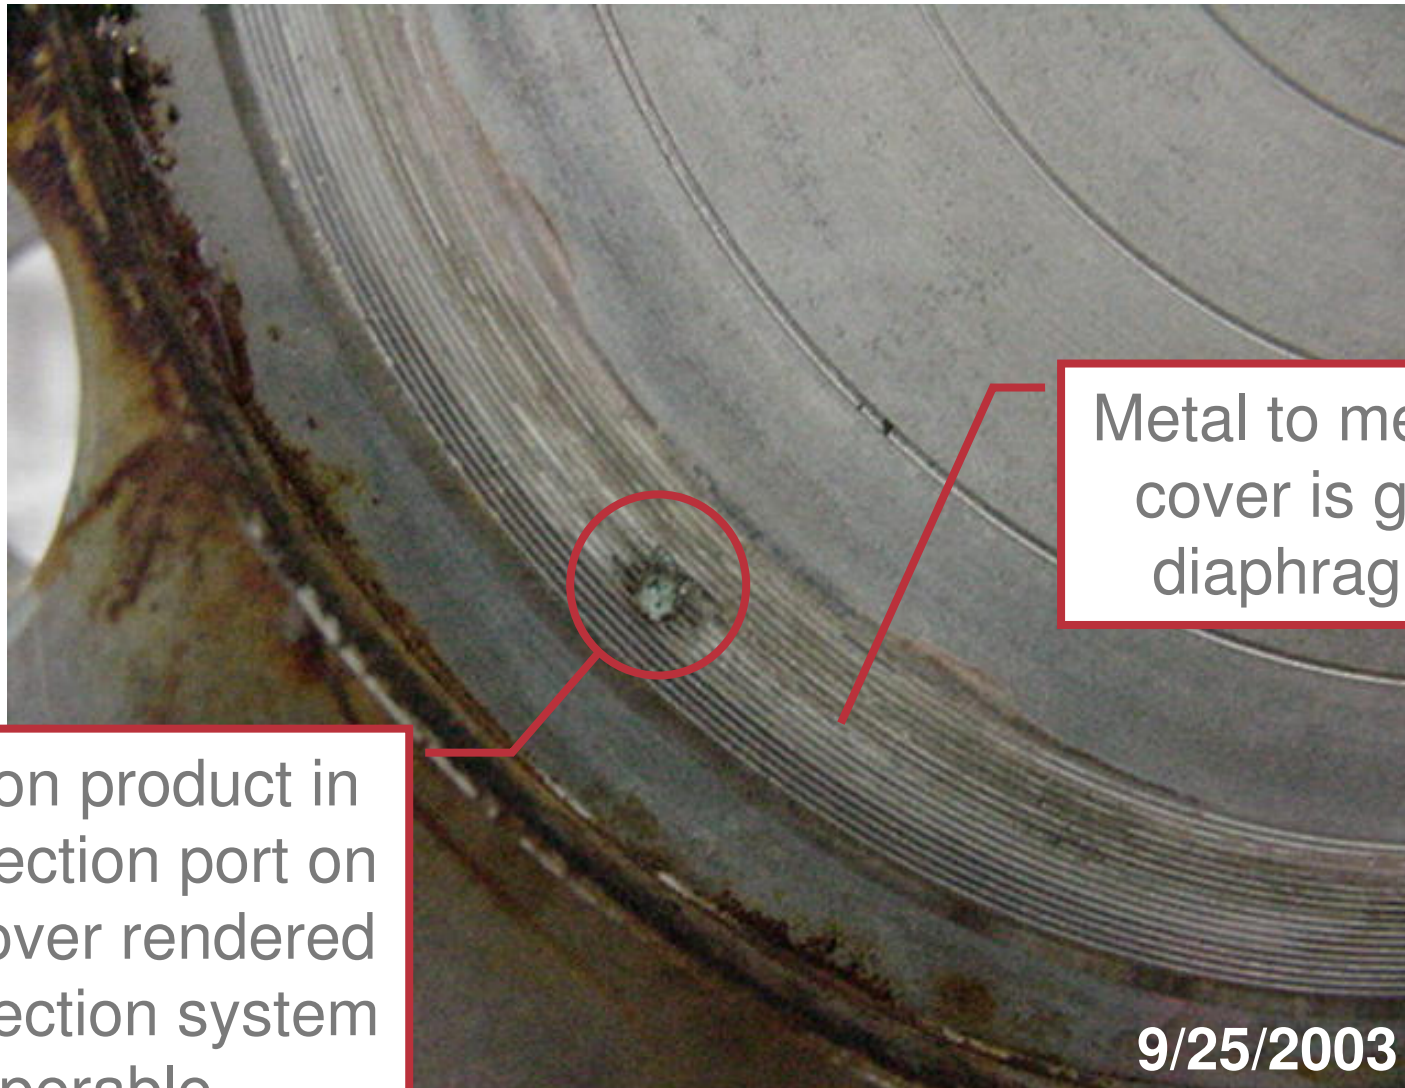
Cover– Leak Detection Port

Metal to metal seal –
cover is grooved /
diaphragm is flat

Corrosion product in
leak detection port on
pump cover rendered
leak detection system
inoperable.

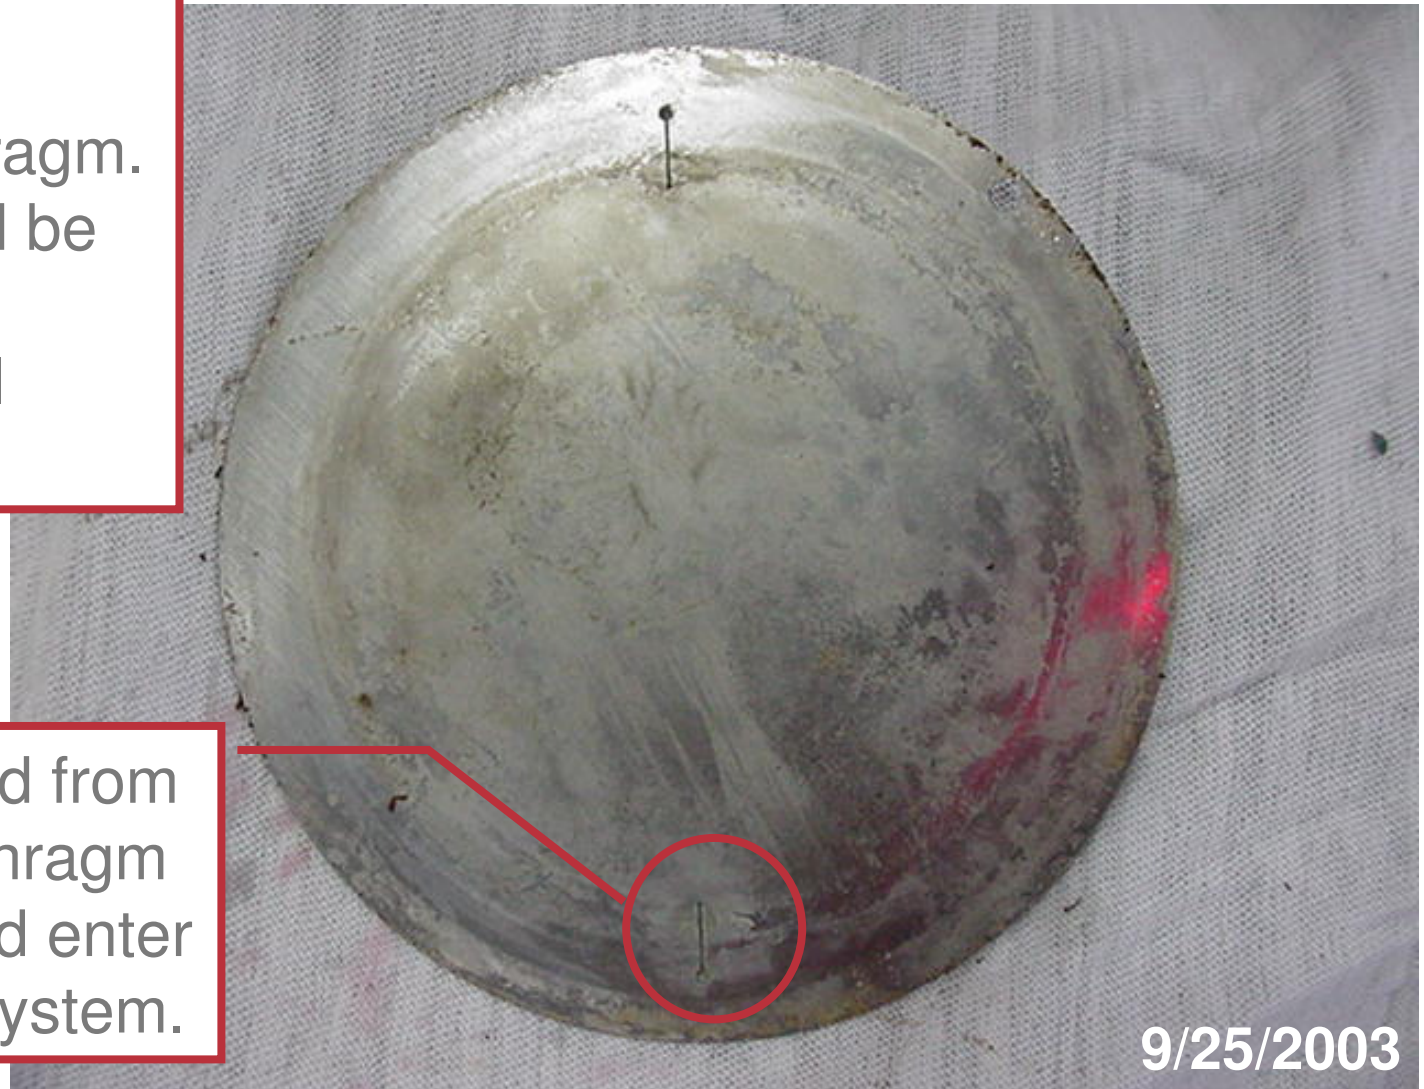
Intermediate Diaphragm – Process Side

Process liquid and contamination on intermediate diaphragm. This surface should be clean, with only the lubricant from initial assembly present.

Slots allow liquid from a cracked diaphragm to cross seal and enter leak detection system.

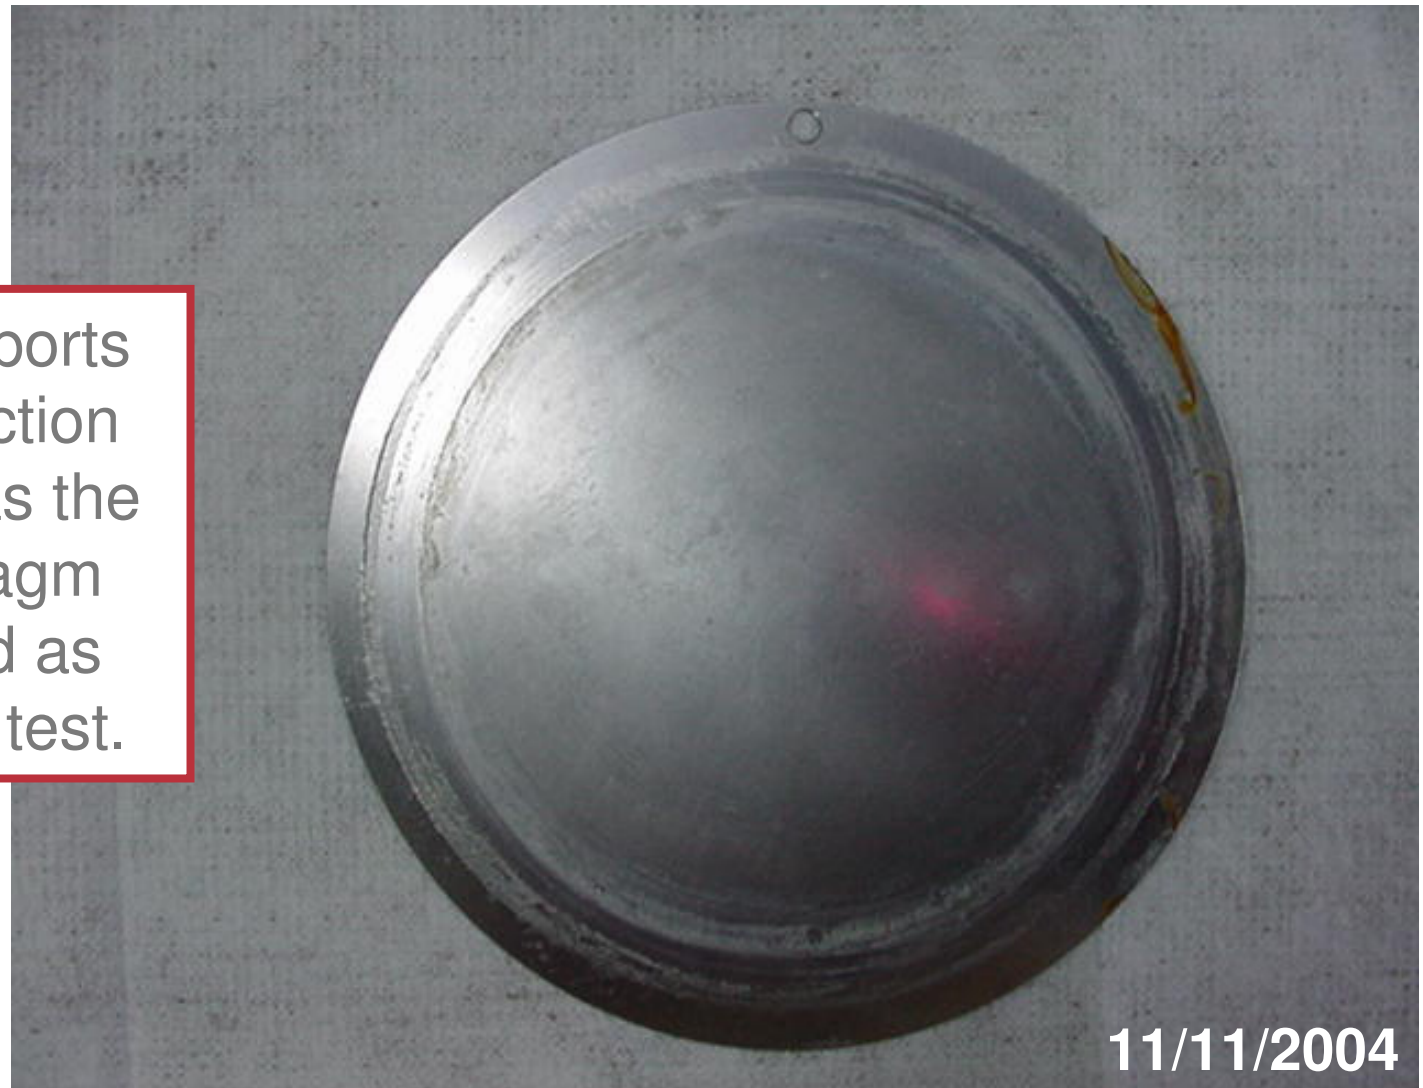
Hydraulic Diaphragm Used as Cover Diaphragm

Note the lack of ports for the leak detection system. This was the hydraulic diaphragm that was installed as the cover for the test.

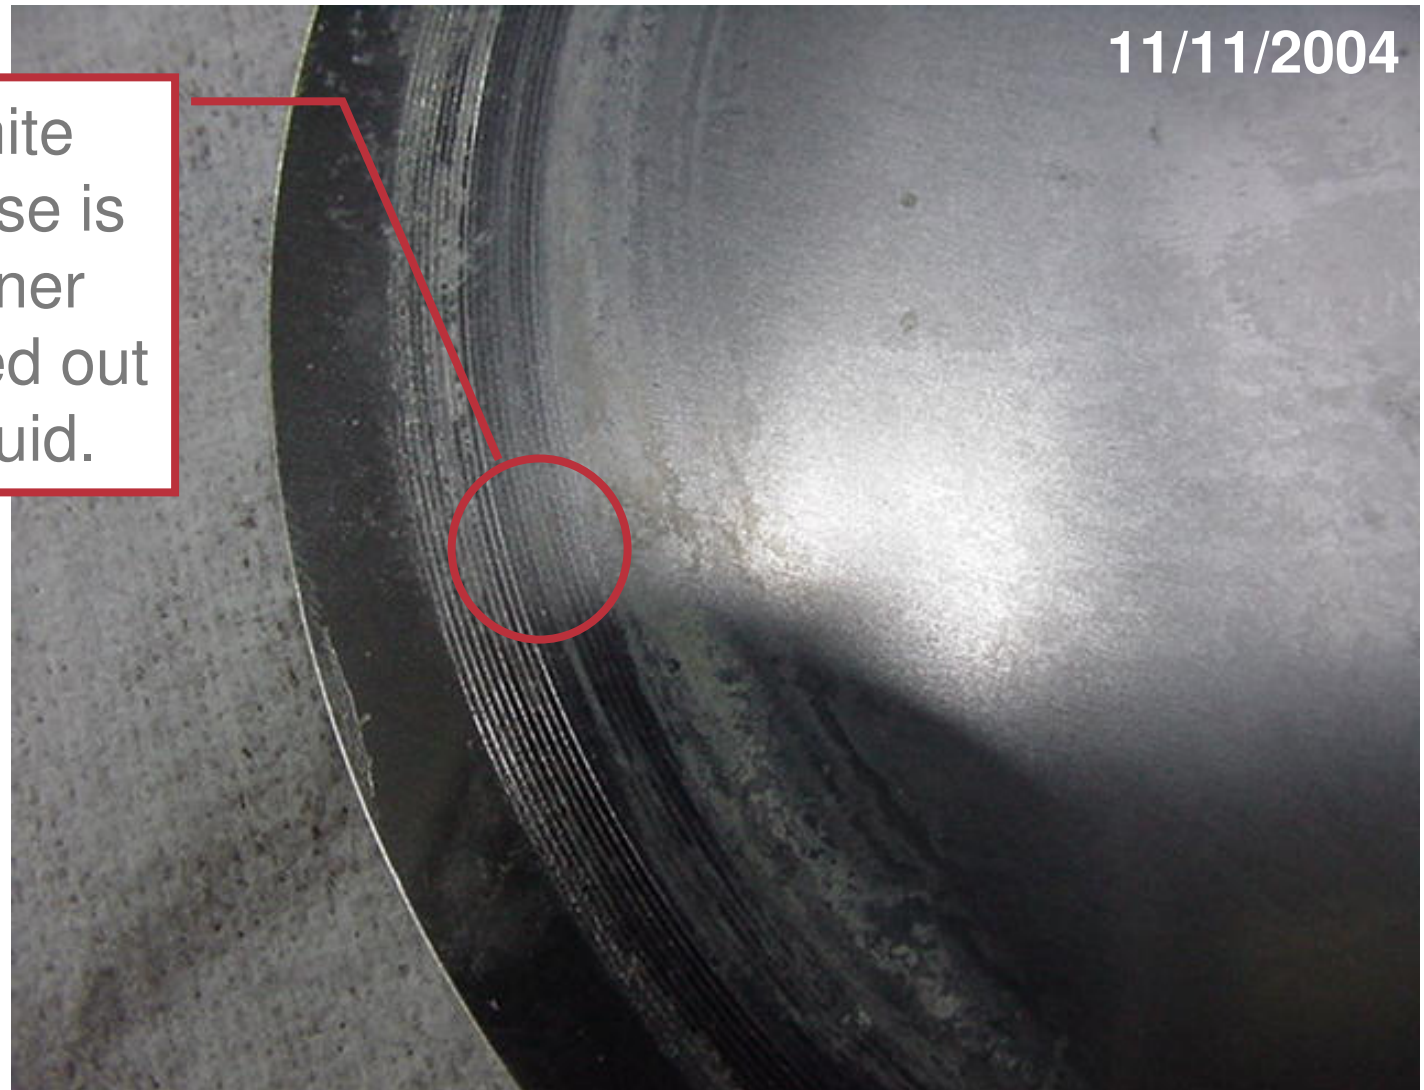
Test Diaphragm – Process Side

Note that the white PFPE based grease is gone from the inner seal. It was washed out by the pumped fluid.

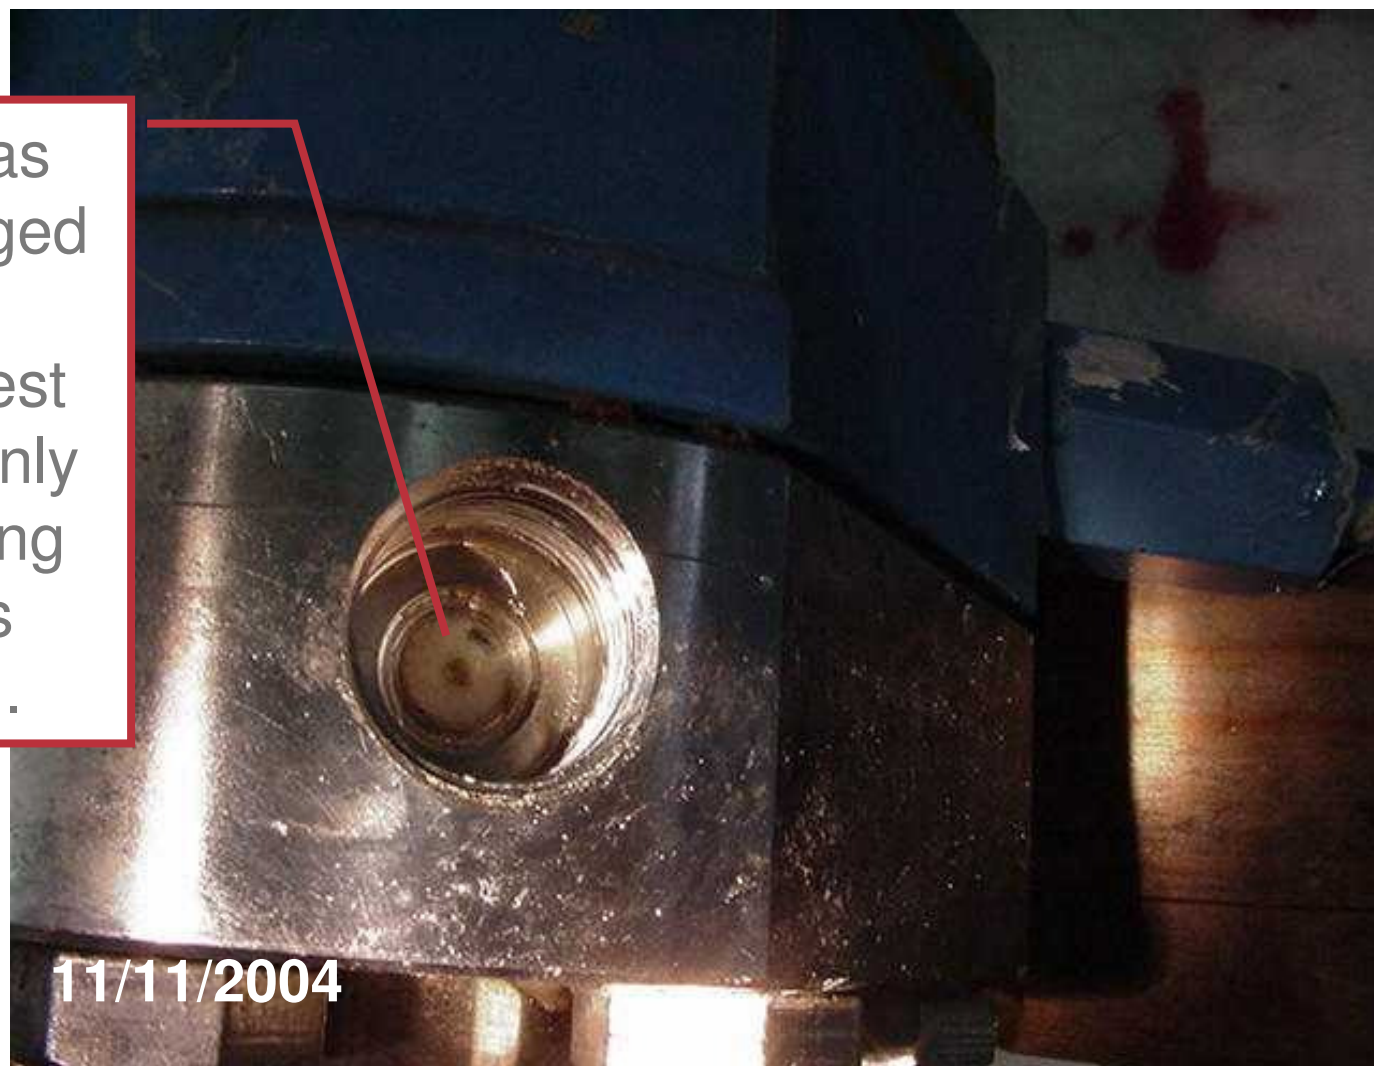
Leak Indicator Port

Pumped fluid was found in the plugged leak detection system. In the test installation, the only means for entering this chamber is across the seal.

- The original pump head was sent to the manufacturer for inspection.
 - It was determined that there may be a sealing issue with the pumped fluid and the existing pump head design.
- The proposal from the manufacturer was to make the cover out of a harder stainless steel alloy.
 - The harder alloy allowed the grooves in the cover to bite into the diaphragm better.
 - The manufacturer supplied this head at no cost.
- The problems have been eliminated. The pump can now easily run one year between scheduled maintenance outages.
