**43rd Turbomachinery
30th Pump SYMPOSIA**

MORTON-LIKE EFFECT IN A CENTRIFUGAL PUMP

Maki Onari
Mechanical Solutions, Inc.
Whippany, NJ

Morton-Like Effect in a Centrifugal Pump

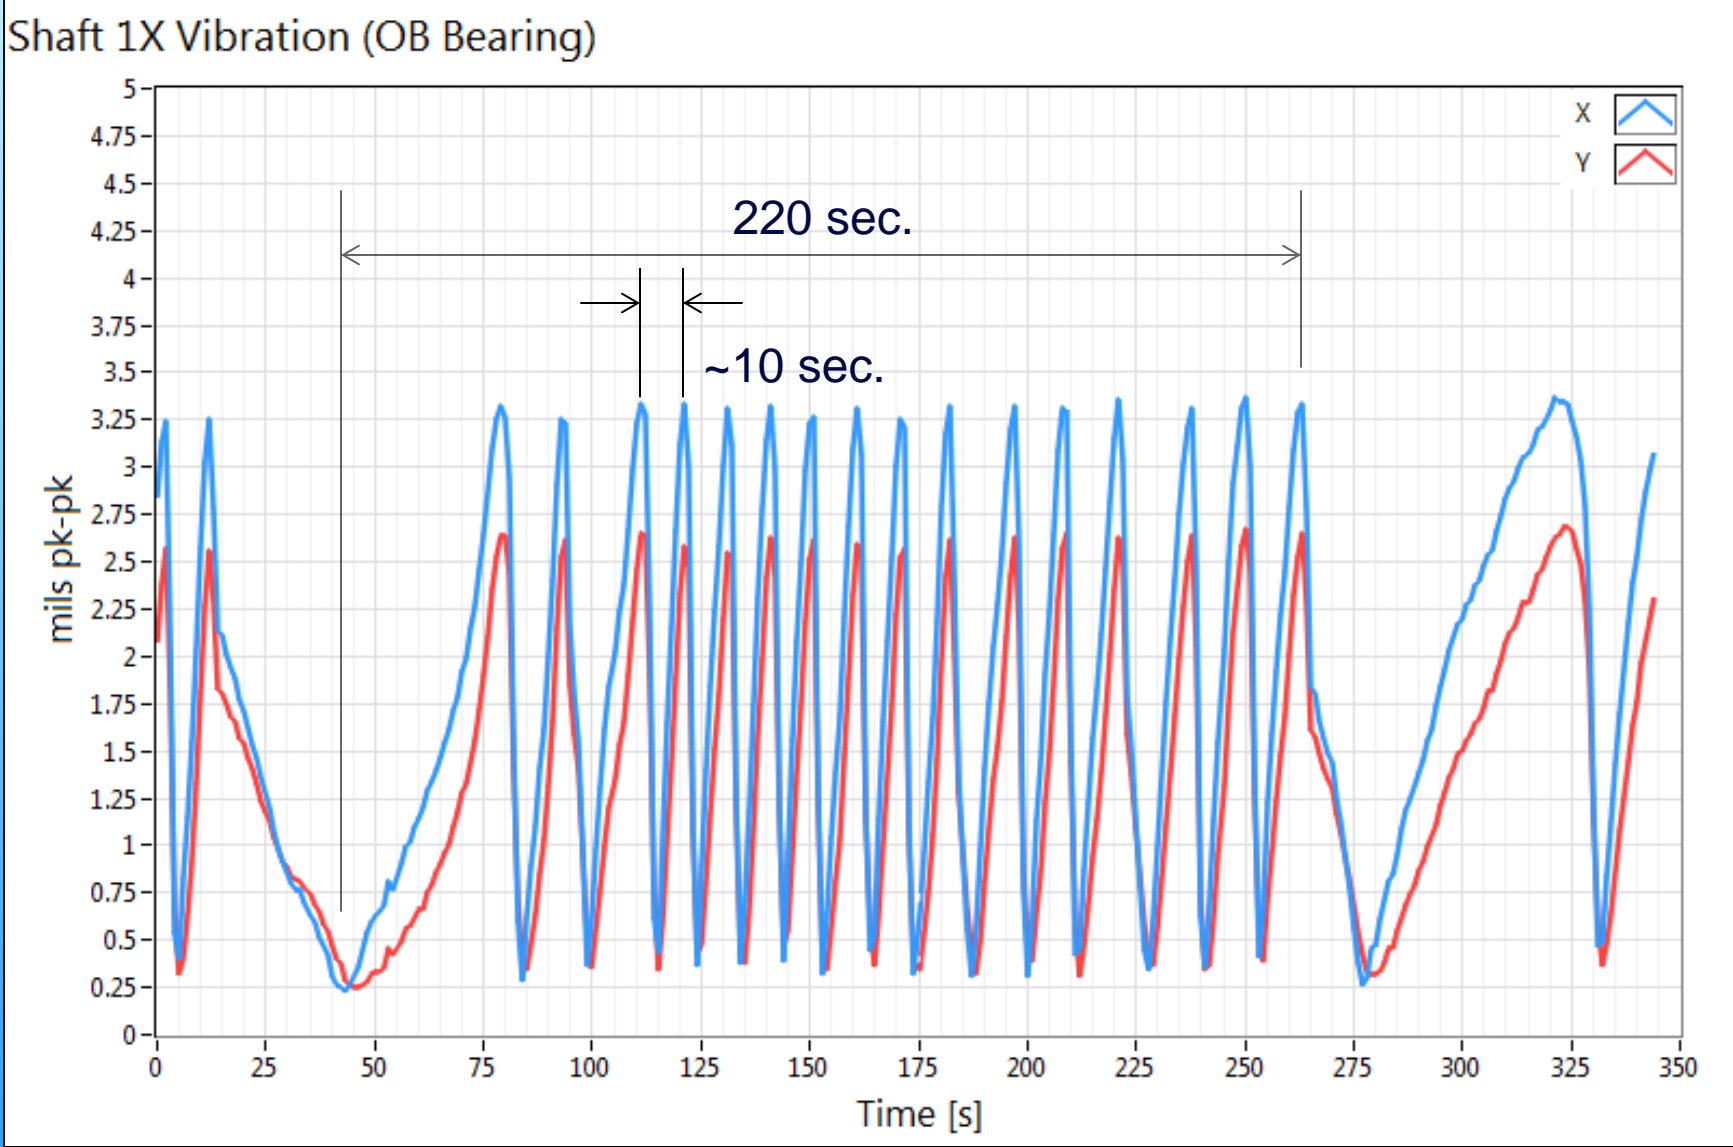
Vibration Testing – Shaft OBB Vibration Trend

- The vibration amplitude was not constant. The overall amplitude was fluctuating with a period between 10 to 60 seconds.

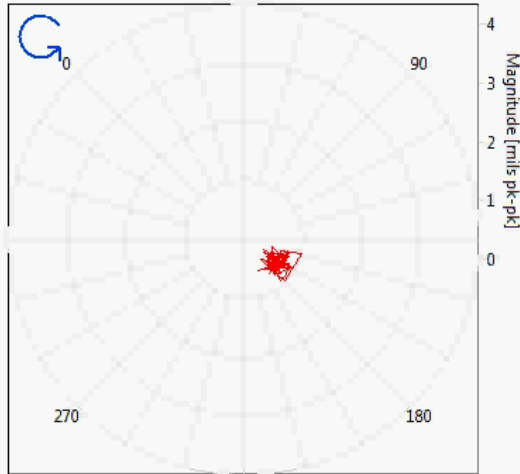
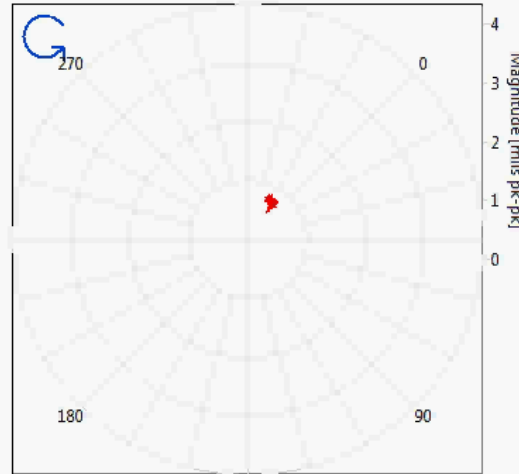
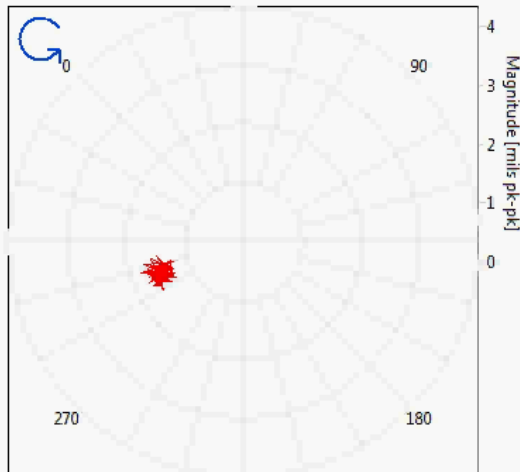
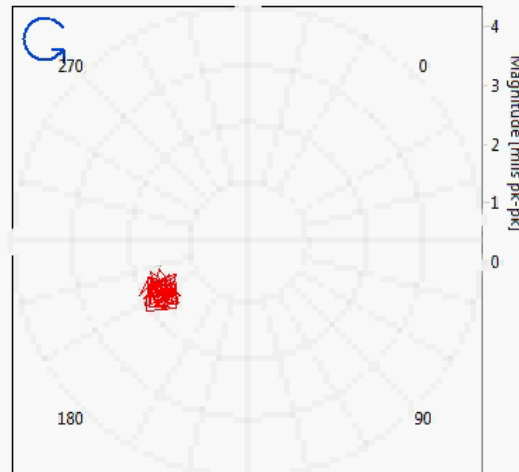
Vibration Testing – Polar Plots

Note:
These plotted points shift in amplitude and phase, following a circular pattern (see animation).

- ***Morton-like Effect:*** static imbalance vector (i.e. the steady average mechanical imbalance) combined with a secondary vector (non-constant phase imbalance vector). The secondary (cycling) imbalance vector is produced from a thermal distortion of the shaft in which a localized high temperature area of the shaft travels the full circumference with every vibration swell. The imbalance vectors behaving in this way are what cause the vibration level cyclic trends such as those experienced by the pump.

- This phenomenon is typically caused by either a light rub or a “near rub” (boundary lubrication at the “pinch point”) in a synchronously whirling shaft leading to a “hot spot” on the “heavy side” of the shaft that leads to thermal bow of the shaft, changing the “heavy side” location. Such a condition can occur in either a bearing or a seal, but in the case of a bearing the vibration cycles are typically longer (on the order of 5 to 10 minutes) than observed in the present case.

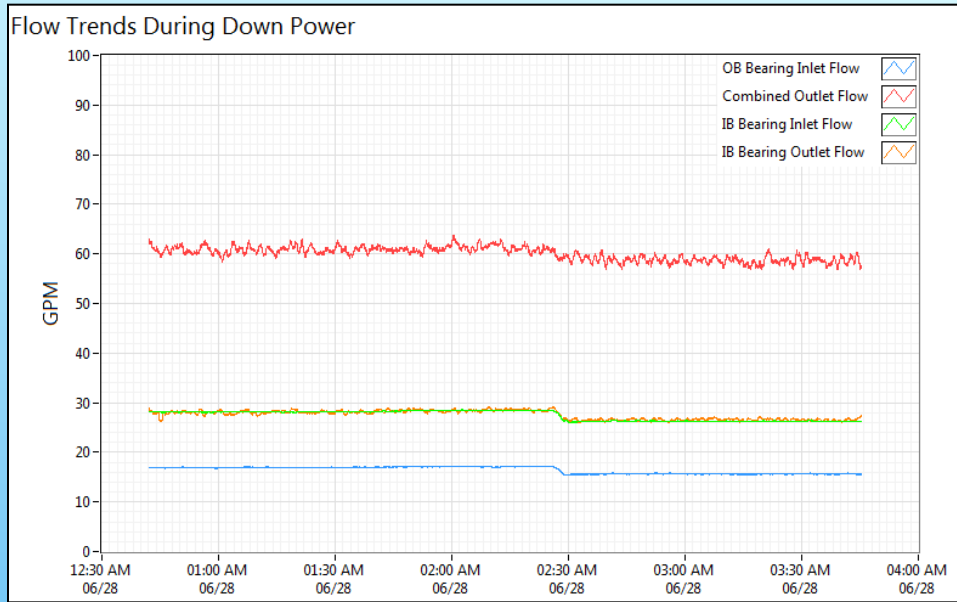
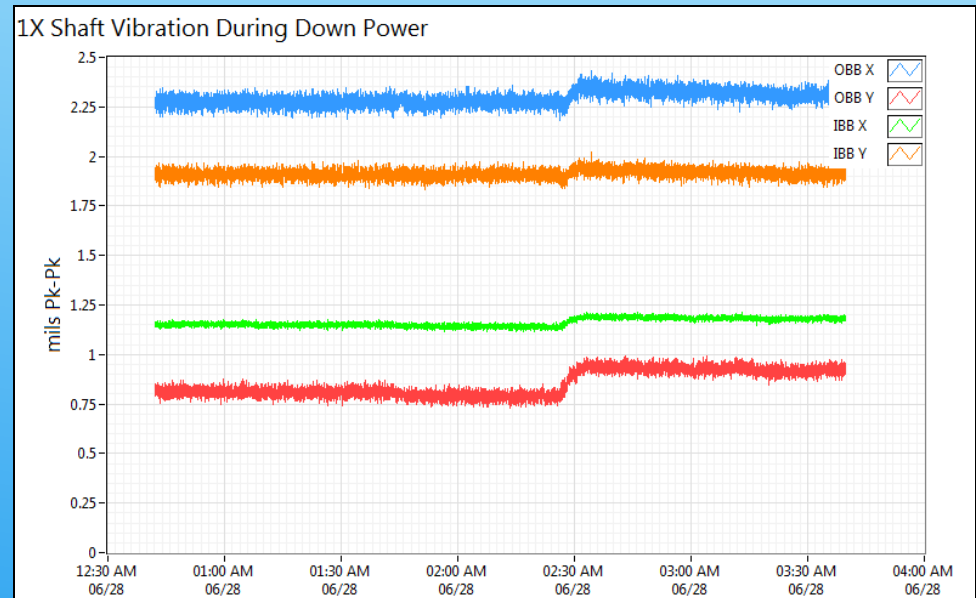
Seal Water Injection Testing

Morton-like Effect not detected after slight reduction of seal water injection flow and increment of drain temperature.

June 2012

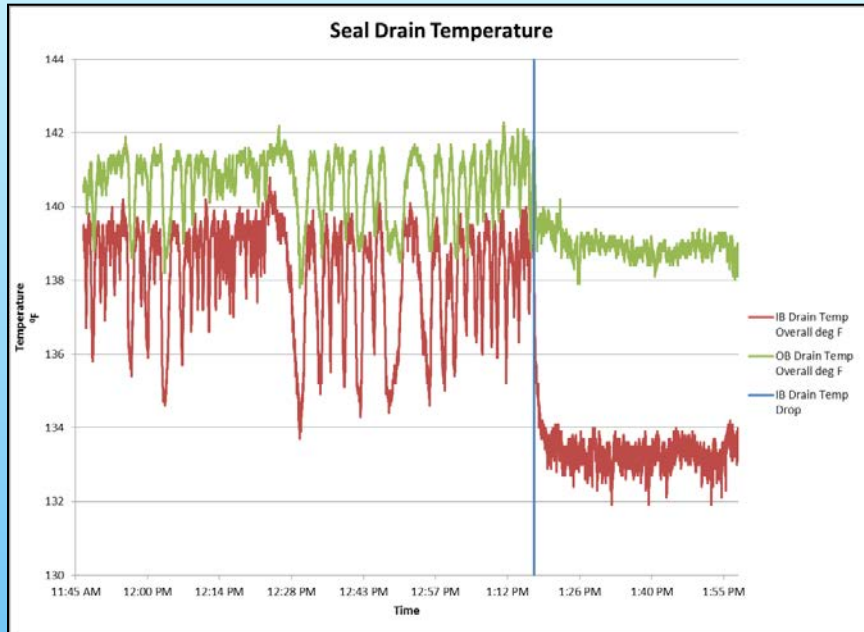
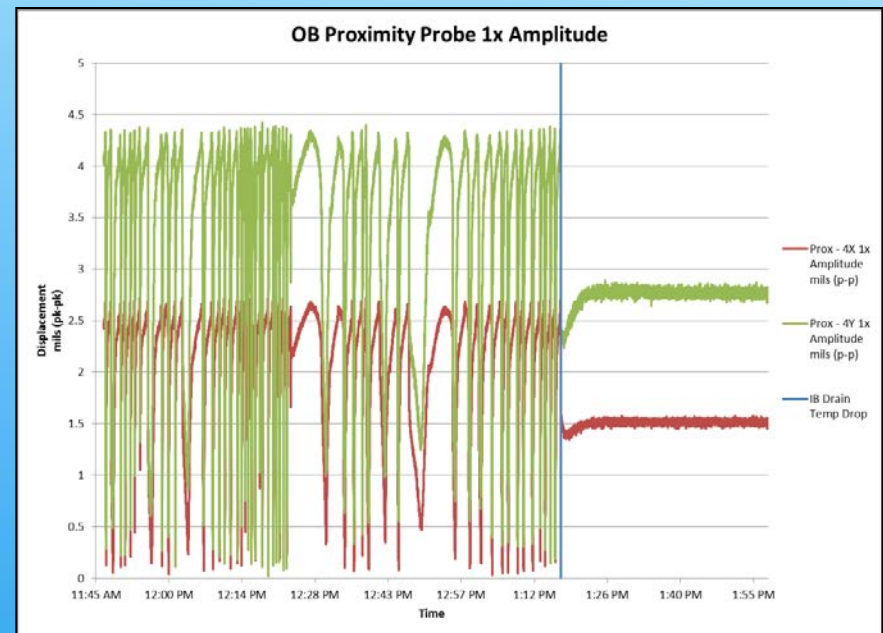
Seal Water Injection Testing

End of Morton-like Effect after increasing seal water injection flow and reducing drain temperature.

August 2012

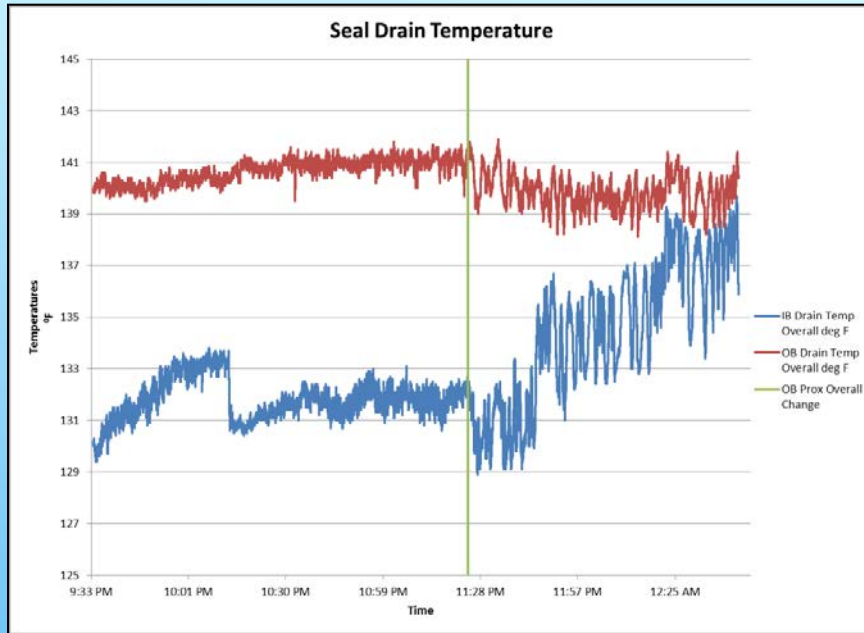
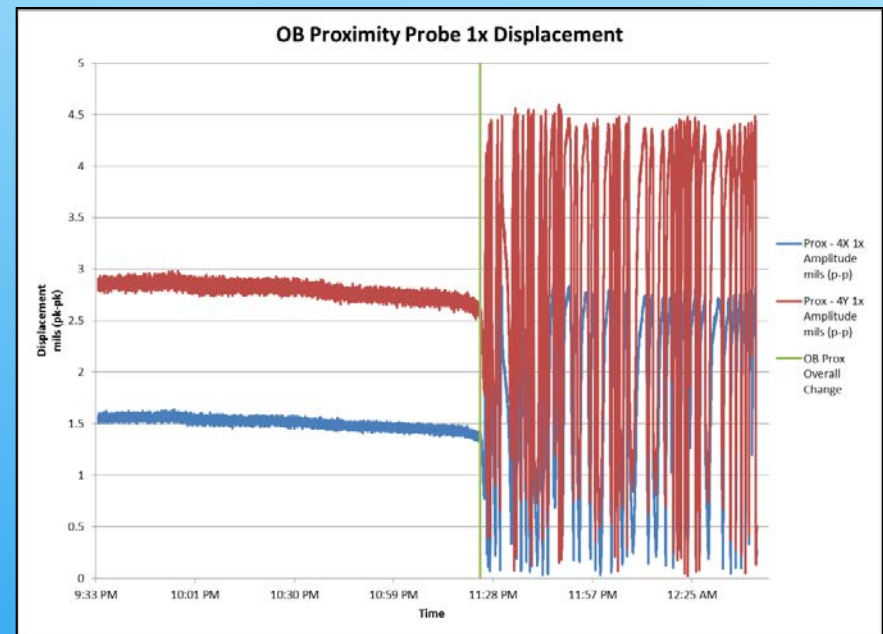
Seal Water Injection Testing

Start of Morton-like Effect after slight reduction of seal water injection flow and increasing drain temperature.

August 2012

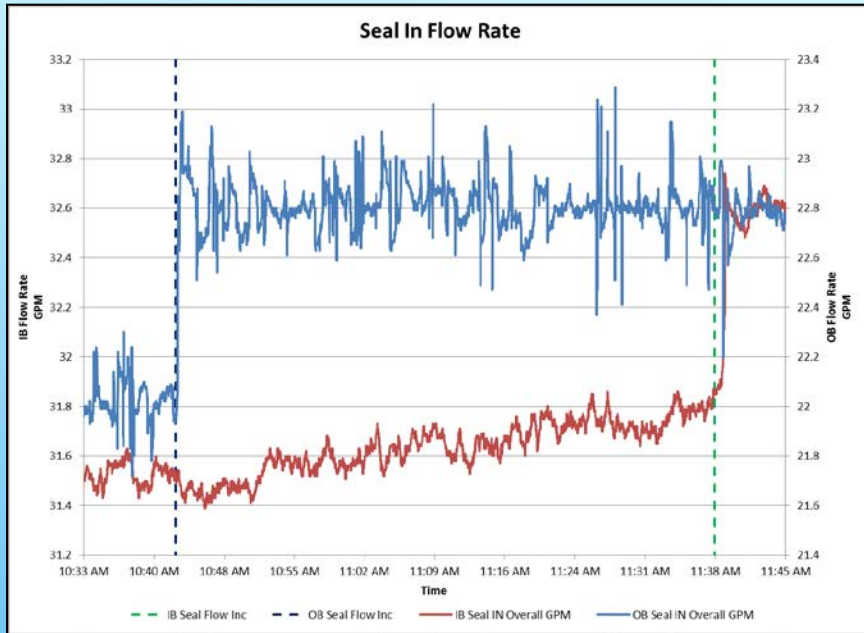
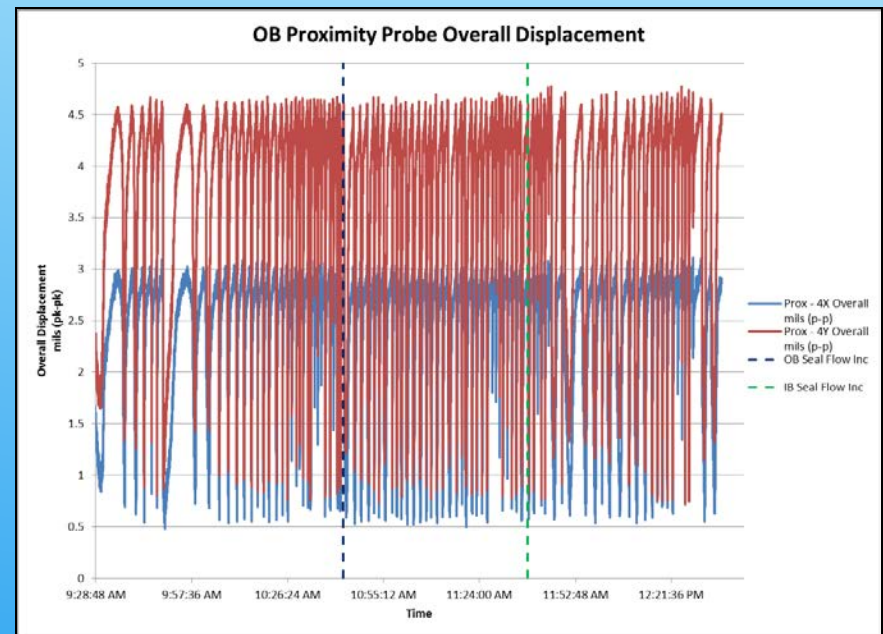
Seal Water Injection Testing

No effect on Morton-like Effect after seal water injection flow increased and reduced drain temperature.

August 2012

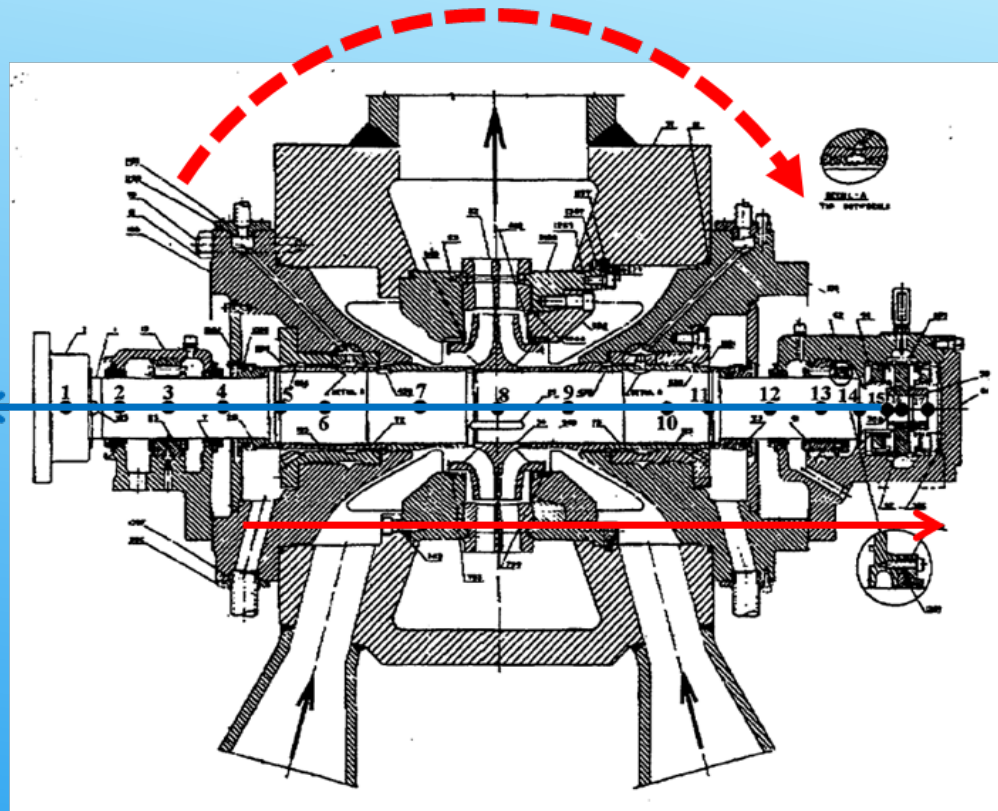
- After a thorough investigation between site personnel and MSI, it was concluded that the root cause of the Morton-like Effect was due to a casing distortion that was altering the internal clearances between the shaft and the long seal sleeve.

Pump shaft
thermal expansion

Pump casing
thermal expansion

- The torque applied to the hold-down bolts to the pedestals at the outboard and inboard end of the pump was approximately 4,400 ft-lb. The required torque, based on the OEM manual, is 1,800 ft-lb at the inboard end and 550 ft-lb at the outboard end. This would allow the casing to grow axially while it reaches the thermal equilibrium.
- Once the torque of the hold-down bolts were corrected, the Morton-like Effect vibration was eliminated.
