PERFORMANCE LOSS INVESTIGATION USING THERMAL IMAGING

LEAD FIELD ENGINEER – SULZER PUMPS (US) INC

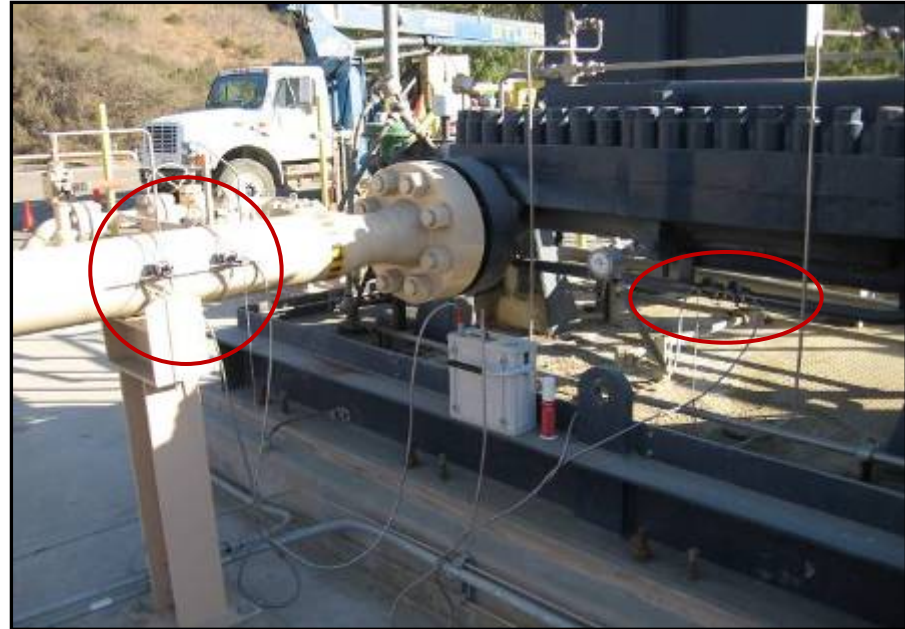
Dual traverse flow cells installed on the suction and balance line leak-off piping

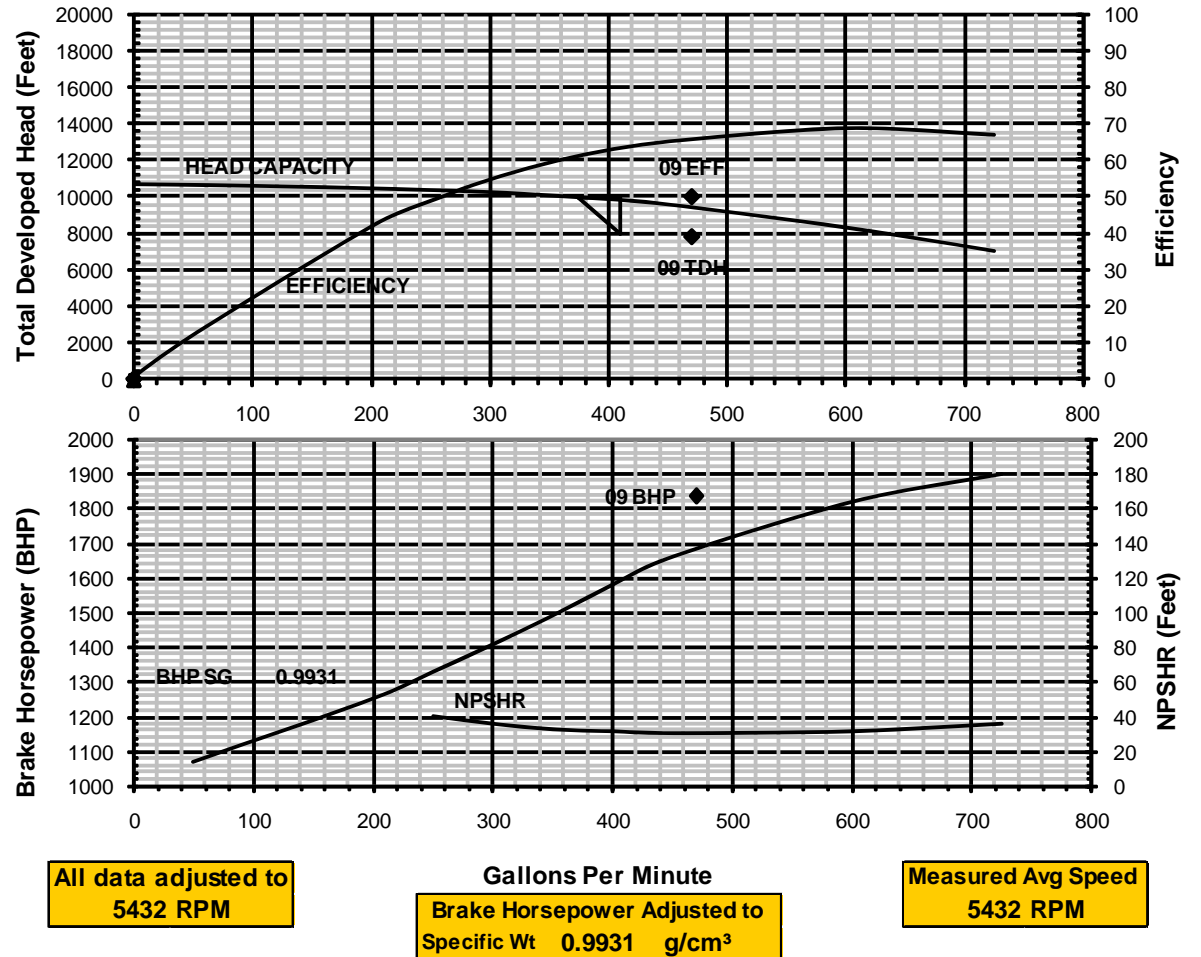
- Field testing suggested severe performance loss. Head low by approximately 20%!!!
- Efficiency down by approximately 30%!!!

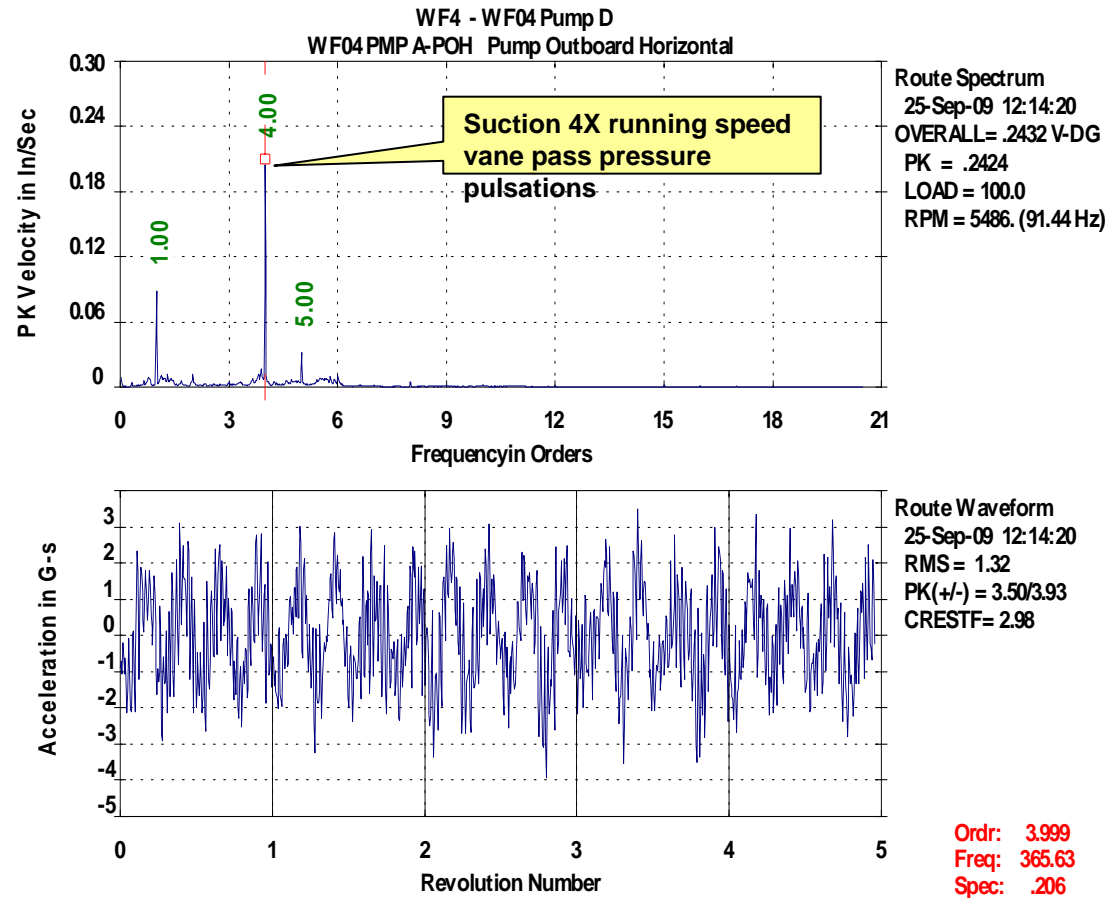
- Vibration spectrums showed no abnormalities that could explain performance loss.
- No readings more than 0.24 in/s overall
- All spectrum characteristics were explainable and typical of normal pump operation

Pump POH spectrum and time waveform indicating the dominance of the 4X suction impeller vane pass pulsations

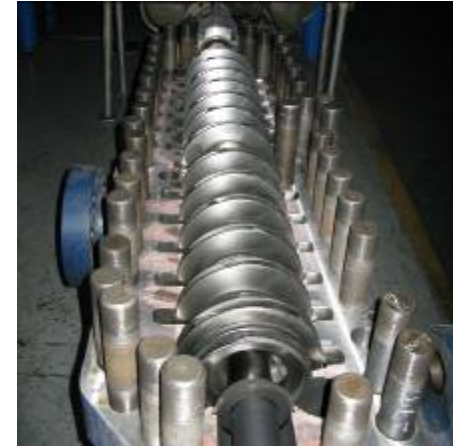
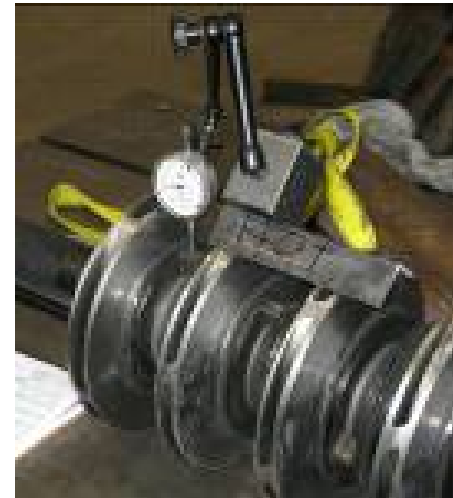
- Initial postulations were focused in internal pump recirculation across the center bushing, possibly due to wear or swelling of the pump casing
- Pump was sent to local service facility for inspection
- Sadly, no smoking guns were found
- High pressure bushings clearances were all in as shipped condition. No material loss noted.
- Wear part lift checks indicated no loss of material at wear ring clearances.

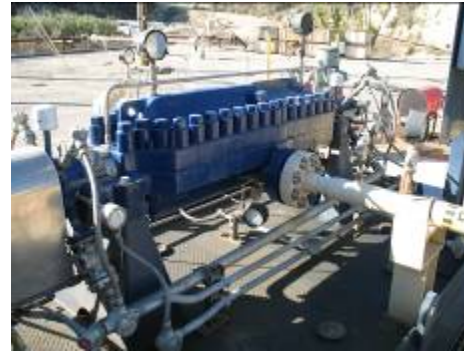
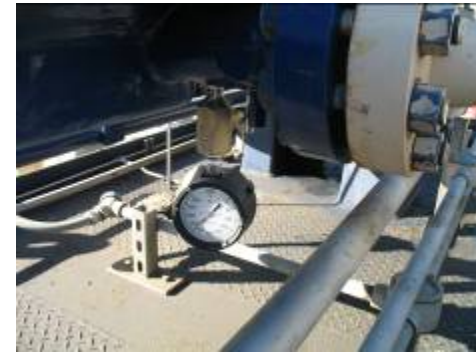
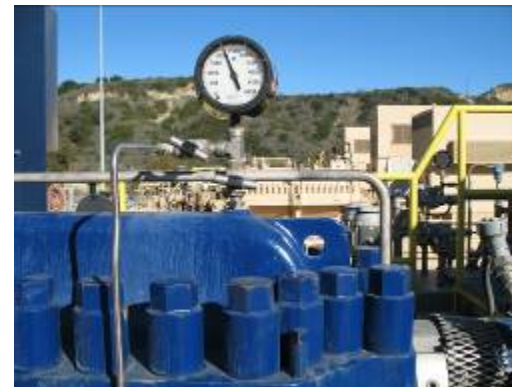
- No improvement was observed!!
- Pressure gauge added to pump discharge nozzle. Reading compared well to gauge on discharge line
- Pressure gauge was added to a vent on the long cross over with interesting results!!!!
- Suction side of pump found to be performing as expected
- All losses isolated to the discharge side of pump
- Pump run down at 3600rpm to allow comparison to factory performance test results. Pump still 20% low at factory test speed!!!
- Further investigation was required

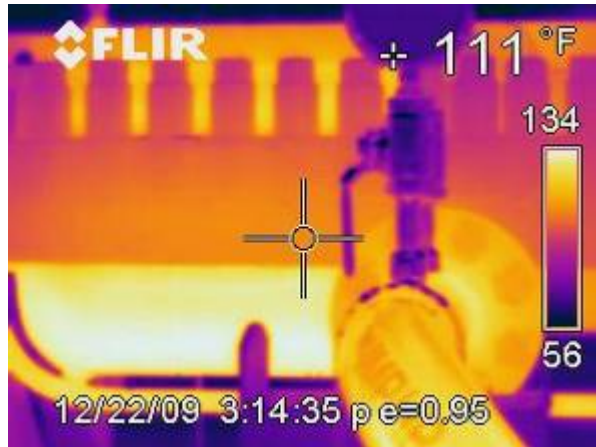
Bottom half of pump was found to be warmer than the top half

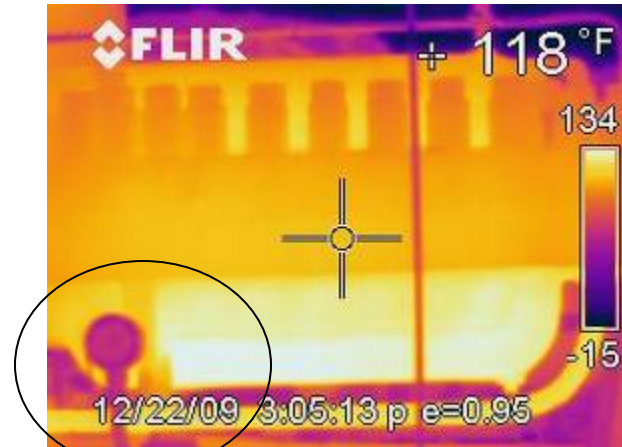
No exceptionally high localized hot spots apparent, however, left of thermowell boss appears cooler

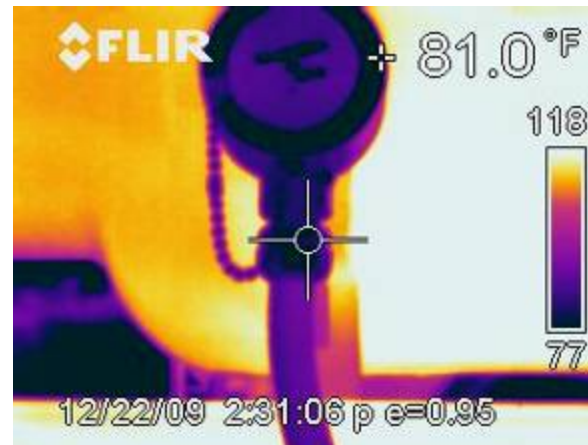
Definite relative difference across thermowell

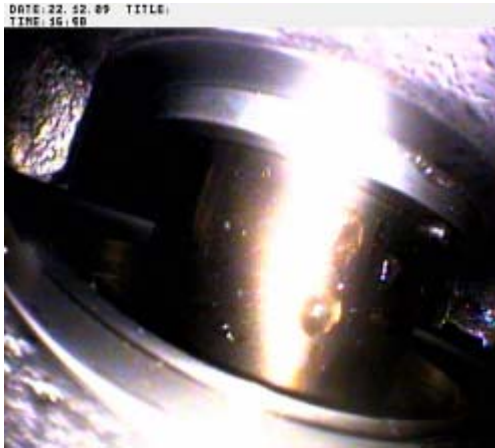
Outlet of long cross over inspected first for obstruction. Nothing found.

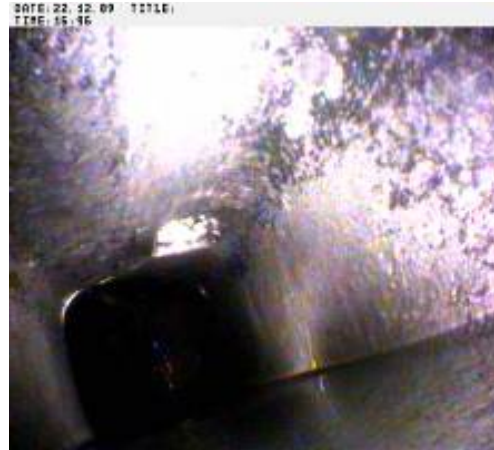
Outlet of long cross over inspected first for obstruction. Nothing found. But what is that we see in the distance?

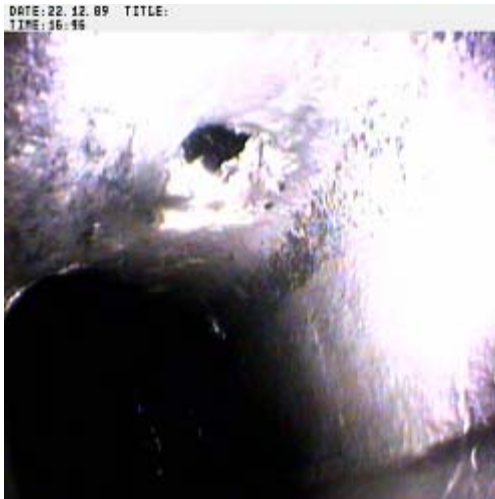
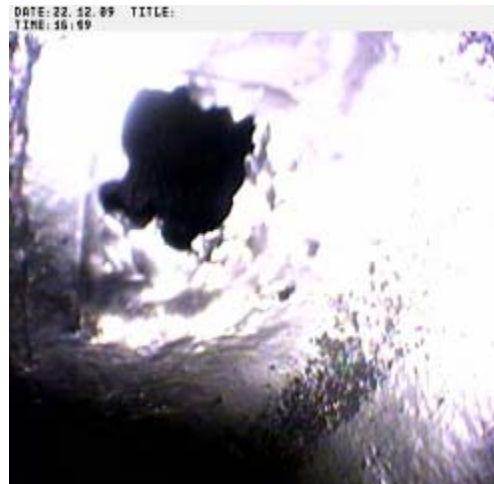
A BIG HOLE!

- Last 7 stages recirculating additional flow due to 1 inch hole from discharge to cross over
- 7 stages worth of differential pressure across 1 in hole = lots of flow
- Excessive temperature rise due to fluid recirculation passing through 7 stages x 2!!

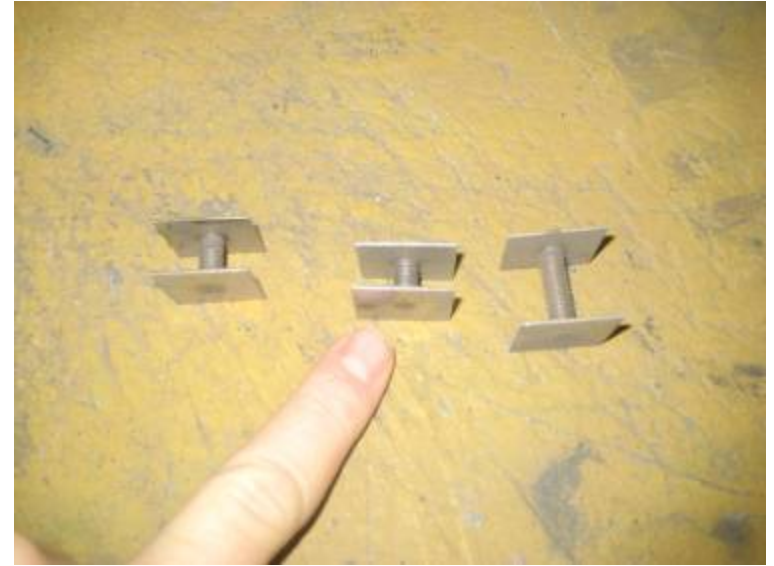
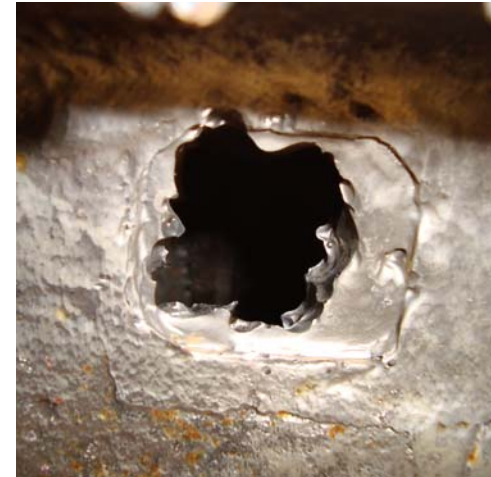
- CHAPLETS (SHOWN BELOW) ARE USED TO POSITION SAND CORE BOXES DURING THE CASE CASTING PROCESS.
- THE CHAPLETS SHOULD BE MADE OF THE SAME MATERIAL AS THE CASTING AND IS INTENDED TO FUSE INTO THE CASTING AND BECOME A PART OF THE FINISHED COMPONENT
- IN THIS CASE IT APPEARS THAT THE CHAPLET MAY HAVE NOT FUSED, OR POSSIBLY BEEN MADE OF THE WRONG MATERIAL
- NOTICE THE SQUARE RECESS AROUND THE HOLE FOUND IN THE CROSS OVER
