Blast Service Management

Misfire Becomes Flyrock Incident

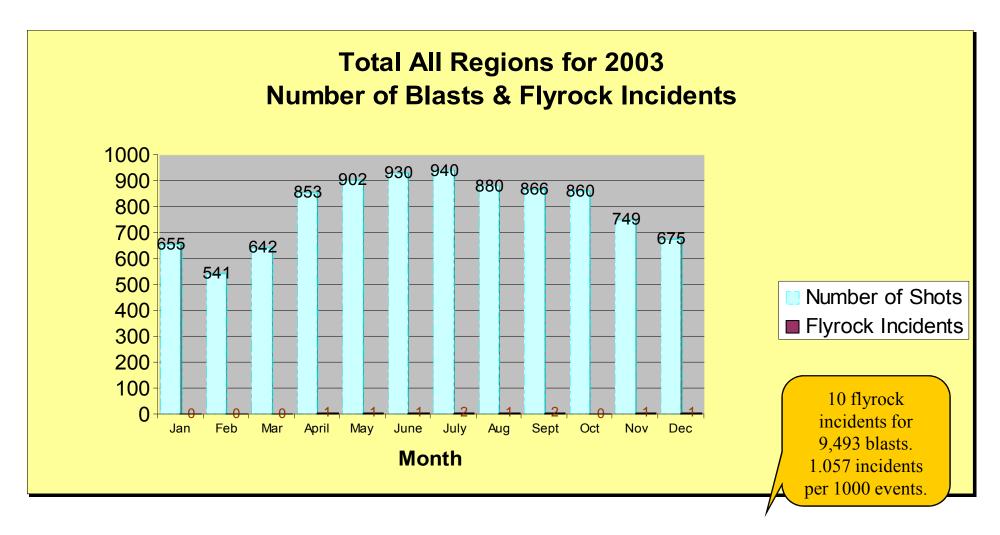
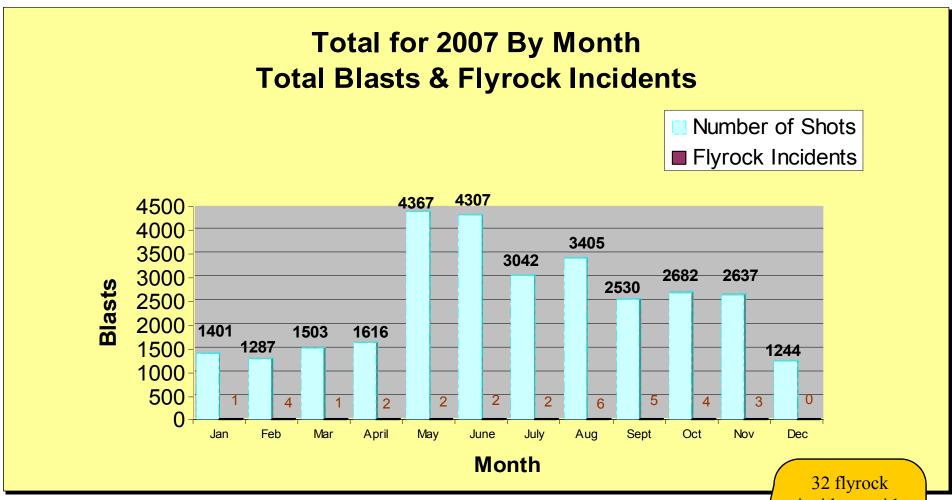
Number of Shots and Flyrock Events

Compared to 2003 for 300 % growth

32 flyrock incidents with 30,021 blasts. 1.07 incidents per 1000 events.

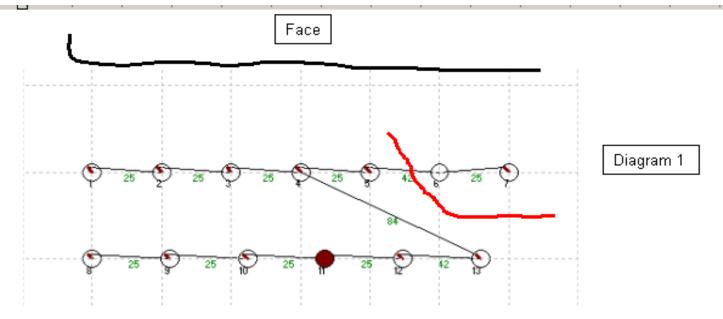
- The blast consisted of 13 holes, two of which were 6¾" and eleven of which were 6¼" on a 104' face.
- The pattern was a 17' x 19' pattern with the front row inverted so that there was 19 feet of burden and 17 feet spacing.
- Since there was no drill log provided and the crushing plant was within the 300' distance, a Hold Harmless Agreement was obtained prior to the start of loading holes.

The misfire occurred along the red line between the holes number 5 and number 6. The drawing below shows the timing used to re-shoot the remaining holes.

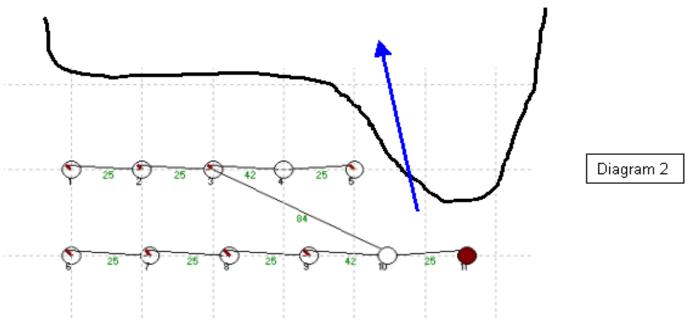
The 84 ms timing was moved one hole to the left to allow for proper timing. The blue arrow represents the location and direction where the flyrock came from.
