43rd Turbomachinery 30th Pump SYMPOSIA

CO2 PIPELINE PUMP – PRESSURE PULSATIONS, VIBRATIONS, SEAL FAILURES – SOLUTION WITH THE HELP OF REMOTE MONITORING

BY: Dale Winterhoff Flowserve Corporation Bethlehem, PA

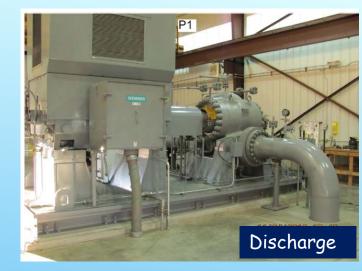
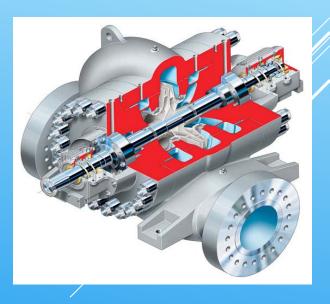
- When running above 2000 rpm significant vane pass vibration was observed leading to seal failures and reduced pipeline availability
- Field testing did reveal abnormal pressure pulsations, >35psi, in the discharge pipe (next slide) and a high amplitude vane-pass vibration on the inboard bearing housing (next slide)

- In addition, as the pumps speed was lowered, the pressure pulsation amplitude reduced as the energy of the pump reduced, however, the response frequency remained unchanged, ≈20,000 cpm (333Hz)

- The pulsation frequency is not linked to the running speed or a multiple of the running speed which indicates that the source of this excitation does not originate at the pump

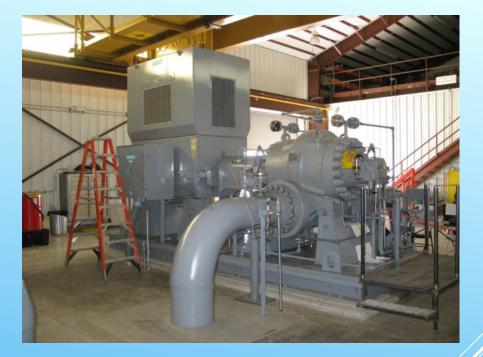
Pump Monitoring Plan

- (5) Dynamic Pressure
 - o Suction pipe near flange
 - o Discharge pipe near flange
 - Seal Flush API 11 with inline filter
 - Inboard Stuffing box
 - Outboard Stuffing Box

(2) Static Pressure

- Suction pipe near flange
- o Discharge pipe near flange
- (2) Process Temperature RTD's
 - o Suction
 - o Discharge
- (1) Outside Air Temperature
- (5) Accelerometers
 - o Inboard Bearing Housing X,Y
 - Outboard Bearing Housing X,Y & Z
- (1) Laser Speed Tachometer

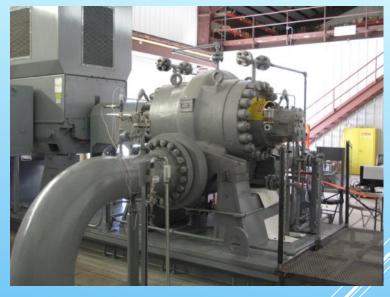
Data Analysis - Field Simulation

- Monitoring system allowed for a controlled test of the pipeline where the suction fluid temperature was raised above 100°F along with increasing pump speed above 2000 rpm.
- This simulated summertime conditions when process temperatures increased, Operations ran pump at higher speeds to compensate for the decrease mass of the CO2 – result was increased pump vane pass frequency
- The speed of sound in CO2 is directly related to the change in process temperature - result was that this temperature increase <u>moved the non-driven frequency</u> <u>lower</u>
- As the non-driven frequency and pump vane pass frequency approached each other, significant and destructive vibrations occurred - result was almost certain seal failure with any prolonged run time

Pump was administratively limited to operate below 2080 rpm when suction fluid temperature exceeded 98°F
