User/Vendor Collaborative Seal Selection

From Problem Evaluation to Commissioning

Problem Statement

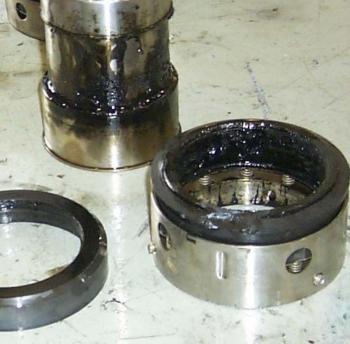
Problematic dual seals in Ethylene Service
Vertical 16 stage pump
1485 psig discharge
High Maintenance costs
MTBF of 2 to 6 months
Residue build up on ID of primary
Heavy wear on secondary

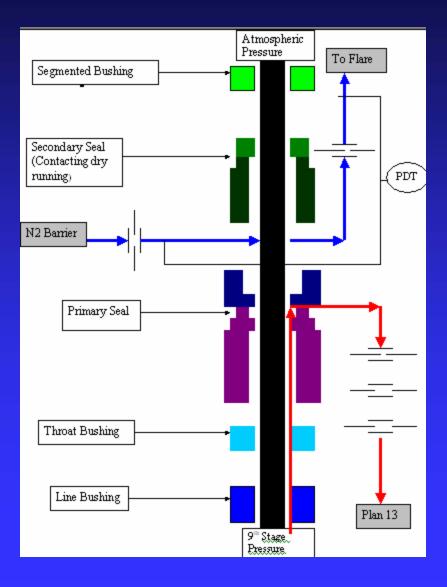
Original Seal Design

Primary – Wet contacting Pusher seal with hydropads

Secondary – Dry Running Contacting Seal with N2 sweep Plan 13 through a triple orifice with flush supply from 9th stage

Balance Ratio of 85.6%

Stuffing box press. 780 psig (super critical state)

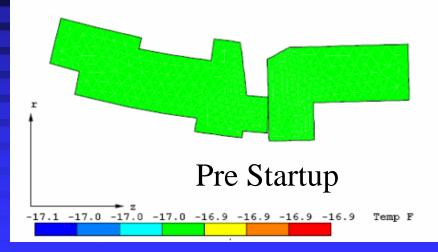
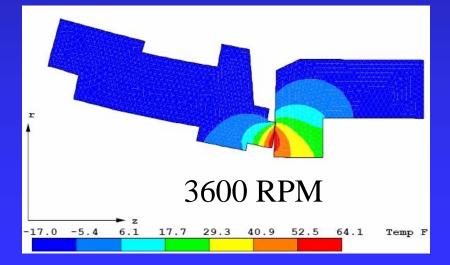
Analysis (Detailed Analysis)

Face distortion
 Heat generation (face temperature)
 Liquid fraction Seal Leakage
 Face Contact pressure
 PV numbers

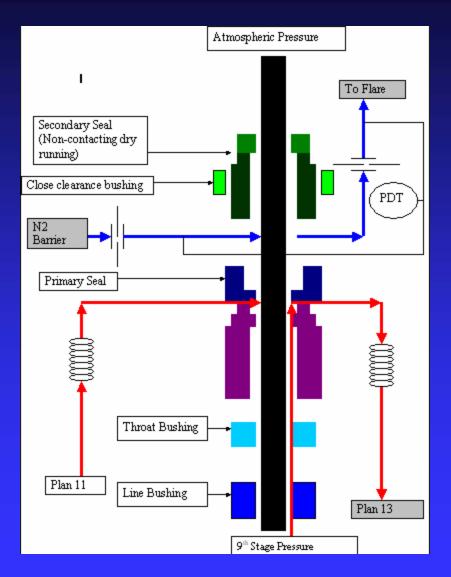
NEW SEAL DESIGN

Primary seal

- Face Geometry Change
- Balance ratio reduction
- Optimized flush distribution for cooling
- Non Contacting Secondary seal
- Intermediate bushing
- Changed Flush Plan
 - Reduced stuffing box pressure by orifice change in Plan 13 (seal gland to suction)
 - Added Plan 11 to increase flow
 - Incorporated Pressure reducing coils

Performance Parameter Comparison: Old/New Seal

SEAL DESIGN ANALYSIS SUMMARY (Steady state- hydropadded area)

Avg. Face Temp. F	PVnet (based on average	Vapor Pressure	Face pressure psi	Balance %	Friction heat BTU/h
		contact pressure) psi-ft/min	psig			
Old Seal	56.11	443586	780	142	85	4067
New Seal	29.7	314409	458	101	76.5	3599

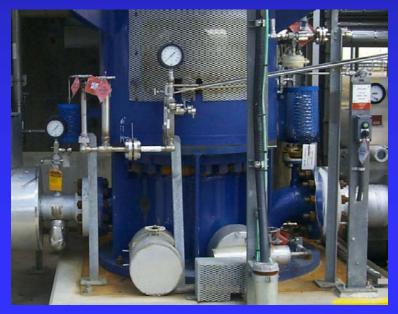
Implementation results

Test results on secondary seals MTBF to date on the pumps ♦ 3 pumps modified No removals to date Lead pump has 28 months Trending of leakages. Cost was 1/3 of the alternative Implementation was fast No added complexity
