# Solving Super-Synchronous Vibration on a Double Suction Pump

**28<sup>th</sup> International Pump Users Symposium**  
**September 24 - 27, 2012**

# Background

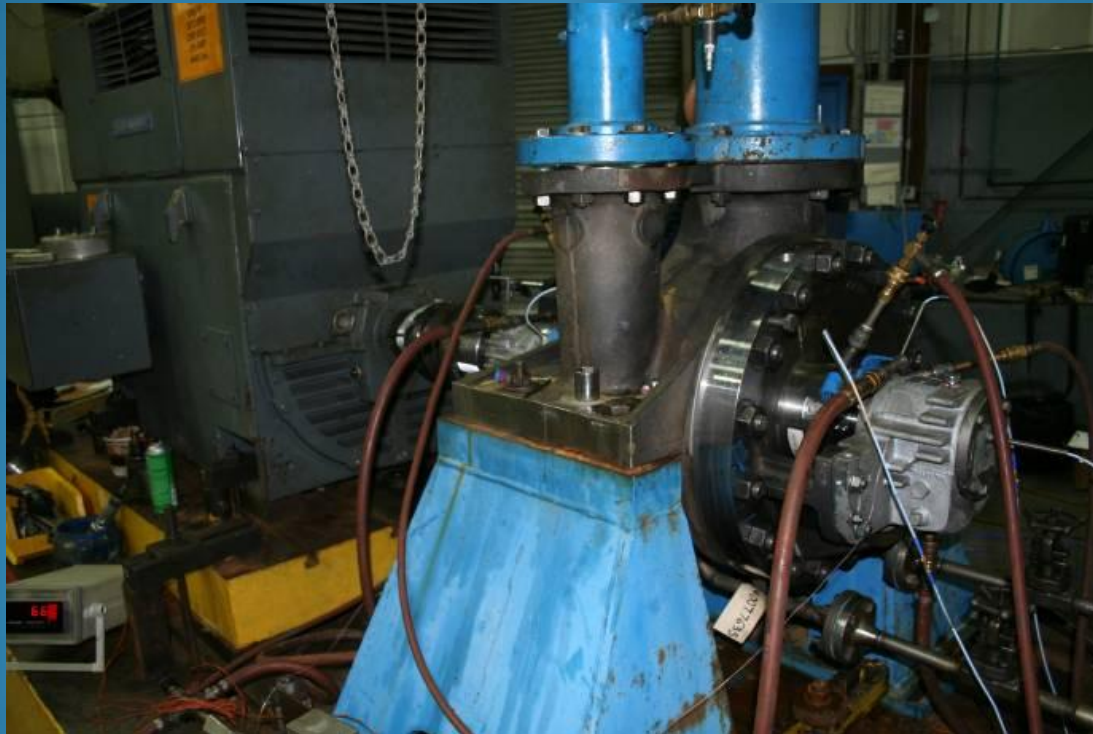
- In March 2010, during the factory performance test, high overall vibration (0.4 in/s RMS) was detected on the bearing housings at super-synchronous frequency (at approximately 100 Hz).
- API 610 10<sup>th</sup> Edition spec.: 0.12 in/s RMS at BEP and 0.154 in/s RMS below 70% BEP.

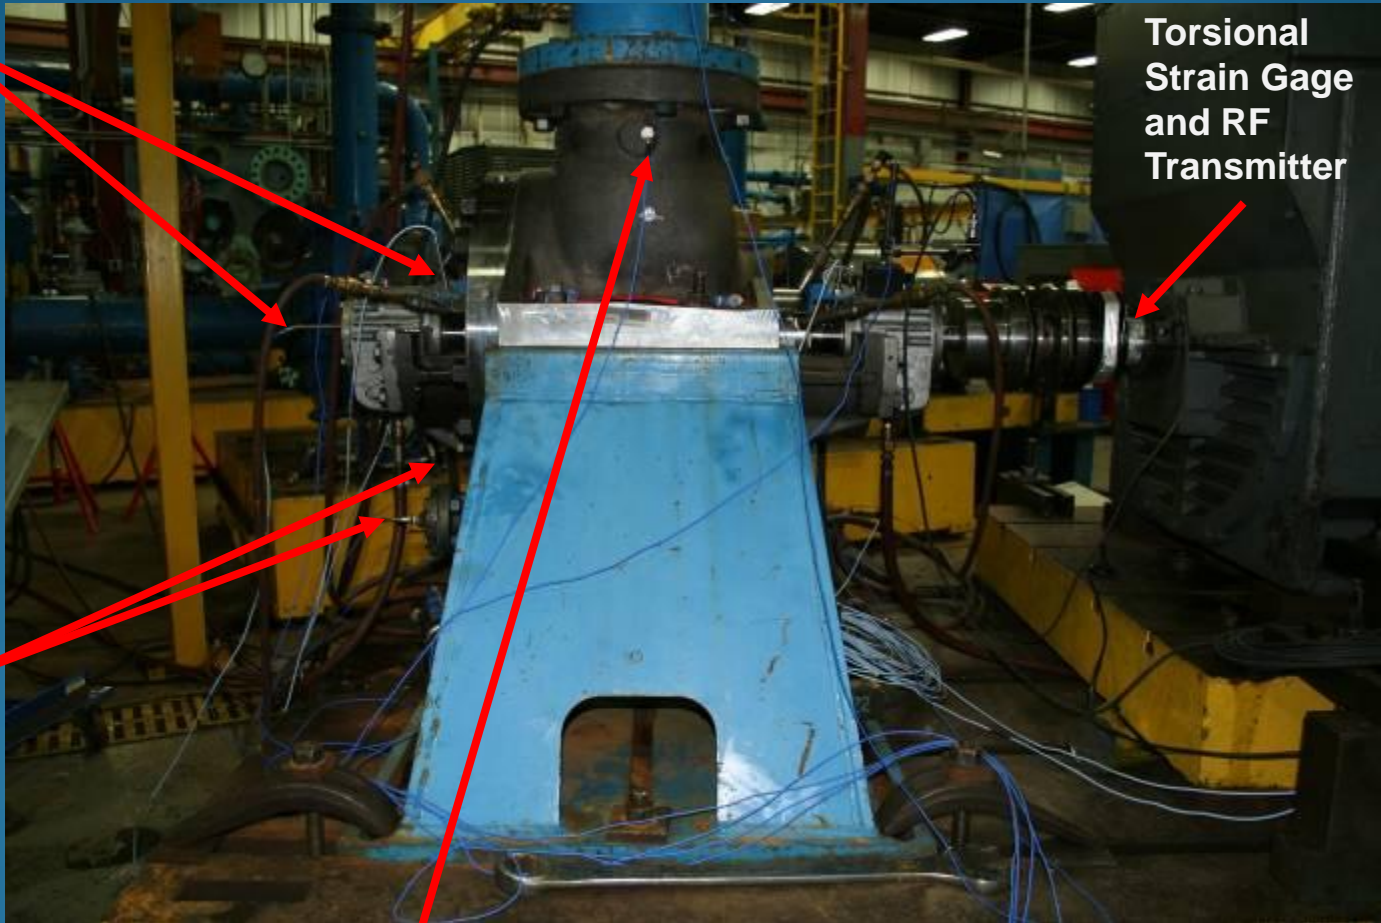
Radial &  
Axial  
Proximity  
Probes

Torsional  
Strain Gage  
and RF  
Transmitter

Dynamic  
Pressure  
Transducers

Tri-Axis  
Accelerometer

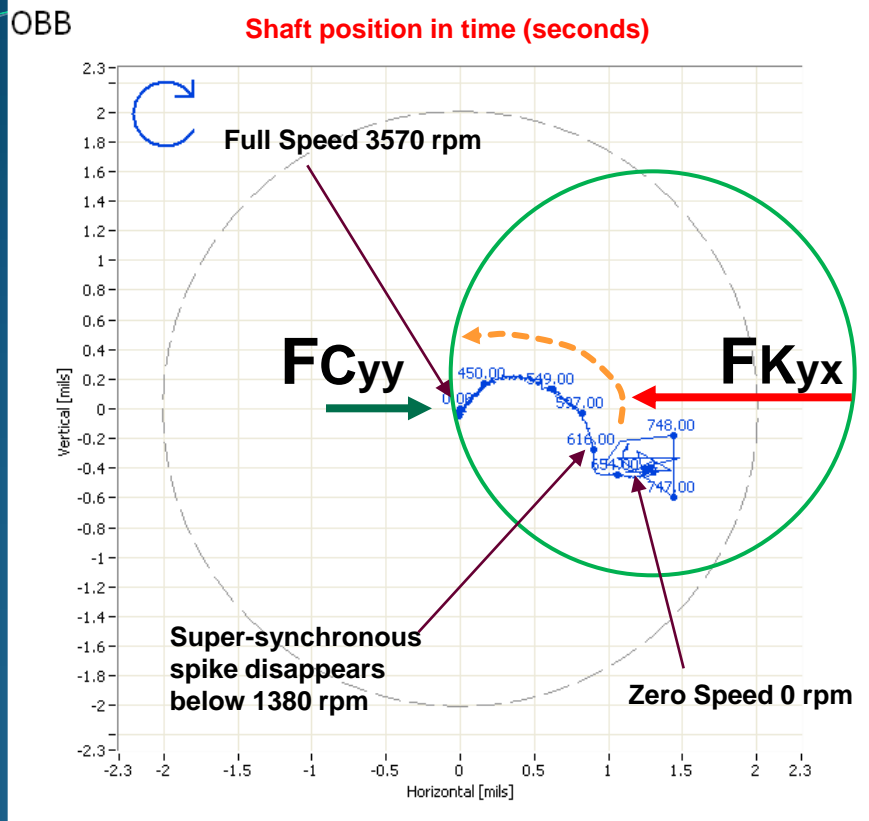
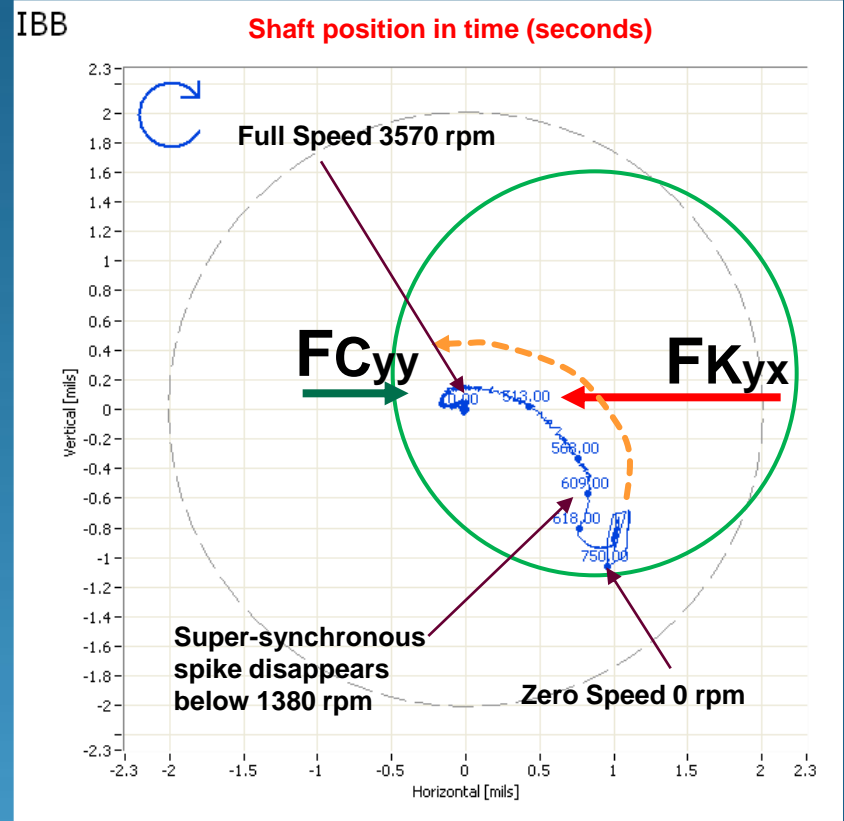
- Shaft center-line plots viewed from the NDE
- Shaft position in seconds during the coast-down from 3570 rpm (0 sec) to 0 rpm 750 sec.
- The shaft moves towards the upper left position after the pump starts (towards 9 O'clock position).
- Green circles represents the shaft centerline plots simulating the start-up process from the bottom (off-set plots). Note the static cross-coupled stiffness force (FKyx) is larger than the calculated synchronous damping force (FCxx) when the shaft speed is above 1380 rpm.

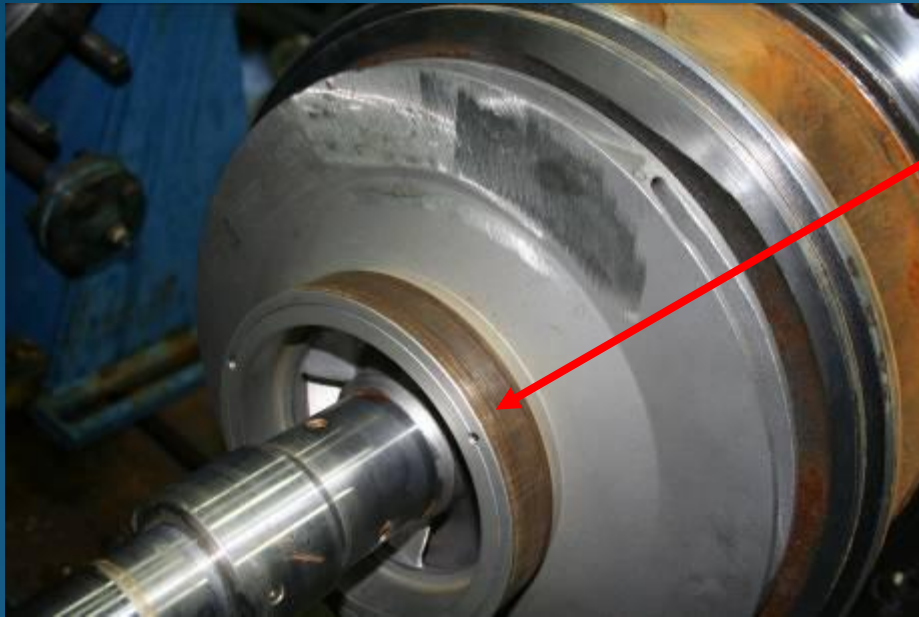
IB side impeller wear ring with evidence of rubbing

1. Based on a collaborative discussion with the OEM, one fix option for this instability was the addition of swirl-breaks by milling radial vanelets (slots) on the case wear ring. These 18 slots were equally spaced leaving vanelets of 1/8" of width and 1/4" of axial depth.
2. The wrap-around wear ring was modified with a tapered design at the ID side of the ring with approximately 2 to 3 degrees with the widest clearance at the exit of the seal at the pump suction.
3. Four slots were recommended to be machined in four clock positions at the bottom of the "pocket".

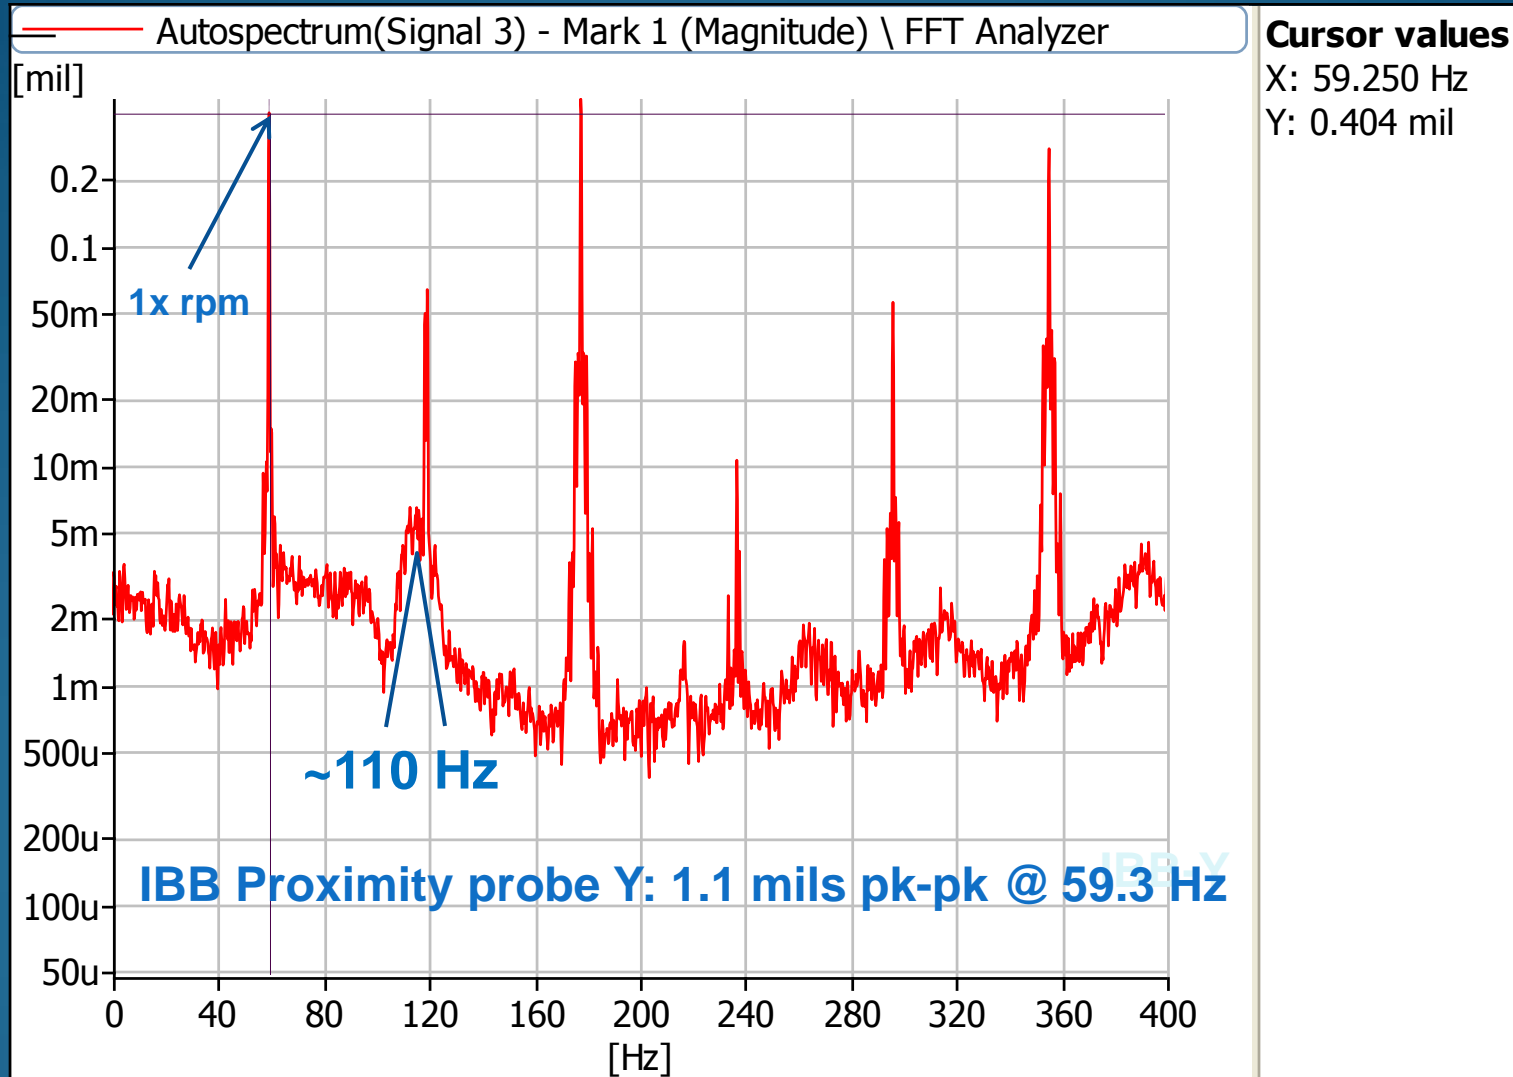
Running Speed 3555 rpm (59.3 Hz) – 1163 GPM – 741 ft

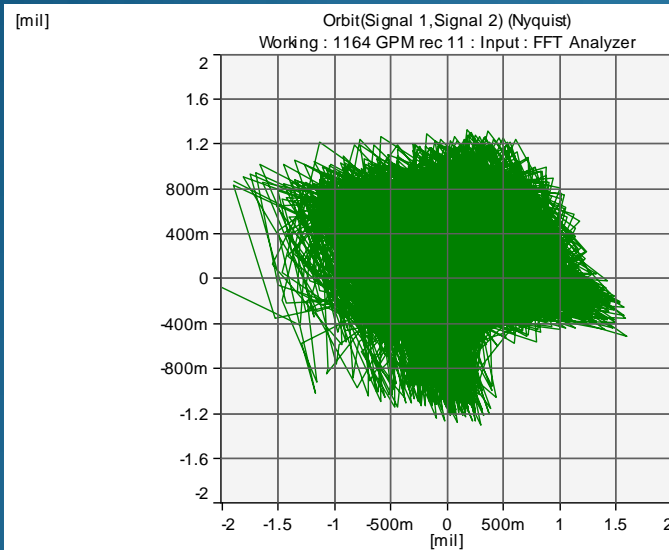
OBB

~2 mils pk-pk  
Mostly Run-Out

Running Speed 3555 rpm (59.3 Hz) – 1163 GPM – 741 ft
