Solving Super-Synchronous Vibration on a Double Suction Pump

27th International Pump Users Symposium
September 12 - 15, 2011

Maki M. Onari & William D. Marscher
Mechanical Solutions, Inc. – Whippany, NJ

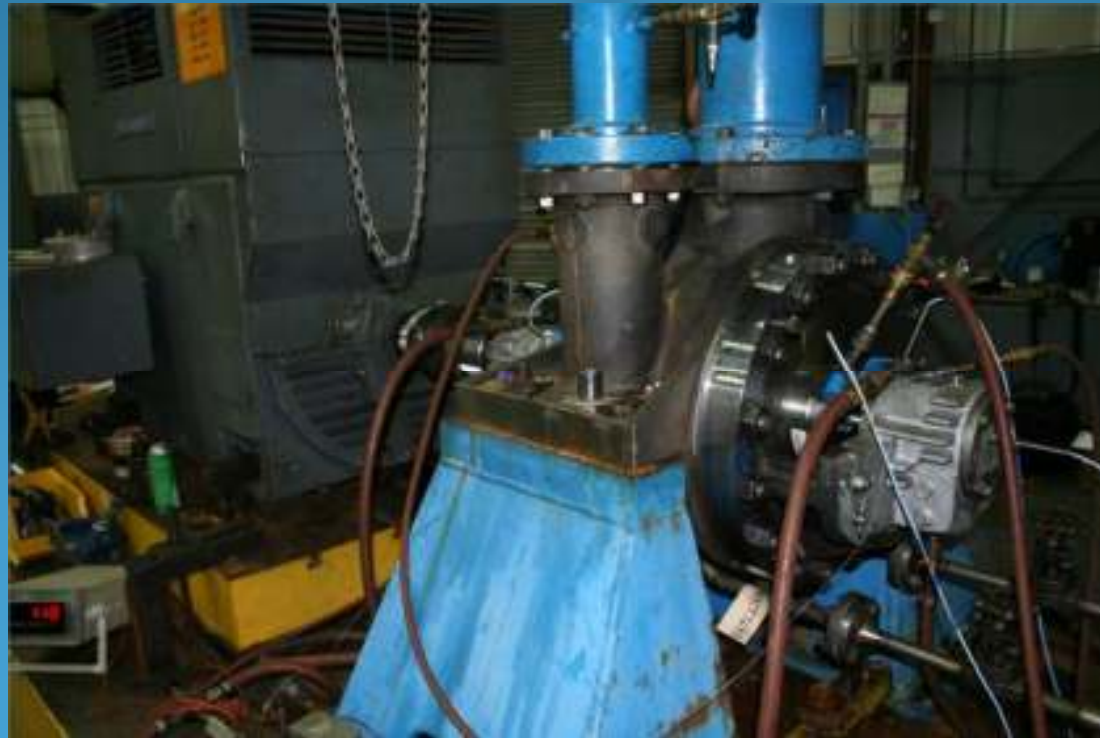
- In March 2010, during the factory performance test, high overall vibration (0.4 in/s RMS) was detected on the bearing housings at super-synchronous frequency (at approximately 100 Hz).
- API 610 10th Edition spec.: 0.12 in/s RMS at BEP and 0.154 in/s RMS below 70% BEP.

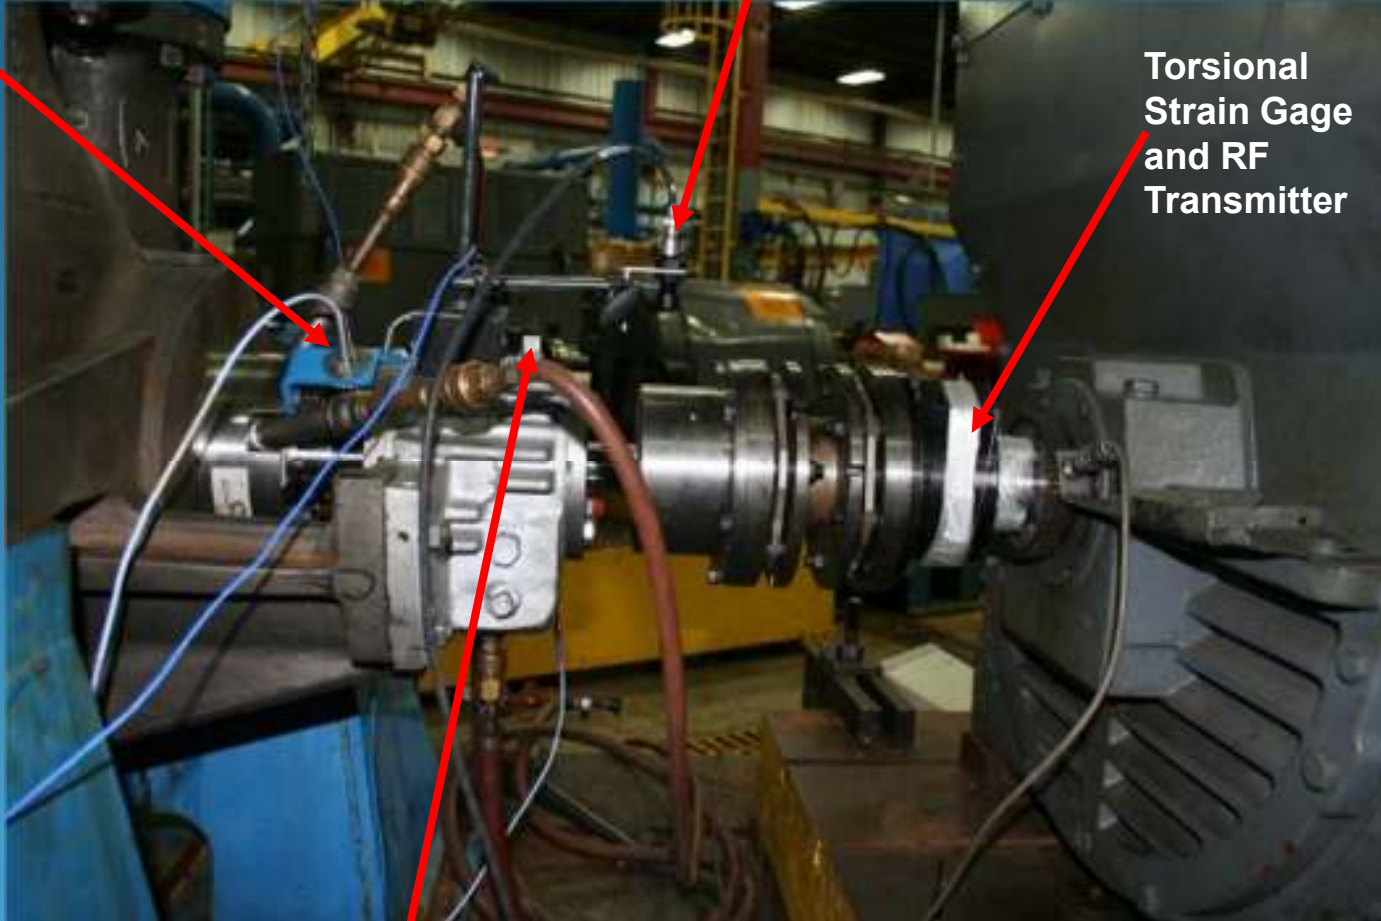
Radial Proximity Probes

Optical Tachometer

Torsional Strain Gage and RF Transmitter

Tri-axis Accelerometer

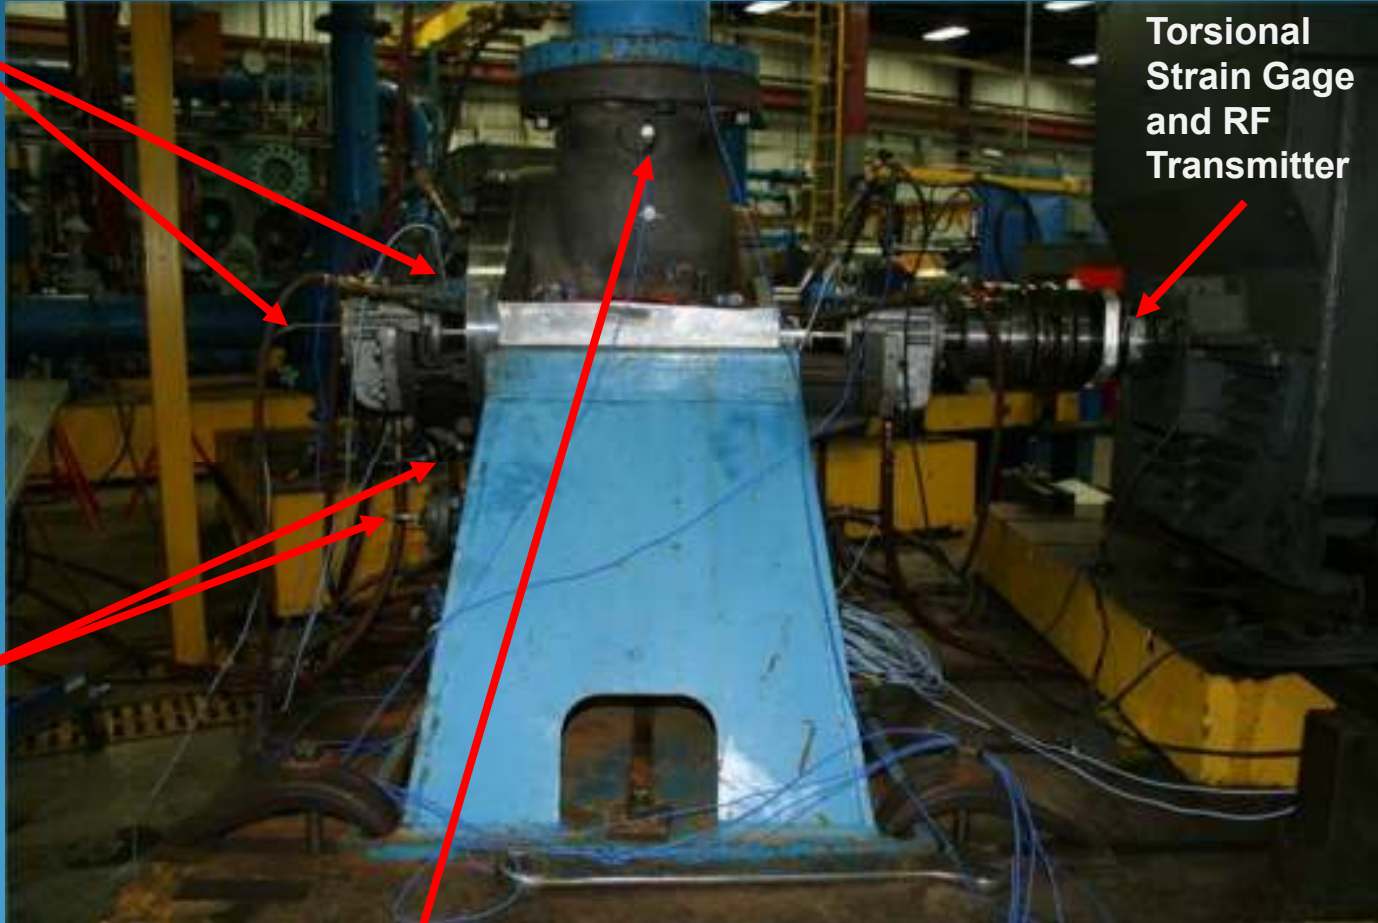
Radial & Axial Proximity Probes

Torsional Strain Gage and RF Transmitter

Dynamic Pressure Transducers

Tri-Axis Accelerometer

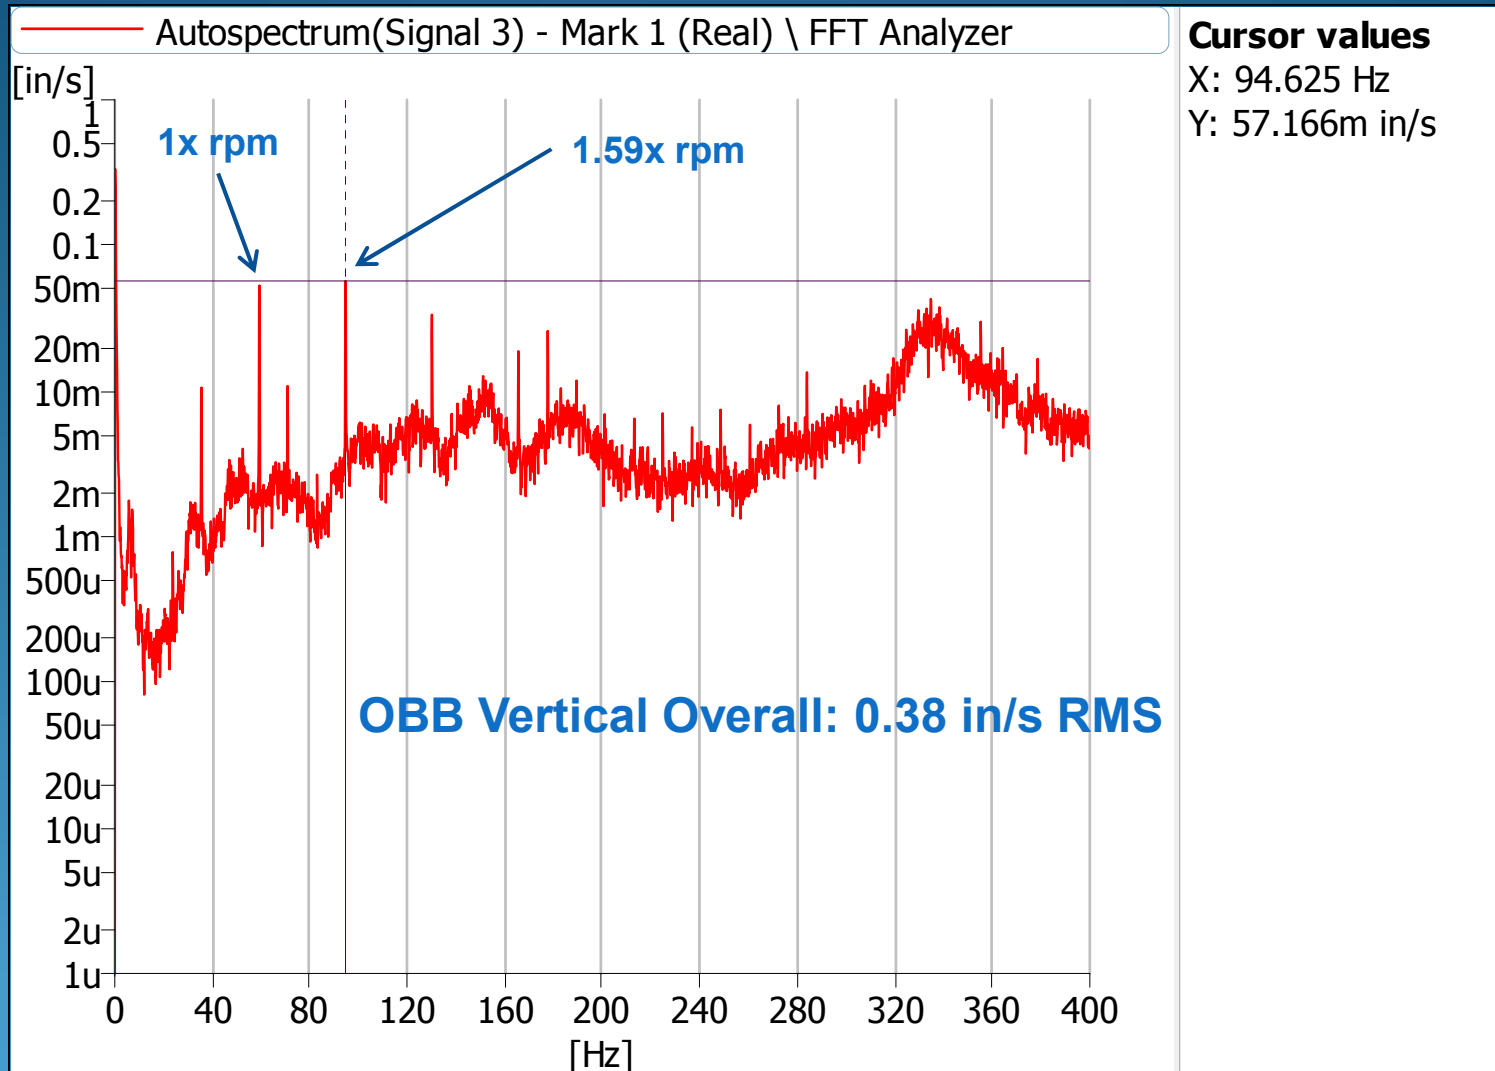
Running Speed 3570 rpm (59.5 Hz) – 1163 GPM – 764 ft

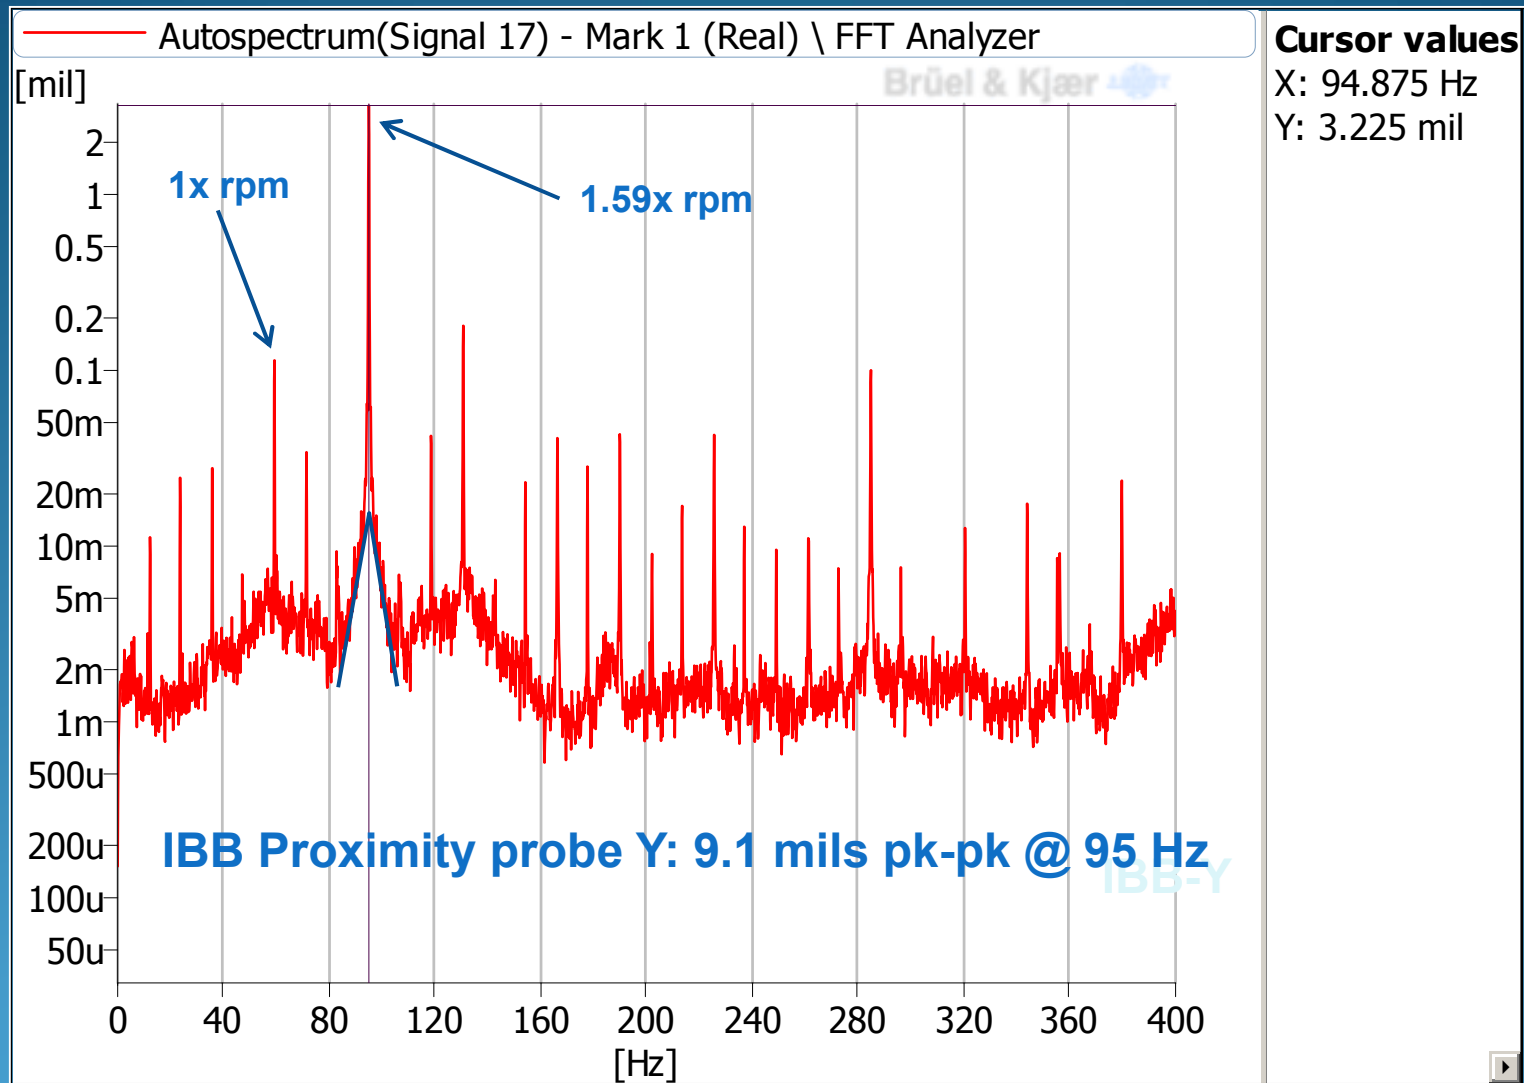
Running Speed 3570 rpm (59.5 Hz) – 1163 GPM – 764 ft

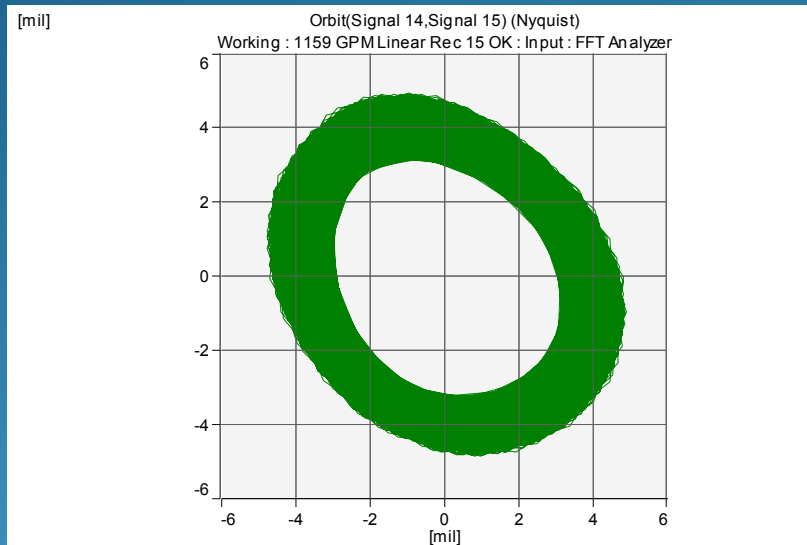
OBB

~9.0 mils pk-pk

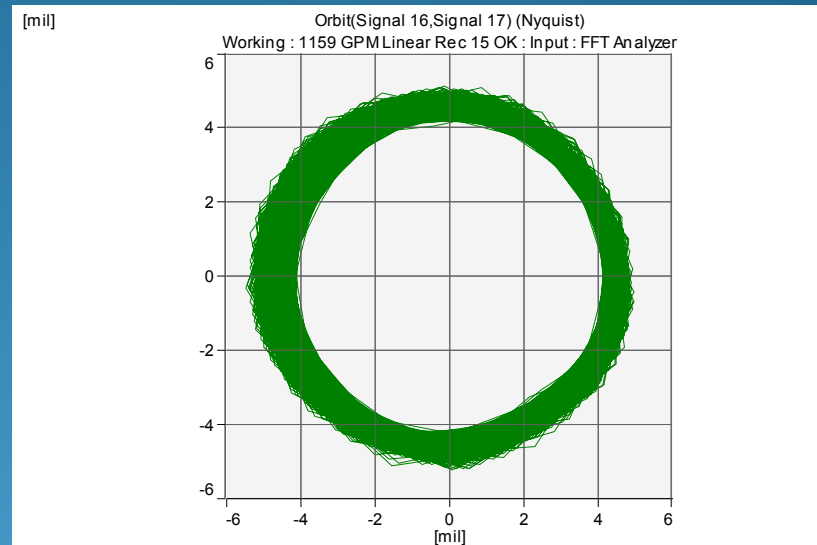
IBB

~9.5 mils pk-pk

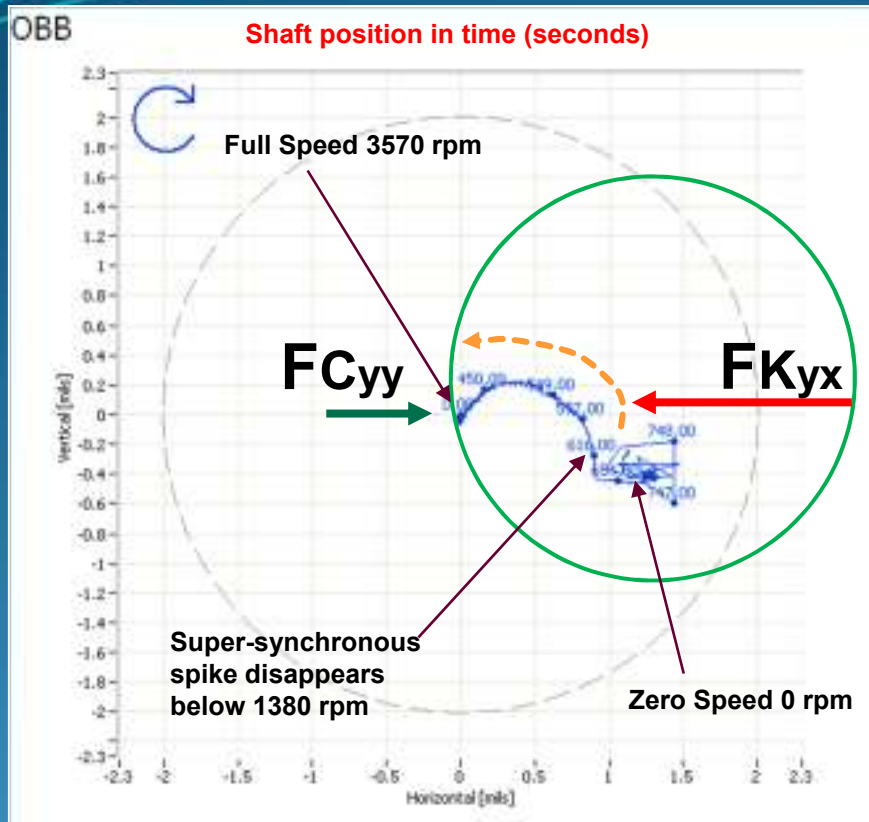
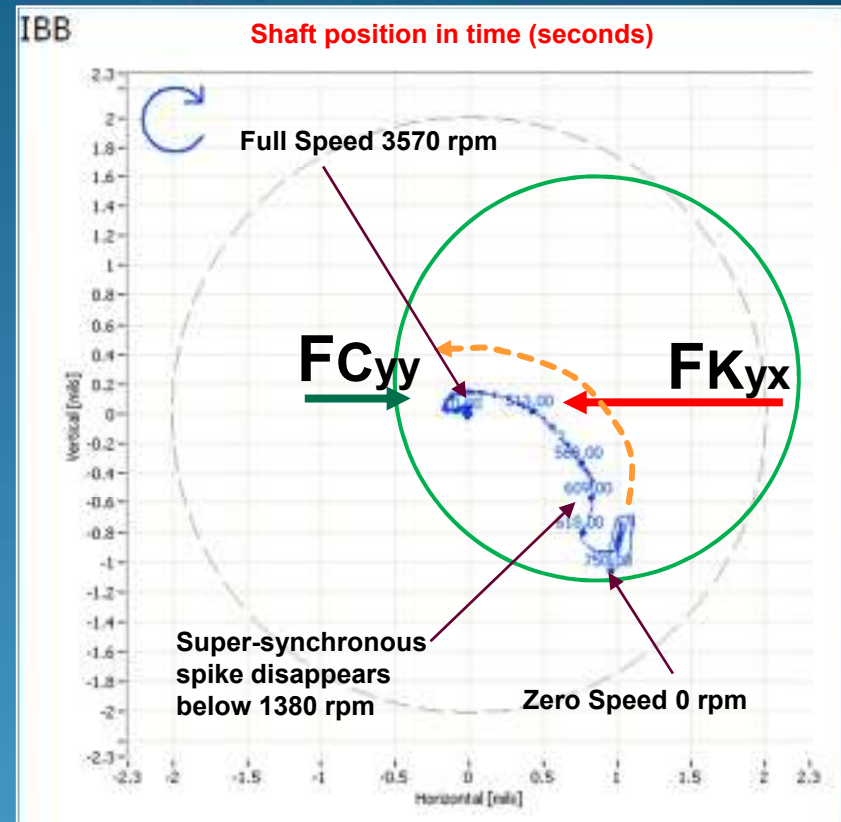
- Shaft center-line plots viewed from the NDE
- Shaft position in seconds during the coast-down from 3570 rpm (0 sec) to 0 rpm 750 sec.
- The shaft moves towards the upper left position after the pump starts (towards 9 O'clock position).
- Green circles represents the shaft centerline plots simulating the start-up process from the bottom (off-set plots). Note the static cross-coupled stiffness force (FKyx) is larger than the calculated synchronous damping force (FCxx) when the shaft speed is above 1380 rpm.

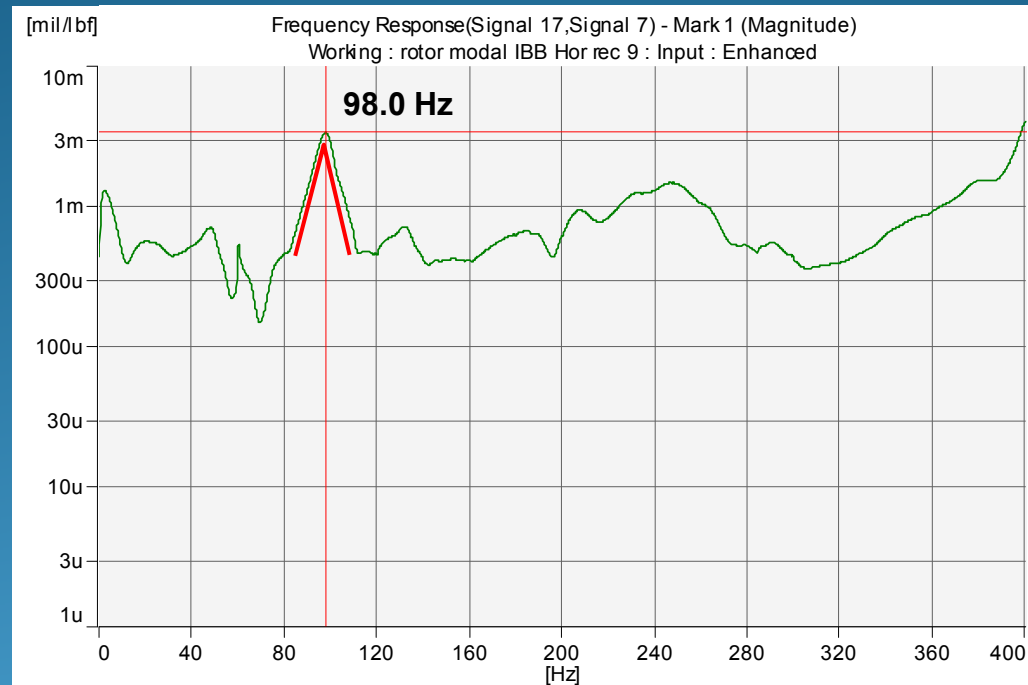
Pump Rotor Frequency Response Function (FRF) plot
while the pump was not operating

Radial Proximity Probe IBB-Y

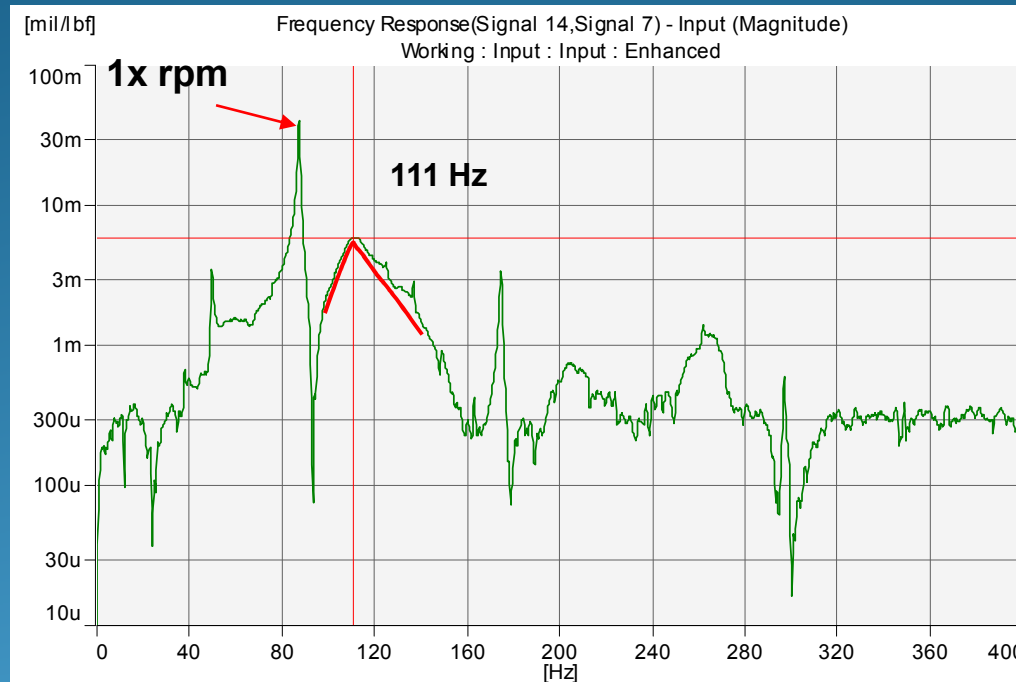
FRF plot while the pump was operating at 49.5 Hz
– 615 GPM and 616 ft of TDH

Reading from the radial proximity probe OBB-X
Note that the rotor natural frequency shifted upwards with
the speed and the stiffness from the wear rings.

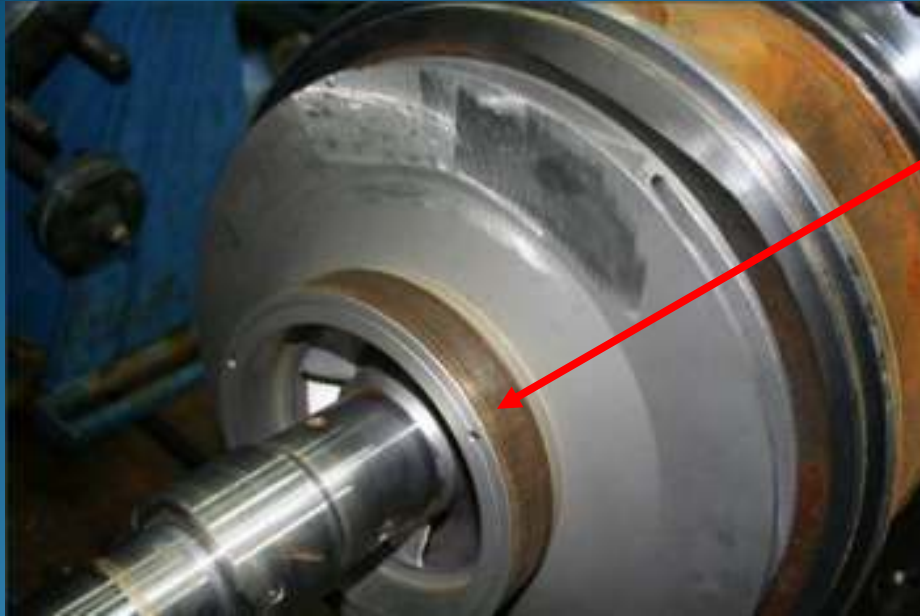
IB side impeller wear ring with evidence of rubbing

1. Based on a collaborative discussion with the OEM, one fix option for this instability was the addition of swirl-breakers by milling radial vanelets (slots) on the case wear ring. These 18 slots were equally spaced leaving vanelets of 1/8" of width and 1/4" of axial depth.
2. The wrap-around wear ring was modified with a tapered design at the ID side of the ring with approximately 2 to 3 degrees with the widest clearance at the exit of the seal at the pump suction.

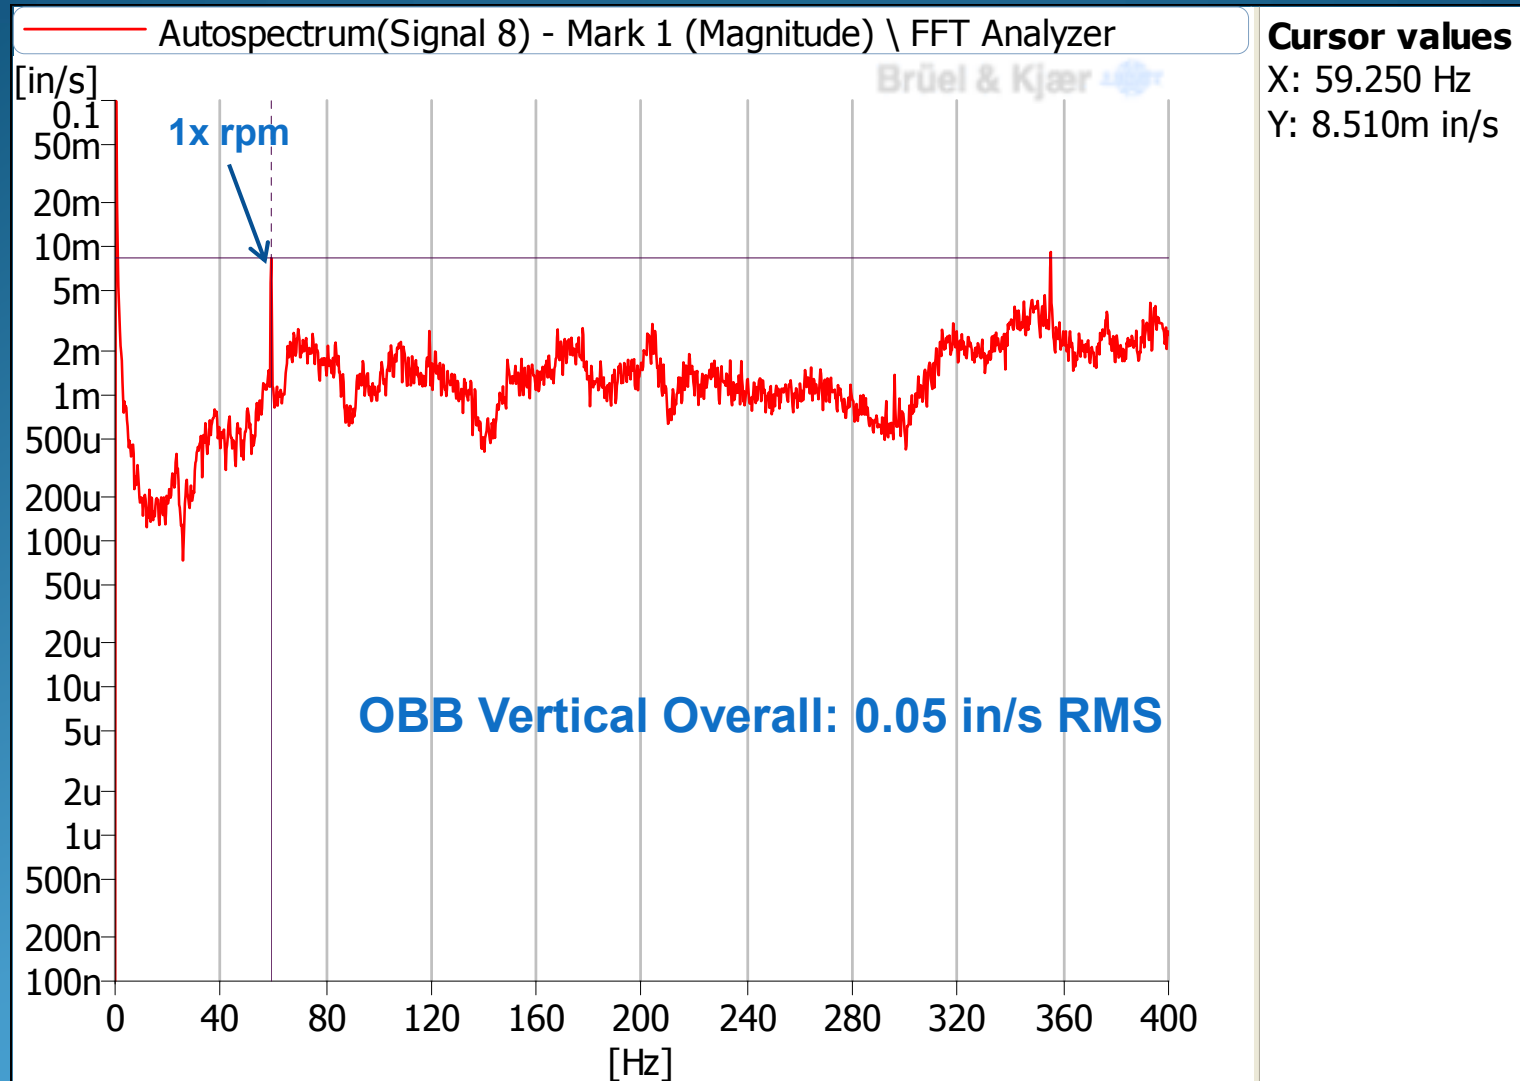
Running Speed 3555 rpm (59.3 Hz) – 1163 GPM – 741 ft

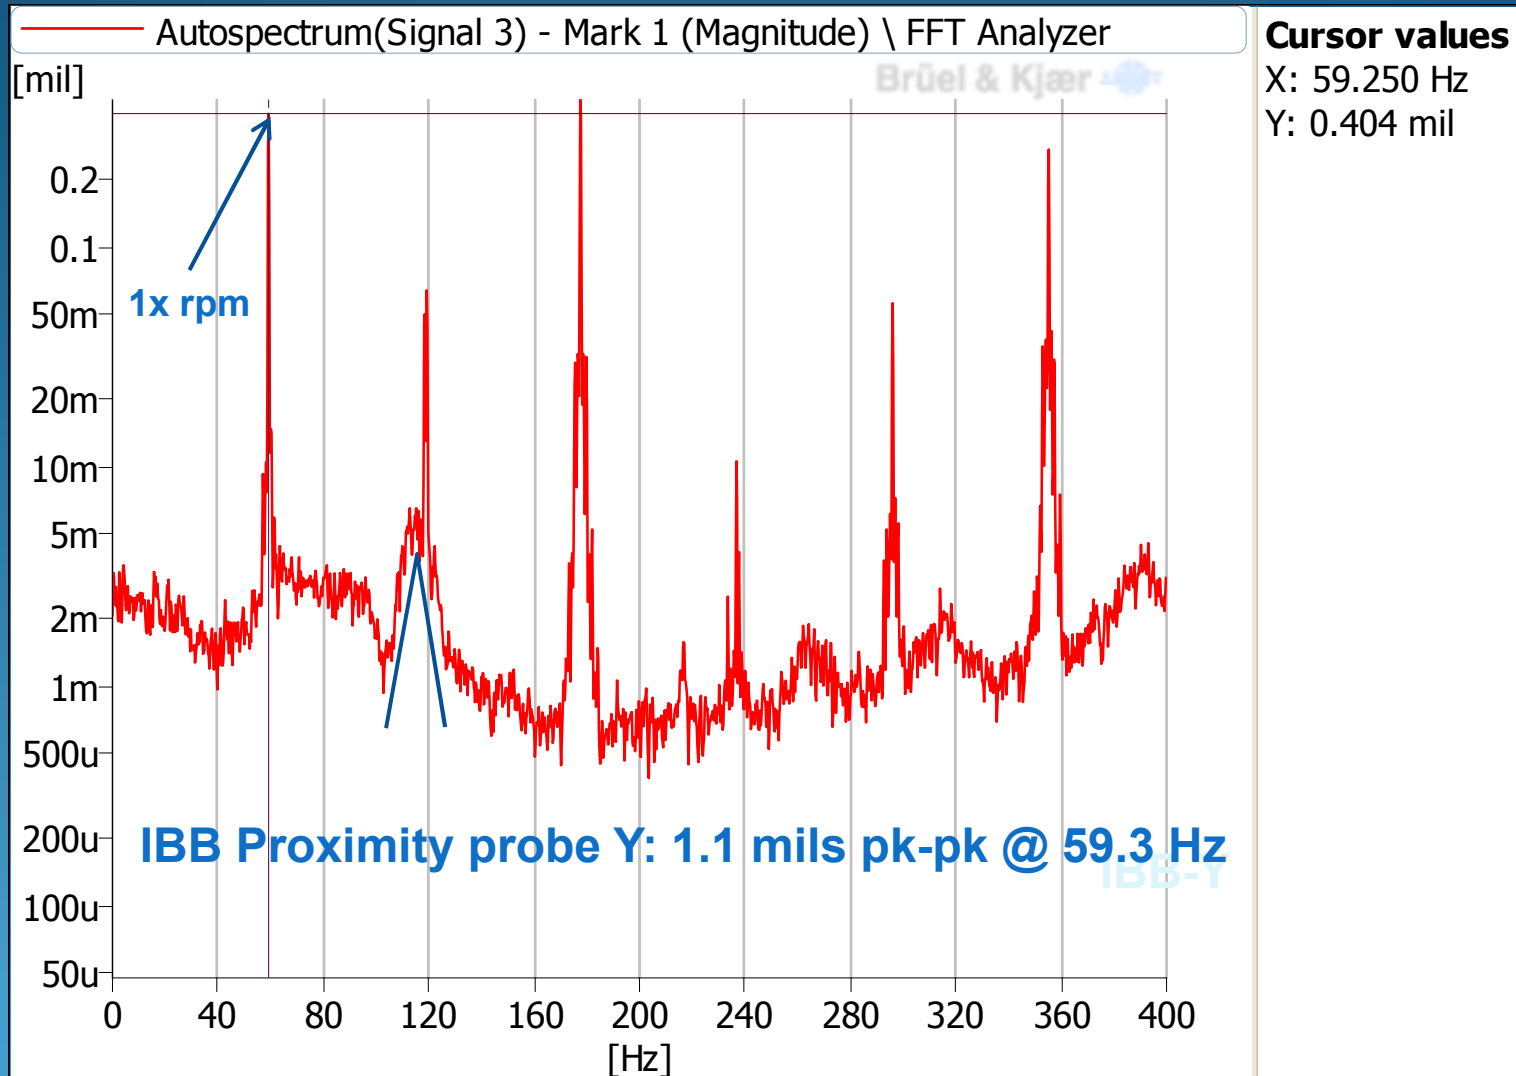
Running Speed 3555 rpm (59.3 Hz) – 1163 GPM – 741 ft

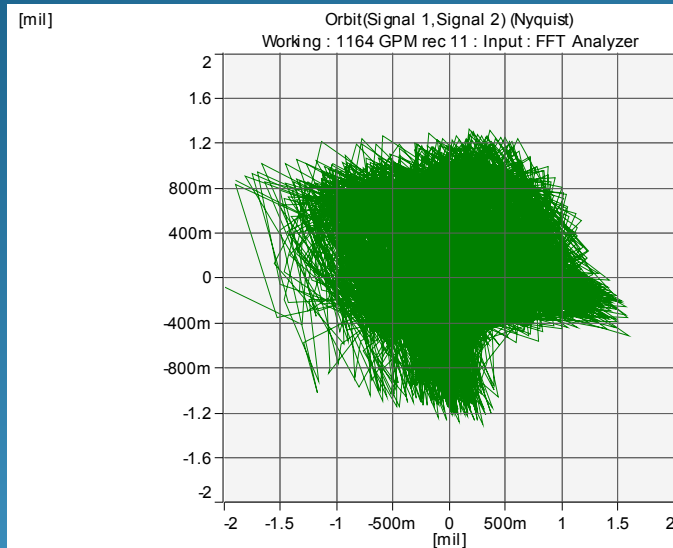
OBB

~2 mils pk-pk
Mostly Run-Out

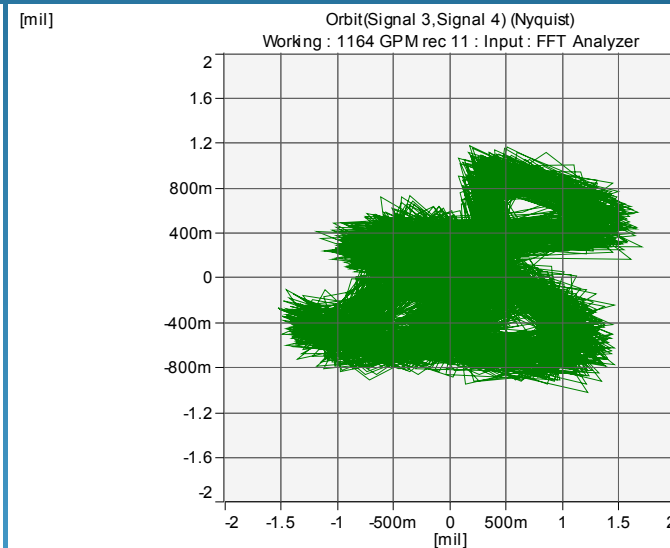
IBB

~2.1 mils pk-pk
Mostly Run-Out
