Case History

Experience with API Plan
53B

Pressurized Dual Seal
Systems

Roger Jones, Ken Savoie & Zhou DaLi

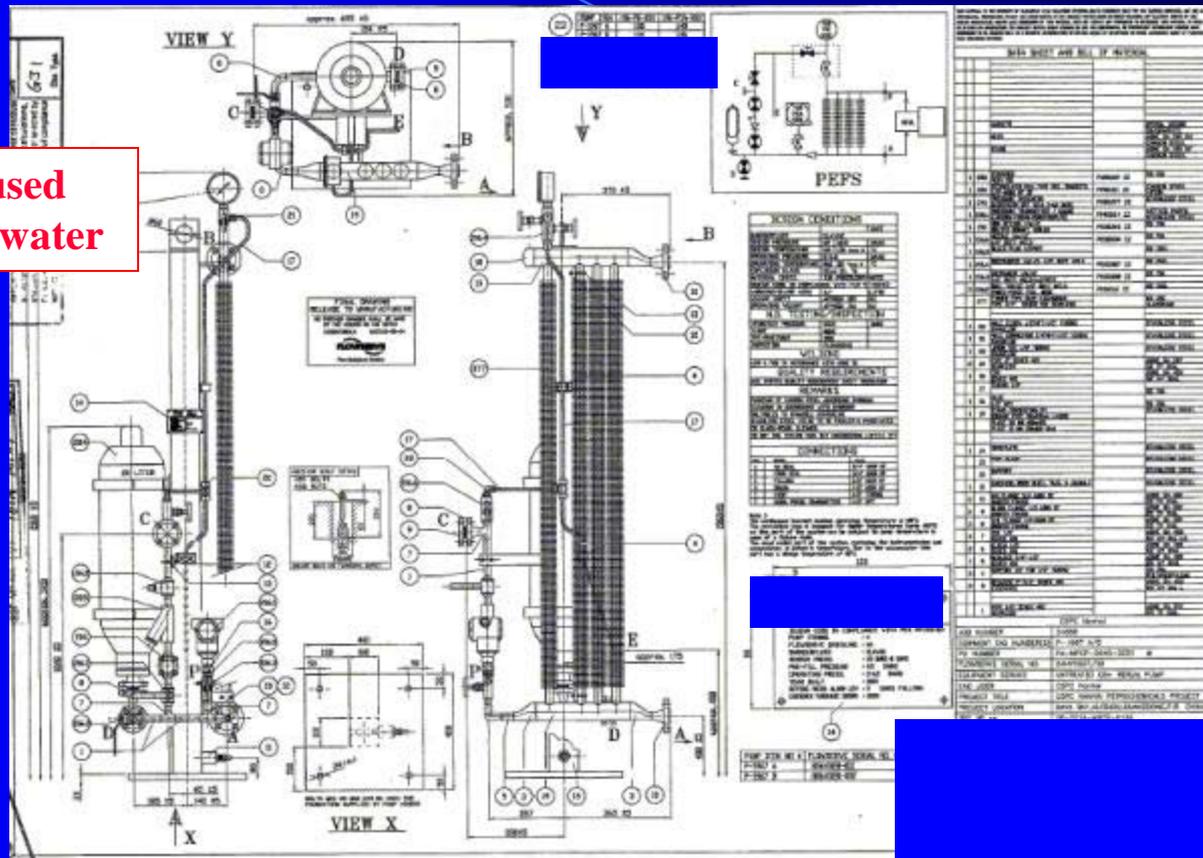
Project mostly used air coolers; few water

All mechanical seals leak. It is the leakage across the faces that lubricates the seal. The manufacturer can tell you the leakage rate. The bladders were sized for a minimum of a months leakage.
