HIGH ENERGY ABRASIVE SERVICE PUMP UPGRADE

ABSTRACT

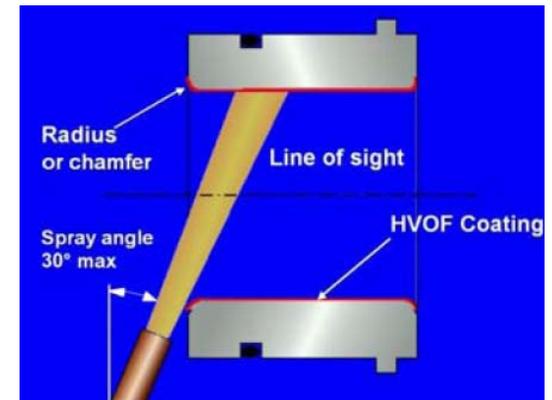
- HIGH VELOCITY OXY FUEL HARD SURFACE COATINGS USED LIBERALLY ON ALL EROSIVE AND ABRASIVE SURFACES.

- TUNGSTEN CARBIDE BASED COATING SELECTED WITH APPROPRIATE METALLIC BINDER BLEND. HIGH HARDNESS FOR ANTI-GALLING AND ABRASION RESISTANCE $>69R_c$
- BINDER SELECTION REQUIRES CAREFUL CONSIDERATION OF CORROSION RESISTANCE AND GALLING RESISTANCE REQUIREMENTS
- IN ORDER TO ACHIEVE HIGH BOND STRENGTH AND MINIMAL POROSITY (LESS THAN 1%) HIGH IMPORTANCE IS PAID TO APPLICATION PROCESS PARAMETERS SUCH AS SPRAY ANGLE, DEPOSITION VELOCITY AND OTHERS⁶
