Improving Reliability Of Canned Motor Pumps in Refrigeration Service

King J. Molder

S. Dennis Fegan

24th International Pump Users Symposium

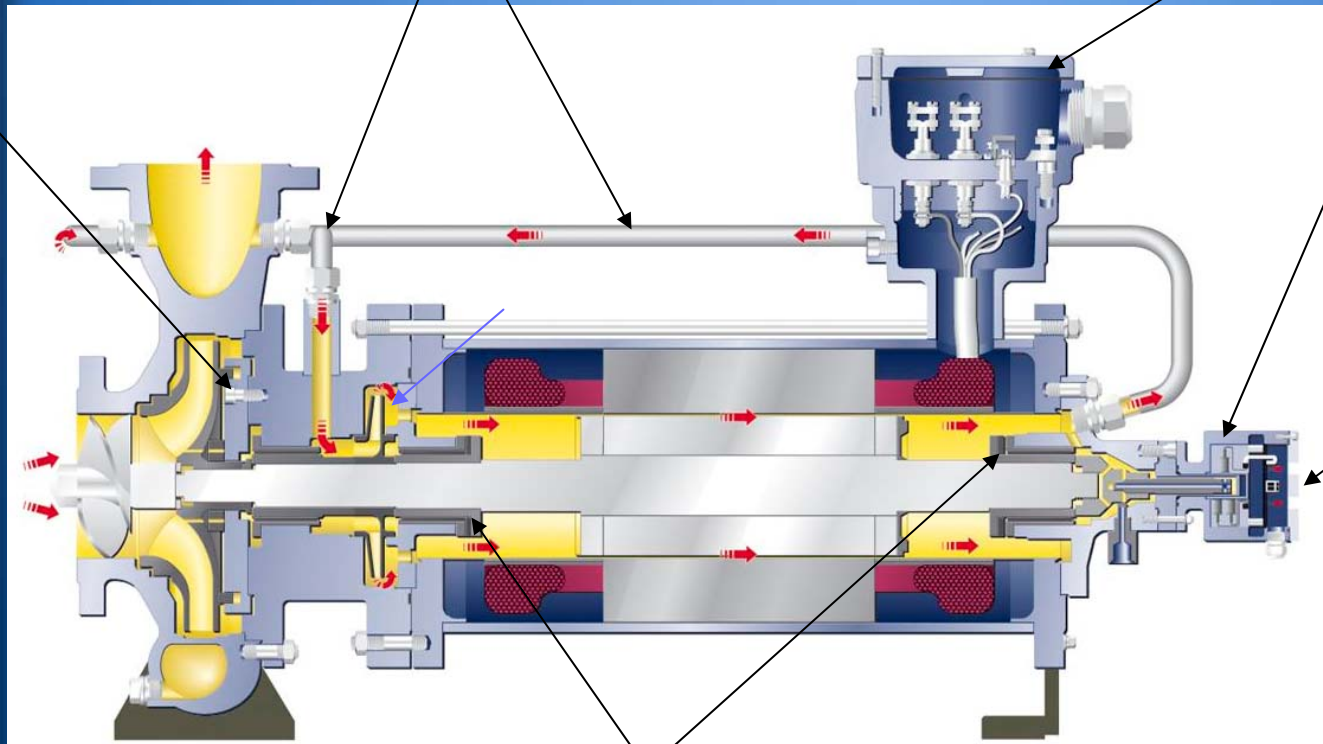
External piping to insure proper venting

Hermetically sealed motor and conduit box

Positive thrust balance control

Bearing wear /shaft position monitor

Rotation indicator

Hydrodynamic bearings

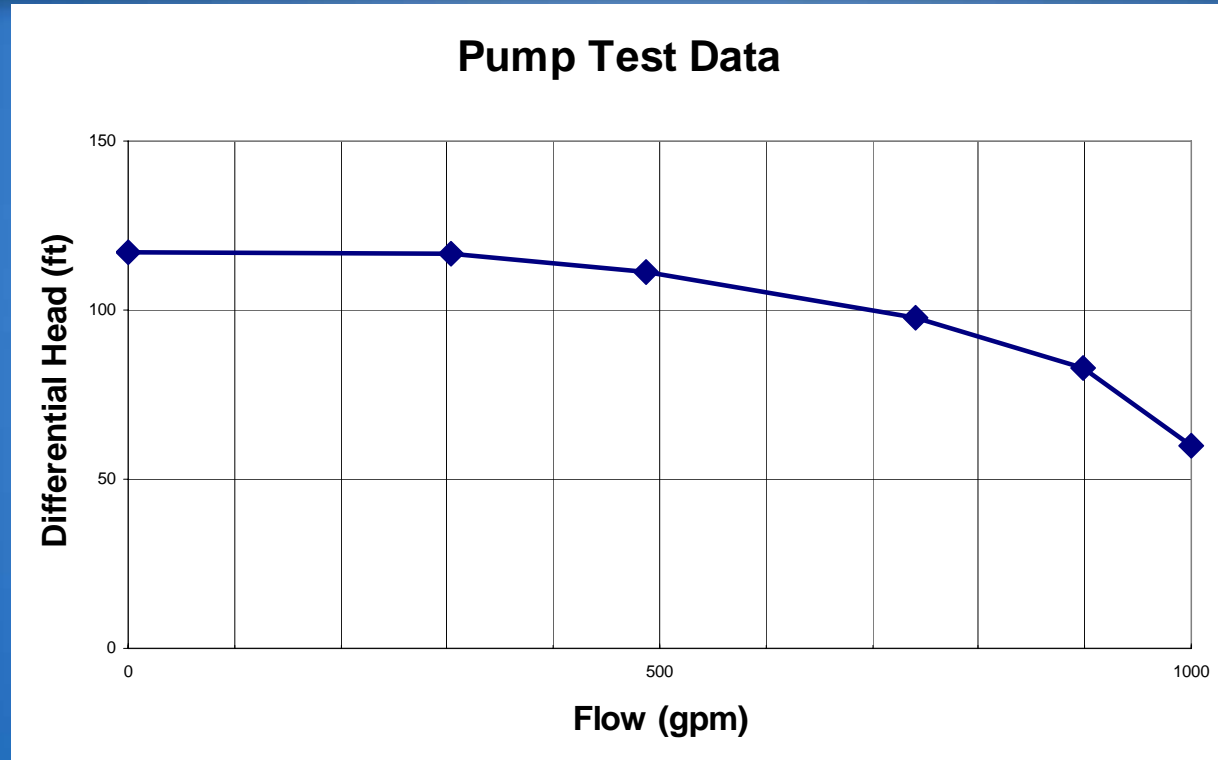
- ❖ Due to the axial thrust problem the manufacturer requested that the pumps not be operated above the 750 gpm design point
- ❖ The facility flow meters consistently indicated a lower flow rate than the values shown by checking the motor current draw.
