ITT

Modification of BB1 pump vibration characteristics to meet ISO 13709 2nd edition (API 610 11th) limits

ITT Goulds Pumps

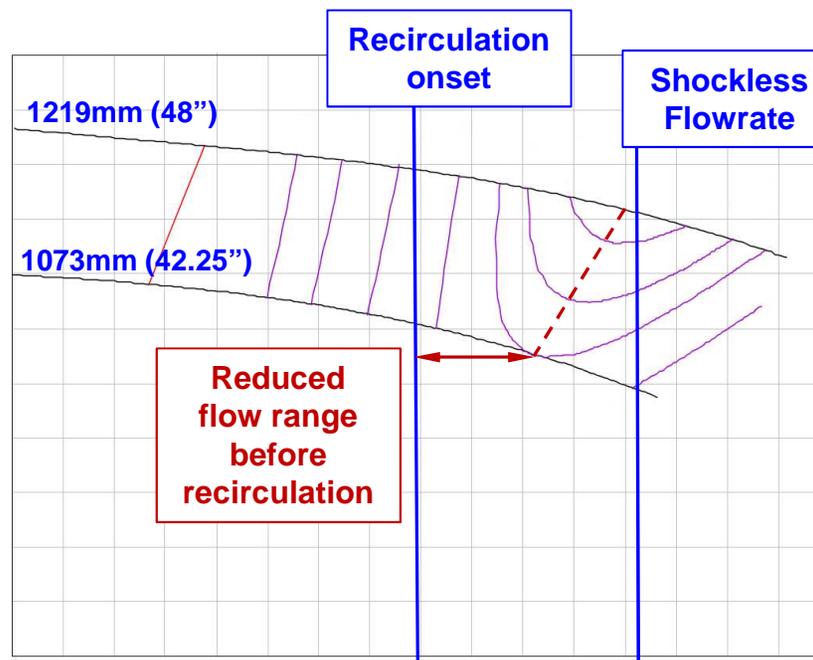
1. Pump design circa 1970 intended for municipal water service (although successful used in ISO 13709 service on prior occasions)
 - 6 vane design, less than ideal with a 180° volute
 - Unstaggered vane design
 - Impeller eye larger than optimum by modern design rules
 - Suction casing area progression not optimum by modern design rules
2. Never previously required to meet ISO 13709 section 8.3.3.6 test
3. Large impeller trim
