Pump Performance and Energy Efficiency Improvement Through Pump Refurbishment and Internal Coatings of Horizontal Split Case (HSC) Pumps

Presented By: Paul Maier

Monroe County Water Authority (MCWA)

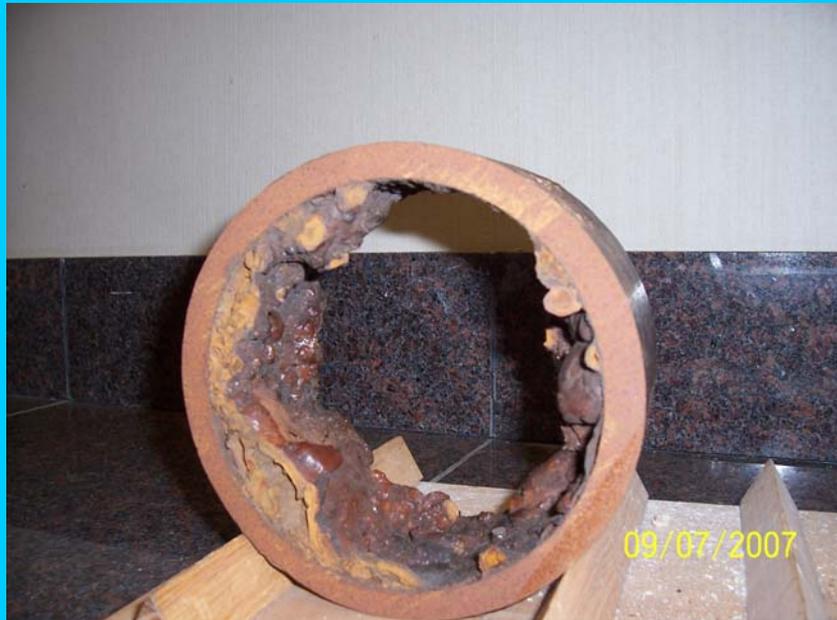
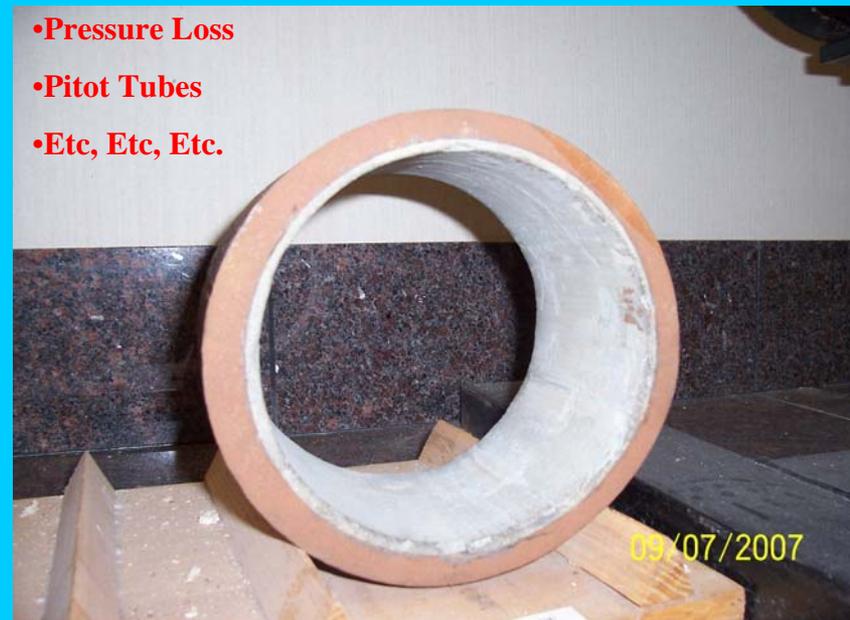
Effects of Tuberculation Inside Pumps?

Not so well Documented - 400 HP, 12x16 HSC Pump Installed 1962

- Does the inside Tuberculation impact Pump Flow, Head, Efficiency and/or Energy Consumption and by how much?
- Can any Loss of Pump performance be restored and/or Energy Consumption reduced by cleaning and coating the interior of the pump casing?

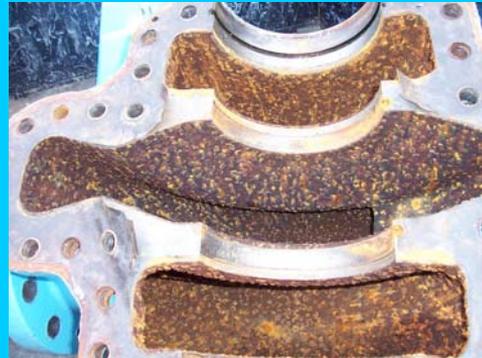
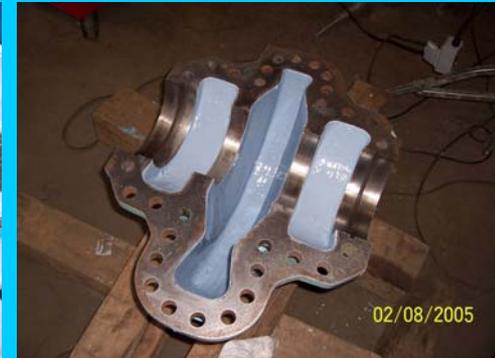
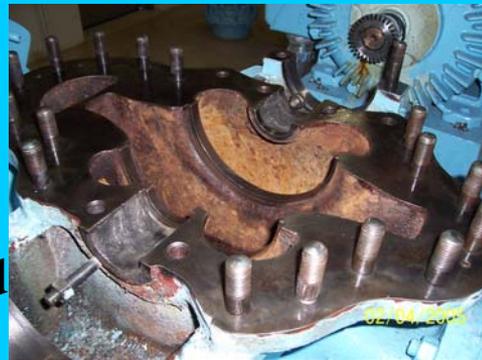
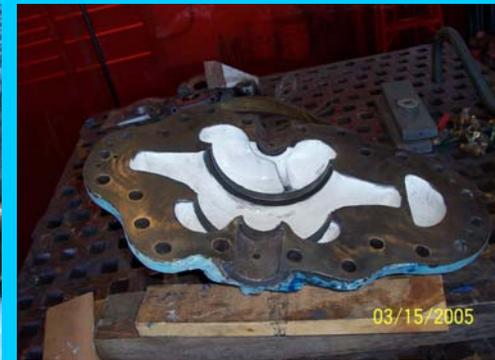
- Rebuilt (wear rings, sleeves, bearings) and Cleaned & Coated two Horizontal Split Case Pumps.
- 100 HP 8" x 8" HSC Pump
- 75 HP 5" x 8" HSC Pump
- Both Cases pump efficiency had dropped by more than 15% from manufacturer's specifications.
- Estimated increase of pump efficiency through cleaning and coating approximately 10%

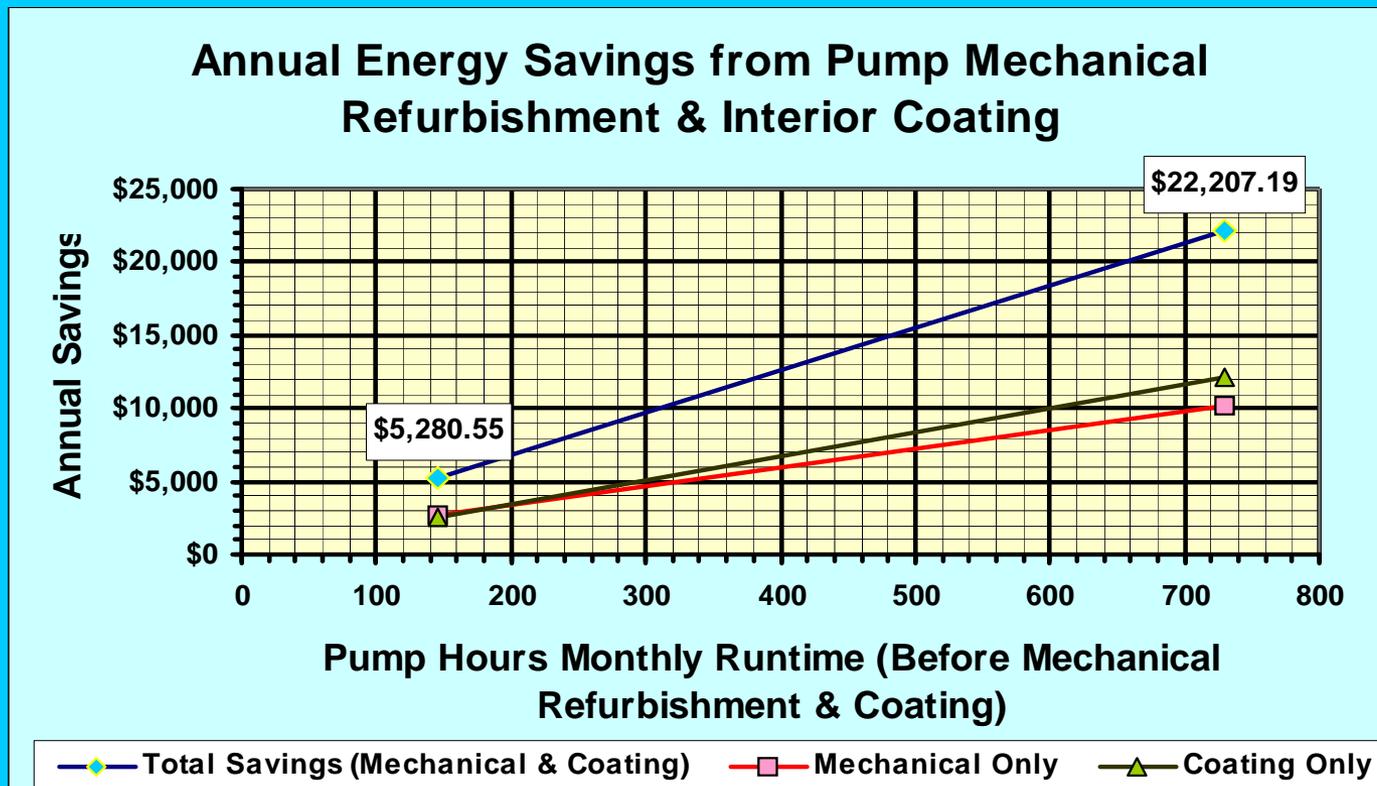
- \$10/kW Demand Charge and \$0.085/kwh Cost
- Estimated Cost of work \$8,500 (\$4500 in wear rings)
- Payback Period Mechanical Refurbishment & Coating
 - 0.38 years continuous running pump (730 hours/month)
 - 1.61 years for 20% operation (146 hours/month)

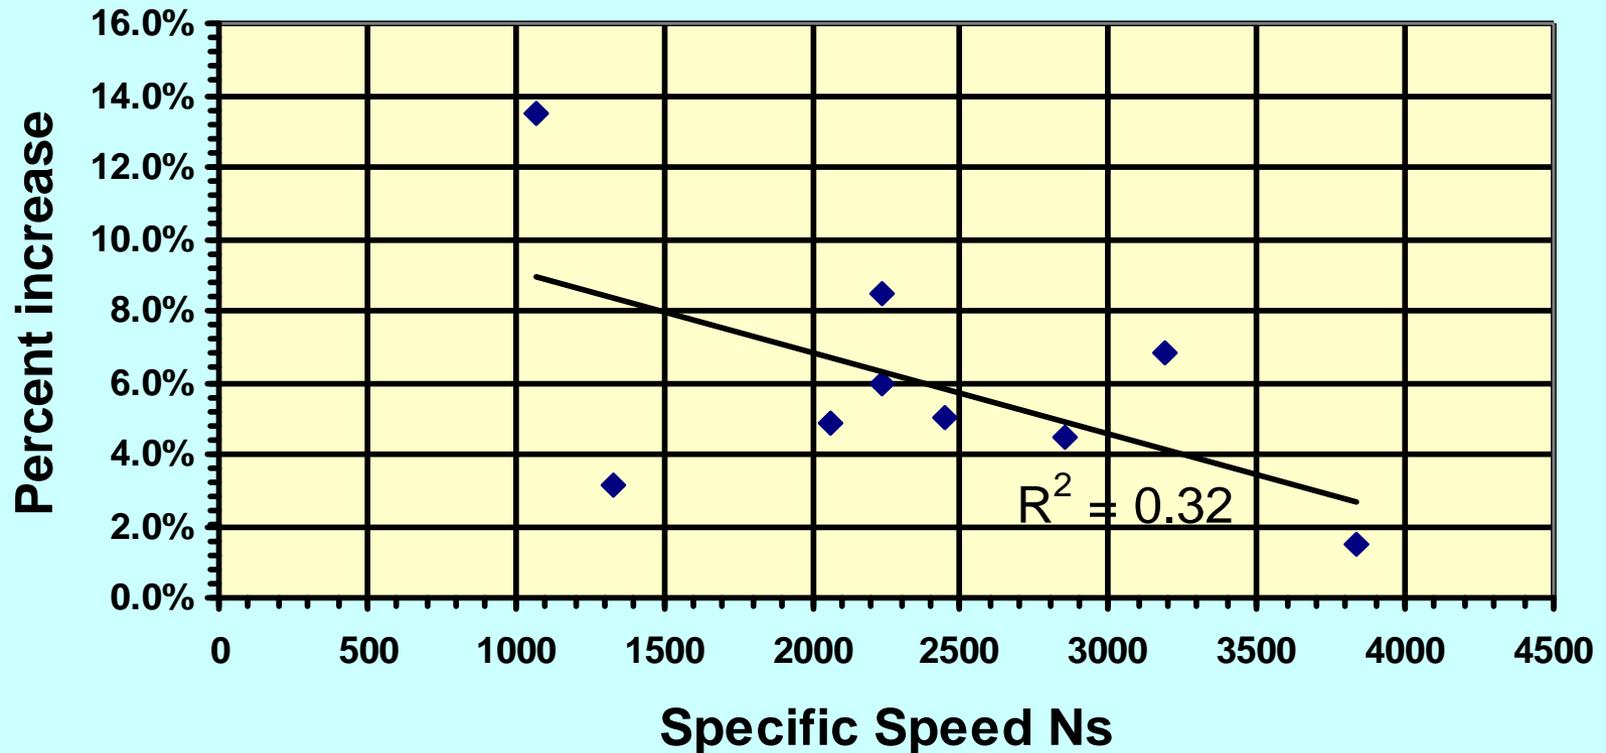
Efficiency Increase from Coating by Specific Speed (N_s) - 9 Pumps Completed

Preliminary Findings of the Specific Speed N_s Relationship
