RELIABILITY IMPROVEMENTS TO A HIGH SPEED/HIGH ENERGY PUMP

Ed Wilcox

Lyondell Chemical Company

Channelview, Texas

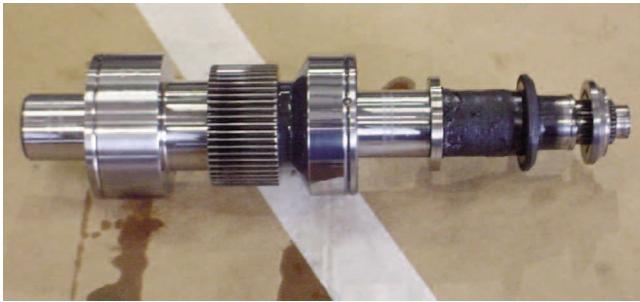
Figure 6. Output Shaft.

The pump was equipped with a tandem, pusher style seal arrangement, with an API plan 52 that was vented to flare. The primary process seal was normally found to be in excellent condition. However, the secondary seal would always show signs of dry running and excessive heat (Figure 5). This was evident as well from the buildup of burned oil on the output shaft (Figures 6 and 7). Likewise, this buildup on the shaft certainly contributed to the unbalance of the rotor. There were several factors that contributed to the failed secondary seal:

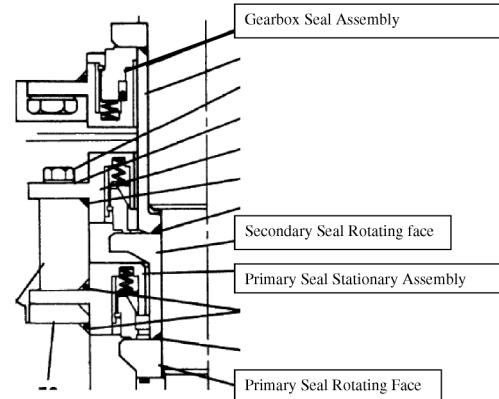
Figure 9. Tandem Pusher Process Seal with Stationary Springs.

- Poor secondary seal rotating face design—The original secondary seal design incorporated a design where the sleeve and rotating face are one piece steel, with the face of the seal coated with tungsten carbide, similar to a “top hat” in appearance (Figures 9 and 10). At high surface speeds, this can create seal problems due to the bond between the coating and the steel, as well as the fact that the steel does not conduct away the heat produced by the seal as well as solid tungsten carbide.

To further improve the reliability of the secondary process seal, the one piece "top hat" design discussed above was replaced with a two piece design that incorporated a separate 17-4 PH sleeve and solid tungsten carbide rotating face (Figure 14). This increases the seals ability to conduct heat away from the faces as well as eliminates problems with the tungsten carbide coating on the steel face.

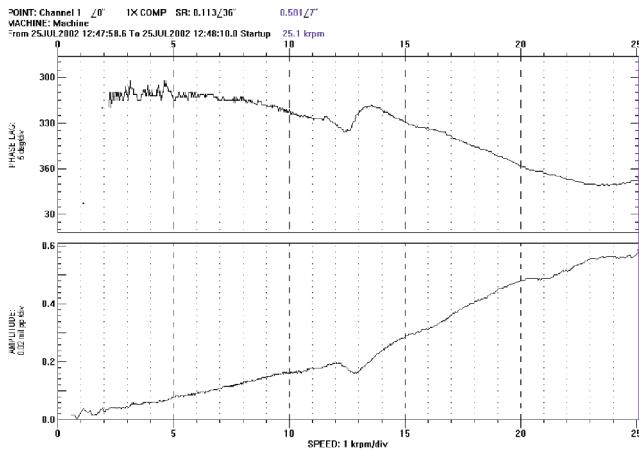
Figure 17. Bode Plot for Pump with Original Bearing.

Even though the vibration had been reduced substantially with the change from stainless steel to titanium hardware, synchronous vibration continued to be a problem. Vibration levels would begin to exceed 2 mils, which at 25,000 cpm was excessive. After approximately six months of operation this vibration would begin to damage the bearings and gears in the gearbox. Since the vibration was all synchronous, it was suspected that the increase in vibration was caused by the buildup on the rotor, described below.

To reduce the vibration of the output shaft, a modified tilting-pad bearing was selected. The axial width of the bearing was increased from 0.6 inch to 0.9 inch, while maintaining the same radial clearance and preload (Table 1 and Figure 15). This was an alternate bearing design, provided by the OEM. This reduces the bearing load and increases the effective damping provided by the bearing because it reduces the stiffness for approximately the same damping. This lowers the predicted critical speed slightly, but also reduces the amplification factor as well. The vibration at the probes is reduced (Figure 16), which compares the predicted maximum amplitude at the shaft probes with both the modified and original bearing. Bode and polar plots for the pump with the original and modified bearings are shown in Figures 17 to 20. As can be seen the synchronous amplitude has been reduced from 0.6 to 0.15 mils, which is very close to the predicted change shown in Figure 16.

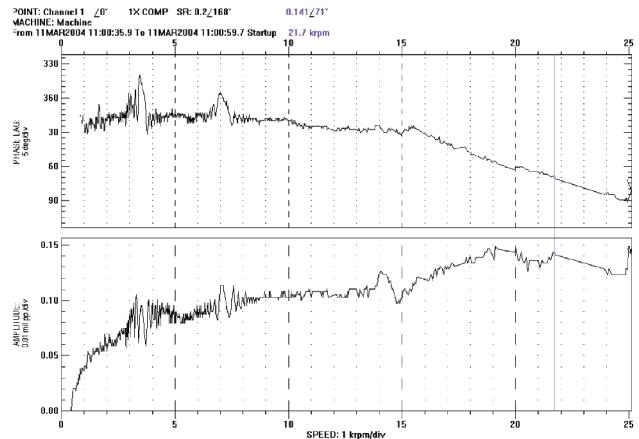
Figure 19. Bode Plot for Pump with Modified Bearing.

These modifications were made to the three pumps in May through August of 2002. Since the modifications, there has not been a pump failure. After the bearing modifications, the synchronous amplitude of the vibration dropped from 0.6 mils to approximately 0.15 mils. The total cost of these modifications to all three pumps was less than \$50,000. The increase in reliability of these pumps has eliminated the need for a \$500,000 pump replacement project that was planned to install new pumps to increase the unit reliability.
