SEAL RELIABILITY AND PERFORMANCE IMPROVEMENTS IN A LARGE, HIGH-PRESSURE, HIGH-TEMPERATURE BARREL PUMP

by
Ed Wilcox
Senior Staff Engineer
Conoco, Inc.
Westlake, Louisiana

Modifications to a high-pressure, high-temperature barrel pump to increase seal reliability and throughput are discussed. The pump is in unsparred hydrodewaxer (HDW) feed service. The original seal design included nonpressurized dual seals to provide an additional level of reliability. However, due to the heavy-oil/high-temperature nature of the service, the dual seals produced less than desirable run times. Substantial modifications to the dual seals were made to improve their reliability, but this also proved to be disappointing. Finally, the dual seals were replaced with single seals of a different design resulting in much more favorable results. The paper provides a detailed description of both seal modifications and their results. After approximately two years of service the capacity of the pump became the unit limit. The throughput of the pump was increased by approximately 25 percent without substantial capital outlays. This performance increase was accomplished by modifying the impeller diameter, the impe

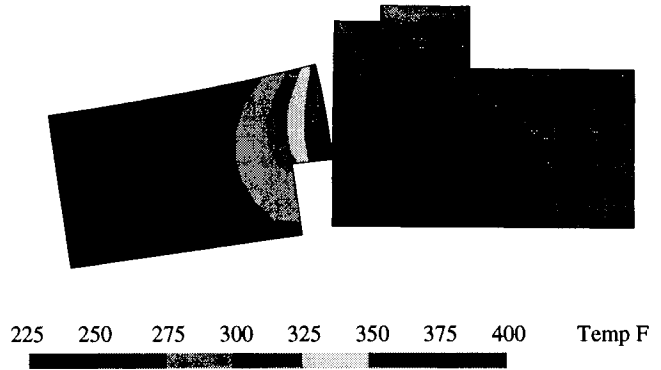
Figure 10. Predicted Temperature Profiles in Secondary Seal Faces Showing Convergent Profile.

It was thought that the waxy gas oil was eventually contaminating the seal oil pot to the point that the secondary seal was running dry, which resulted in the excessive face wear. Likewise, because of the high surface velocity and low fluid pressure on the secondary seal (1 psig), it was thought that the secondary seal was not being properly lubricated (i.e., the centrifugal effects on the oil were overcoming the hydrodynamic pumping action of the seal). This was confirmed by the evidence on the secondary seal carbon face that the seal was running hot and contacting on the inside diameter (Figures 8 and 9). A hydrodynamic/thermal model (Lebeck, 1991) of the seal faces confirmed that there was a large amount of thermal deflection of the rotating seal face. This produces a highly convergent face profile resulting in contact on the inside diameter of the seal faces (Figure 10).

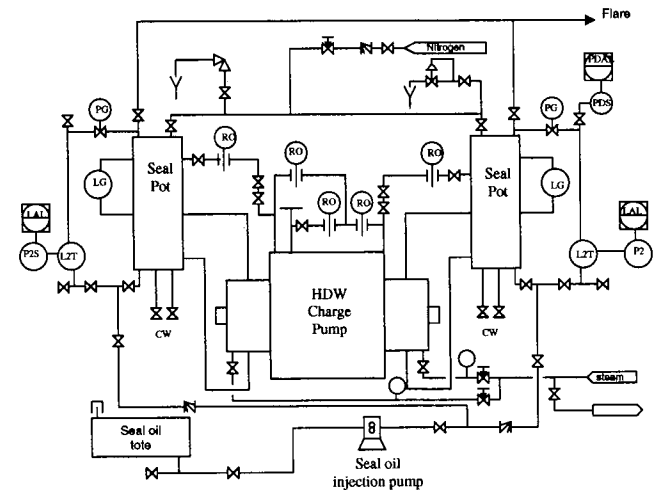
Figure 11. Schematic of Pressurized Seal Oil System.

By this time the seal oil system had become quite complicated (Figures 11 and 12). Each seal pot had a local level indicator that activated a common alarm in the control room if the level dropped too low. Likewise, there was a differential pressure switch that monitored the differential pressure between the seal pot and the pump stuffing-box. It was also tied into the common trouble alarm. A nitrogen pressure regulator was used to maintain the seal oil differential pressure. Also, a relief valve had to be added to the system to protect the seal pot from a blocked in liquid scenario.

The seal design was changed to a pressurized tandem. This would keep the waxy gas oil out of the seal pot and also provide

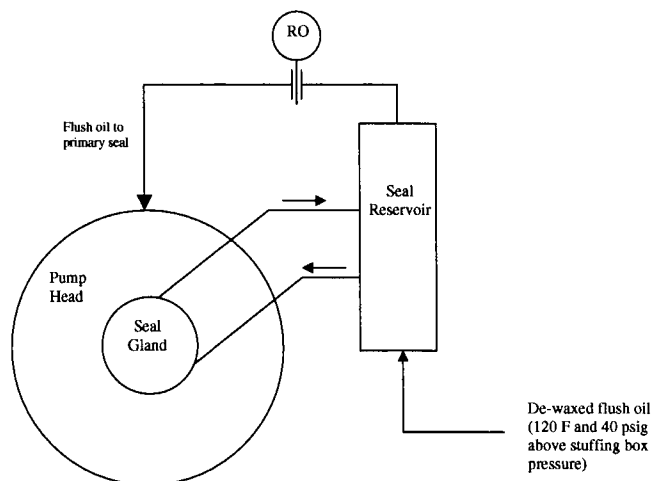
Figure 14. External Flush Used to Supply Seal Oil Pot (API Plan 32/53).

These modifications did not improve the seal oil leakage rates. After approximately one month, the leakage rate into the pump became unmanageable. Operations was having to add oil to the seal pots every hour. An alternate external flushing source was located and the seal oil pot was modified so that the external flush oil entered the bottom and exited the top before entering the pump stuffing-box through a restriction orifice (Figure 14). The seal pots were liquid full at all times; however, there was a continuous flow through the pots from bottom to top. This eliminated the need to fill the pot every hour and lowered the seal oil pot temperature to approximately 140°F. Likewise, nitrogen was no longer required to pressurize the pots.

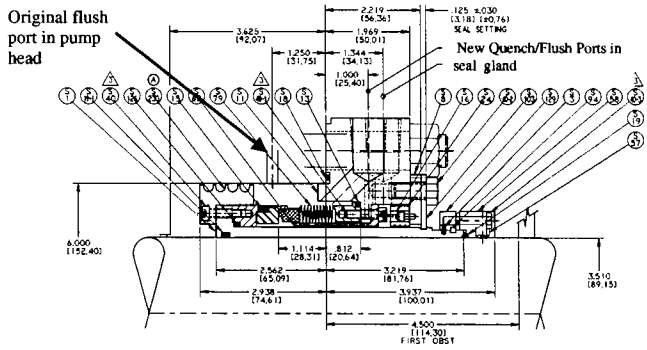
Figure 15. Single, Stationary Metal Bellows Seal.

Several different factors contributed to the dual seals lack of reliability:

- As mentioned above, an anti-coking device was not available on the secondary seal due to axial space limitations. A steam quench was applied through the quench port; however, this still did not provide enough steam to the seal faces to keep them free of waxy buildup.

- A rotating bellows was used because there was not enough axial space for two stationary bellows. Because of the large seal diameter, the surface velocity (70 fps) was close to the maximum for the seal (75 fps). This may have contributed to its instability.

A single, stationary metal bellows seal was selected to replace the dual seals (Figure 15). Because more axial space was available with a single seal, an anti-coking device could be incorporated in the design and a thicker bellows was used. Likewise, the seal flush that had been used to fill the seal pots was now used as an external flush on the seals, i.e., API Plan 32. The seal flush was routed through the seal gland instead of the gland tap to ensure adequate flow past the seal faces. Likewise, the Plan 11 flush from the

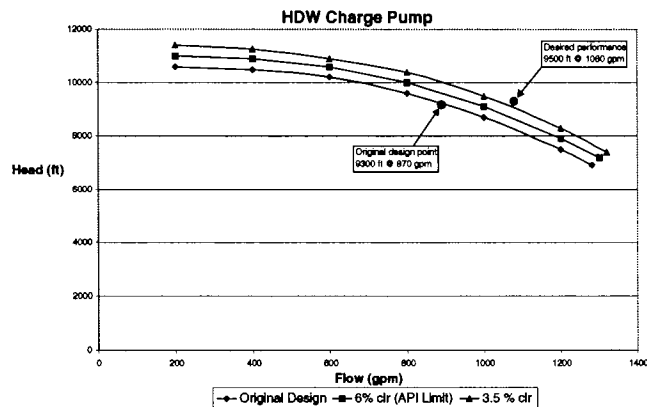
Figure 16. Original Performance, Performance with 6 Percent CLR, and 3.5 Percent CLR.

- **Increase impeller diameter**—The new process conditions required were 9500 ft at 1060 gpm. Increasing the impeller size to the maximum diameter allowed by API would only produce 8300 ft at 1060 gpm (Figure 16). The API maximum impeller diameter is set by the requirement that the minimum gap between the impeller vane and volute tip be 6 percent of the impeller diameter. Because this was substantially below the required conditions, it was decided to increase the impeller diameter to 14.00 inches, which gives a volute to vane tip clearance of 3.5 percent. However, this was still short of the desired performance (Figure 16).

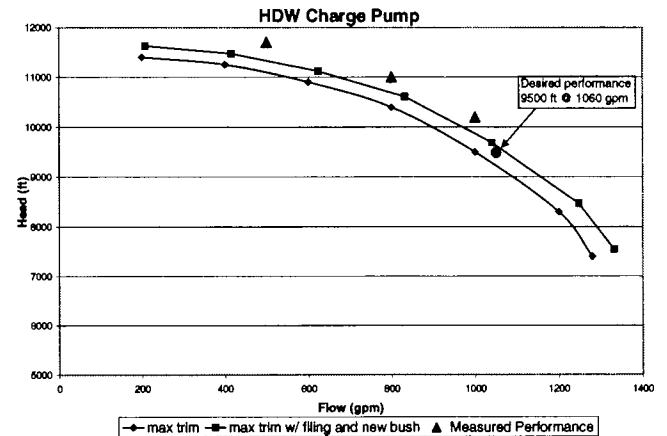
Figure 35. Predicted Performance Curve with Underfiling and Measured Performance.

The modified rotor and bushings were installed in the HDW charge pump in February of 1999. The performance was measured immediately after startup and was found to be above the predicted values (Figure 35). This was probably a result of improvements in efficiency caused by the reduced vane-to-volute clearance that was not taken into account. Since then, the performance has been checked several times and has shown no decrease. The overall vibration of the HDW charge pump has been less than 1.0 mil of shaft displacement since the modification. Figures 36 and 37 are shaft vibration spectra from before and after the modification.
