The Effect of Foundation Piers on the Natural Frequencies of a Vertically Mounted Sewage Pump in Resonance with Vane Pass Excitations

27th International Pump Users Symposium
George R. Brown Convention Center
Houston, TX
September 12 - 15, 2011

Paul A. Boyadjis

Mechanical Solutions, Inc.

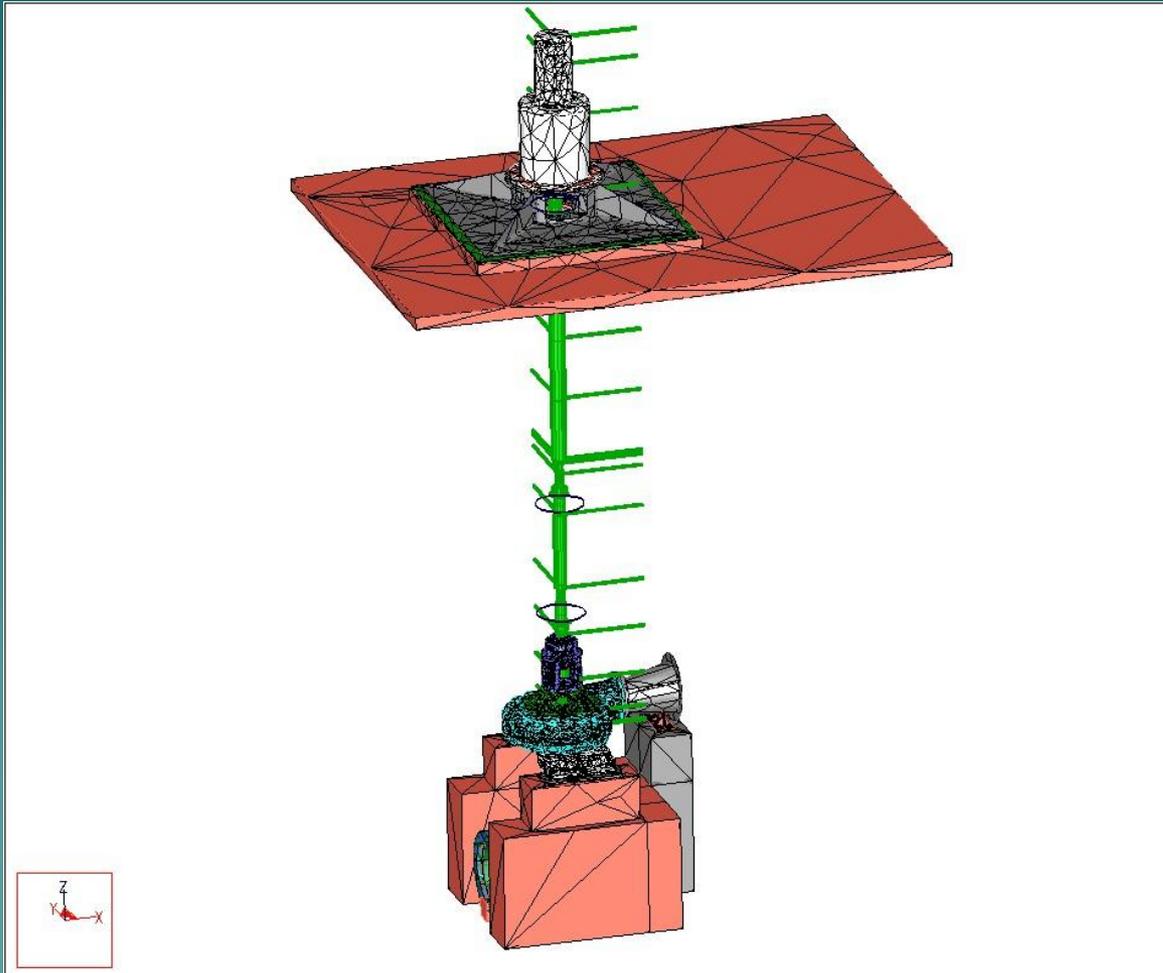
Figure 2

- ◆ Modifications to the model were made prior to the pump's installation which consisted of supports for the suction and discharge nozzles as well as joining the two vertical piers on the discharge side to form a horseshoe support. These modifications were predicted to raise the offending casing rocking mode natural frequencies to 20% above 4x running speed (vane pass) to ~ 48 Hz.

Original Modified FEA Results

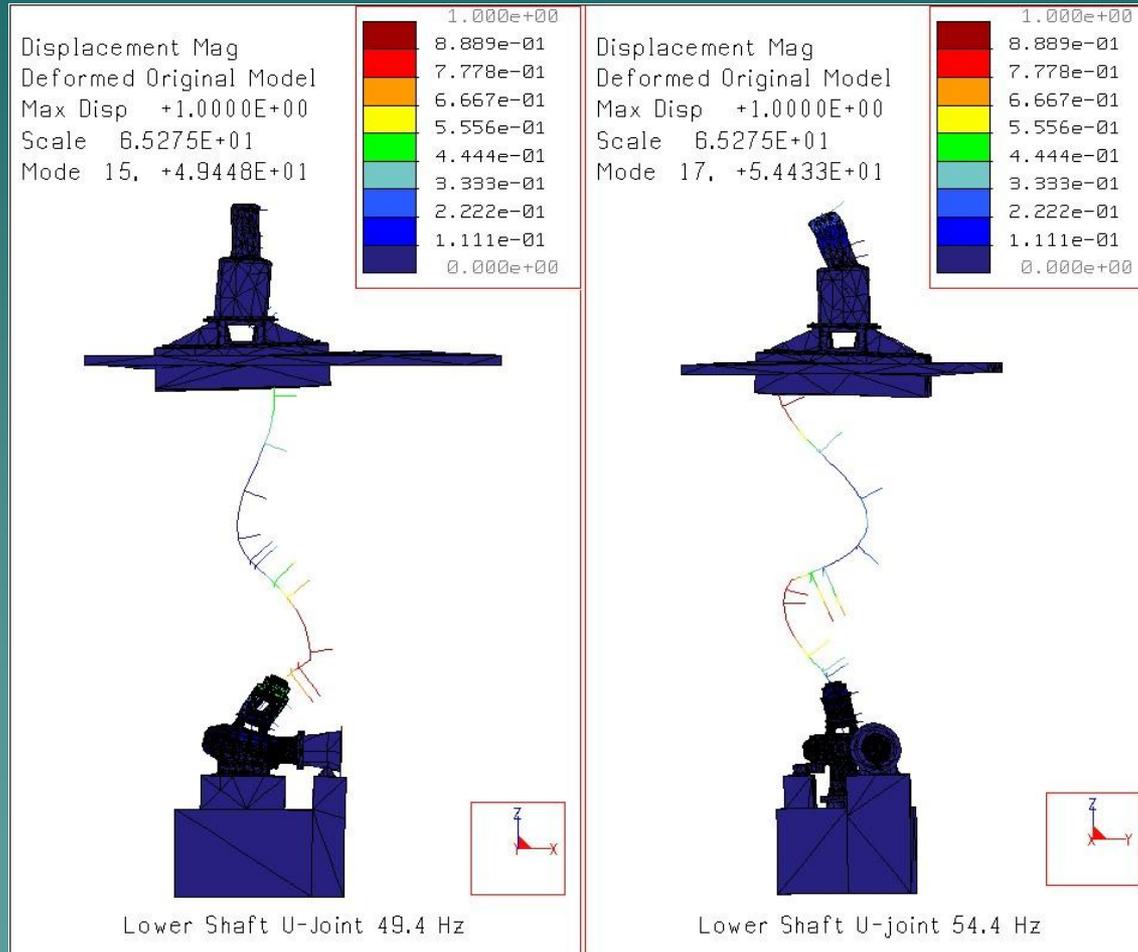
Figure 3

Original Modified FEA Results

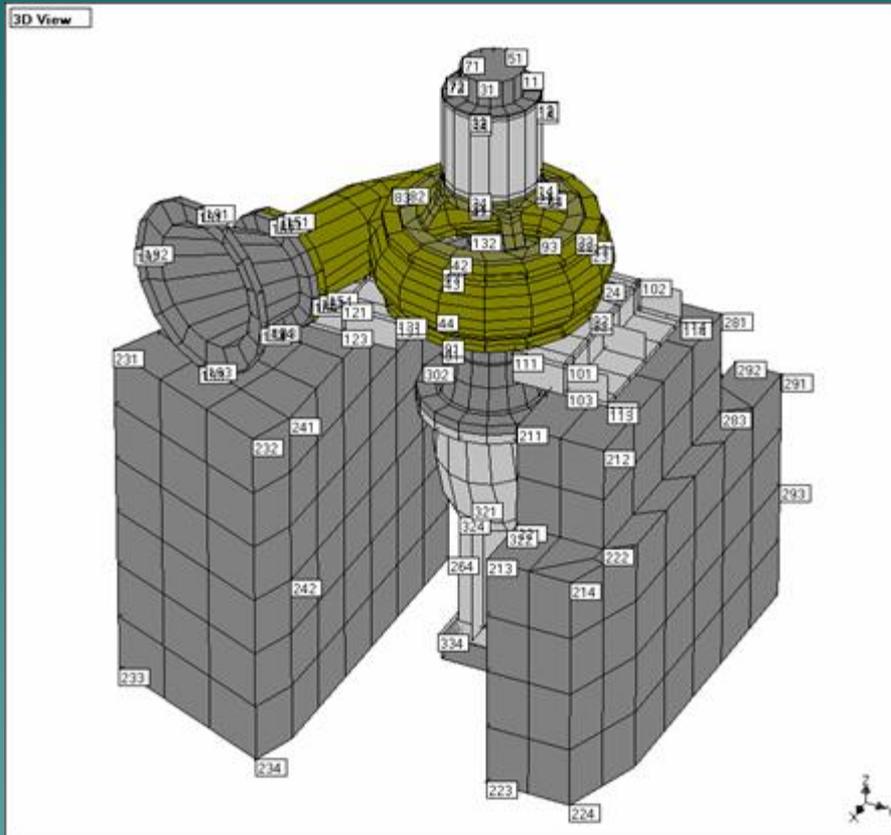
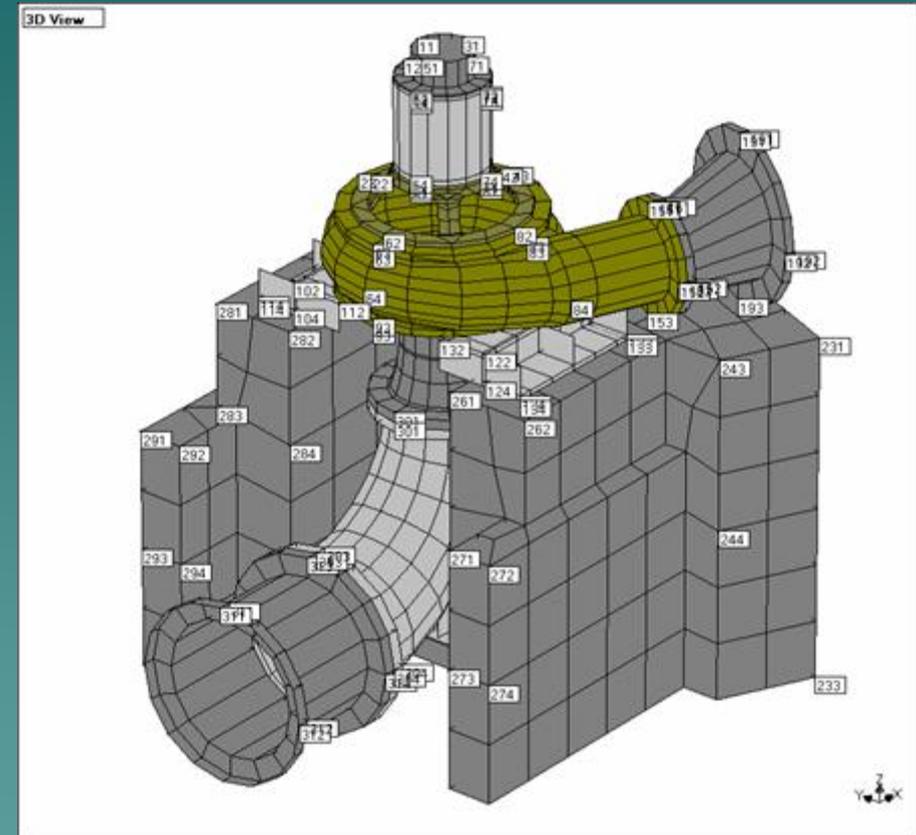
Figure 4

Field Testing Measurement Points

Over 500 vibration measurement/ direction using tri-axial accelerometers

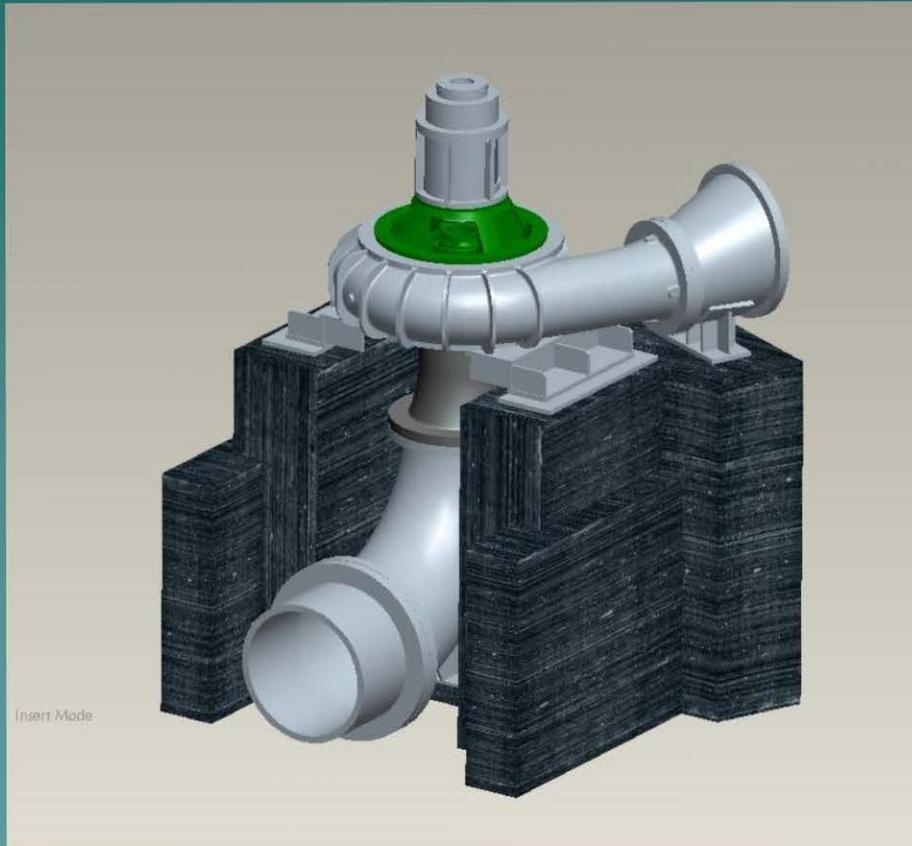
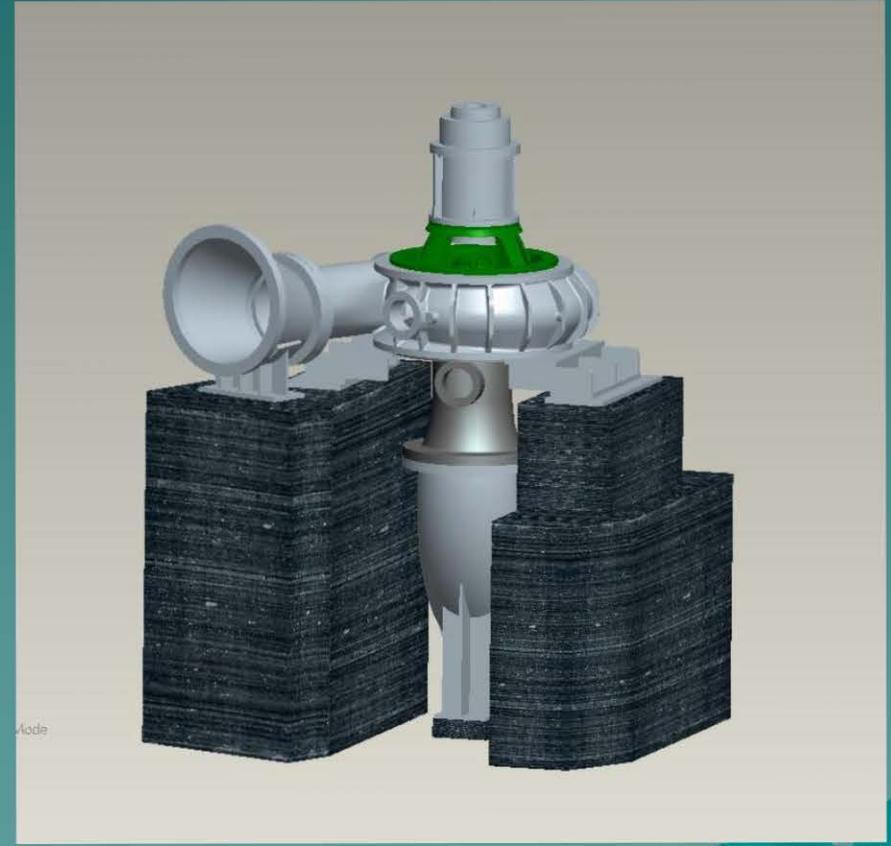
Figure 10

- ◆ It was suspected that in addition to the obvious differences between what was analyzed and reality, there may have been soft foot conditions present.
- ◆ Thus, the previous finite element analysis needed to be updated to reflect the current pier configuration and casing orientation to establish a new baseline from which modifications could be evaluated.

Solid Model of Existing Pump

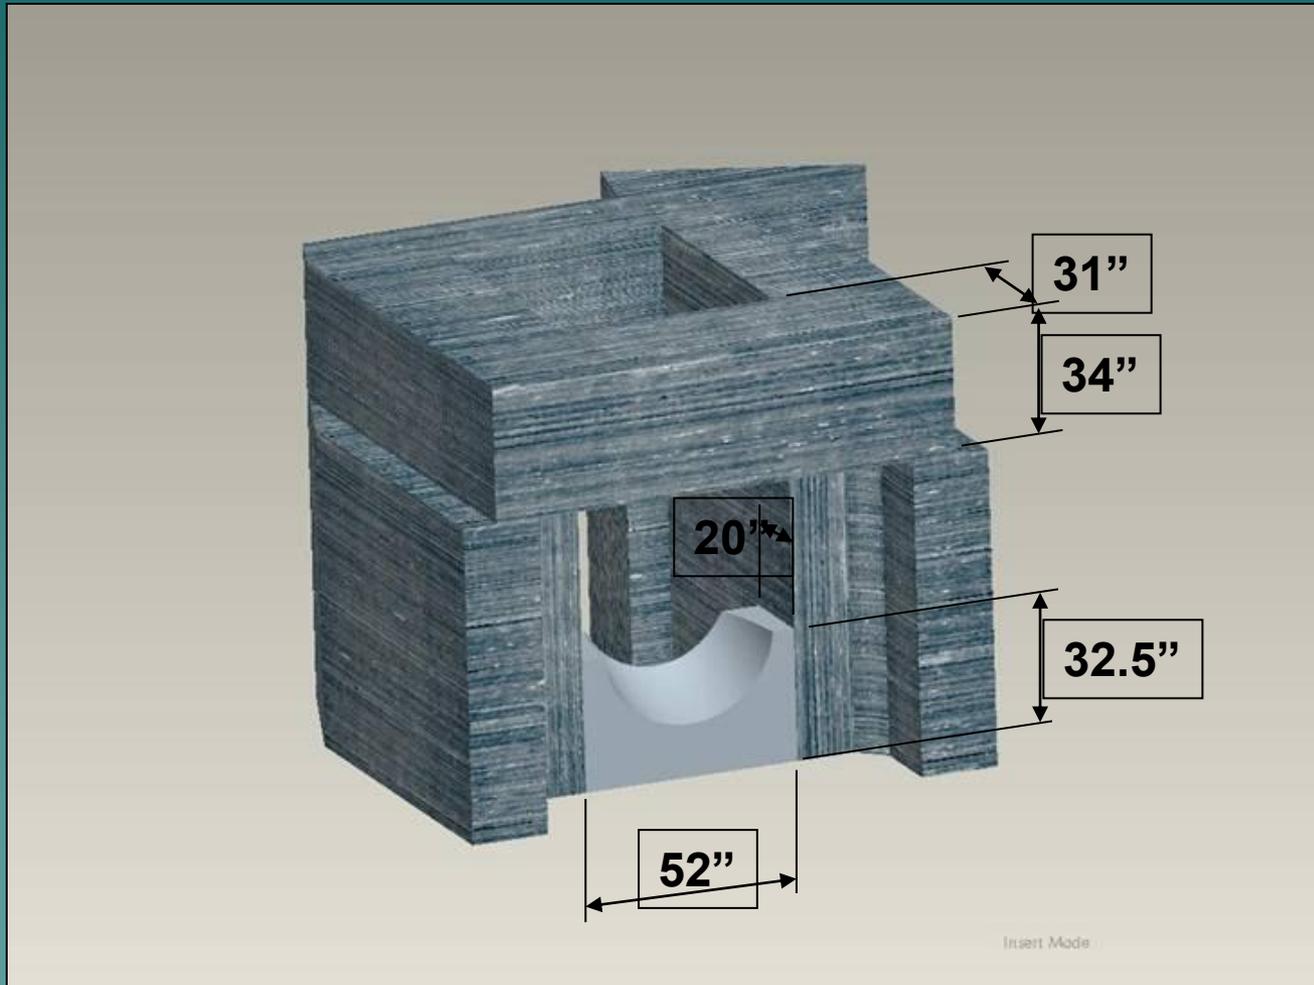
Figure 13

Modification to Pump Support

- ◆ It is obvious that communications between the analyst, pump OEM, and contractor need to be more transparent in order to avoid such problems.
- ◆ The concrete piers were tied together and the suction nozzle supported as analyzed and two additional brackets were employed.
- ◆ The bolting torques were increased and washers added to the pump mounting bolts to spread out contact surfaces to minimize soft foot conditions.
- ◆ The discharge nozzle support bracket was inspected and found to be loose and it was re-grouted and bolts torqued to higher levels

- ◆ After the recommended fixes were implemented, the vibration levels decreased from 0.6 in/s RMS to less than 0.2 in/s RMS at the bearing tower.
- ◆ Follow up field test by others showed that the frequencies that were at 38 Hz had shifted to 46Hz and 52.5Hz, close to analysis predictions.
