A CASE STUDY: UNUSUAL PROBLEMS DISCOVERED DURING THE RERATE OF 2800 HP BOILER FEEDWATER PUMPS AND TURBINES

John P. Henderson

Novacor Chemicals (Canada) Ltd.

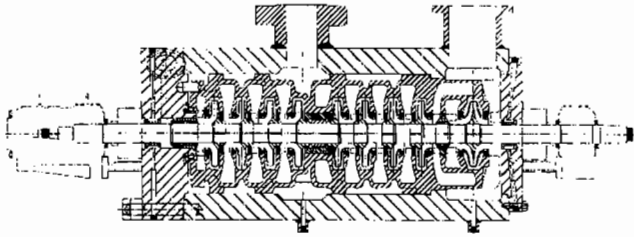
Figure 1. Pump Cross Section.

- *Pumps*—The pumps are 6×8×10 horizontal nine stage API 610 barrel style pumps with opposed impellers and an internal crossover for thrust balance (See Figure 1). The complete inner assembly consisting of the rotating element and the inner volute case were replaced. The outer barrel, bearings and seals remained the same. These are the highest capacity internals that could be fitted into the existing barrel.

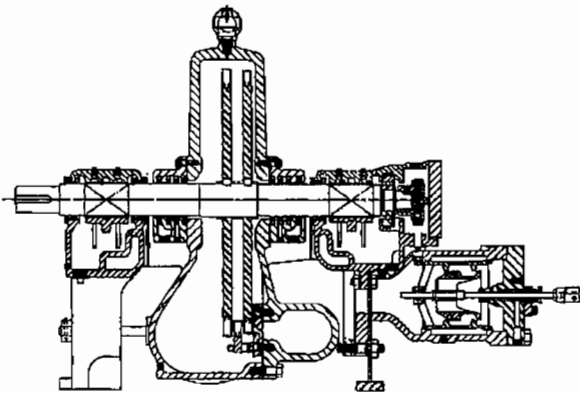
Figure 2. Turbine Cross Section.

- **Turbines**—The Turbines were API 611 single stage impulse type design that utilized 500 lb inlet and 50 lb exhaust steam (Figure 2). The power rating was increased from 2100 hp to 2800 hp. This required a new nozzle ring and governor valve. In addition, an electronic governor conversion, installation of new technology dry gas steam seals and a general overhaul was performed. This change was approaching the largest power rating of the design.
