**43rd Turbomachinery
30th Pump SYMPOSIA**

MORTON-LIKE EFFECT IN A CENTRIFUGAL PUMP

Maki Onari
Mechanical Solutions, Inc.
Whippany, NJ

Morton-Like Effect in a Centrifugal Pump

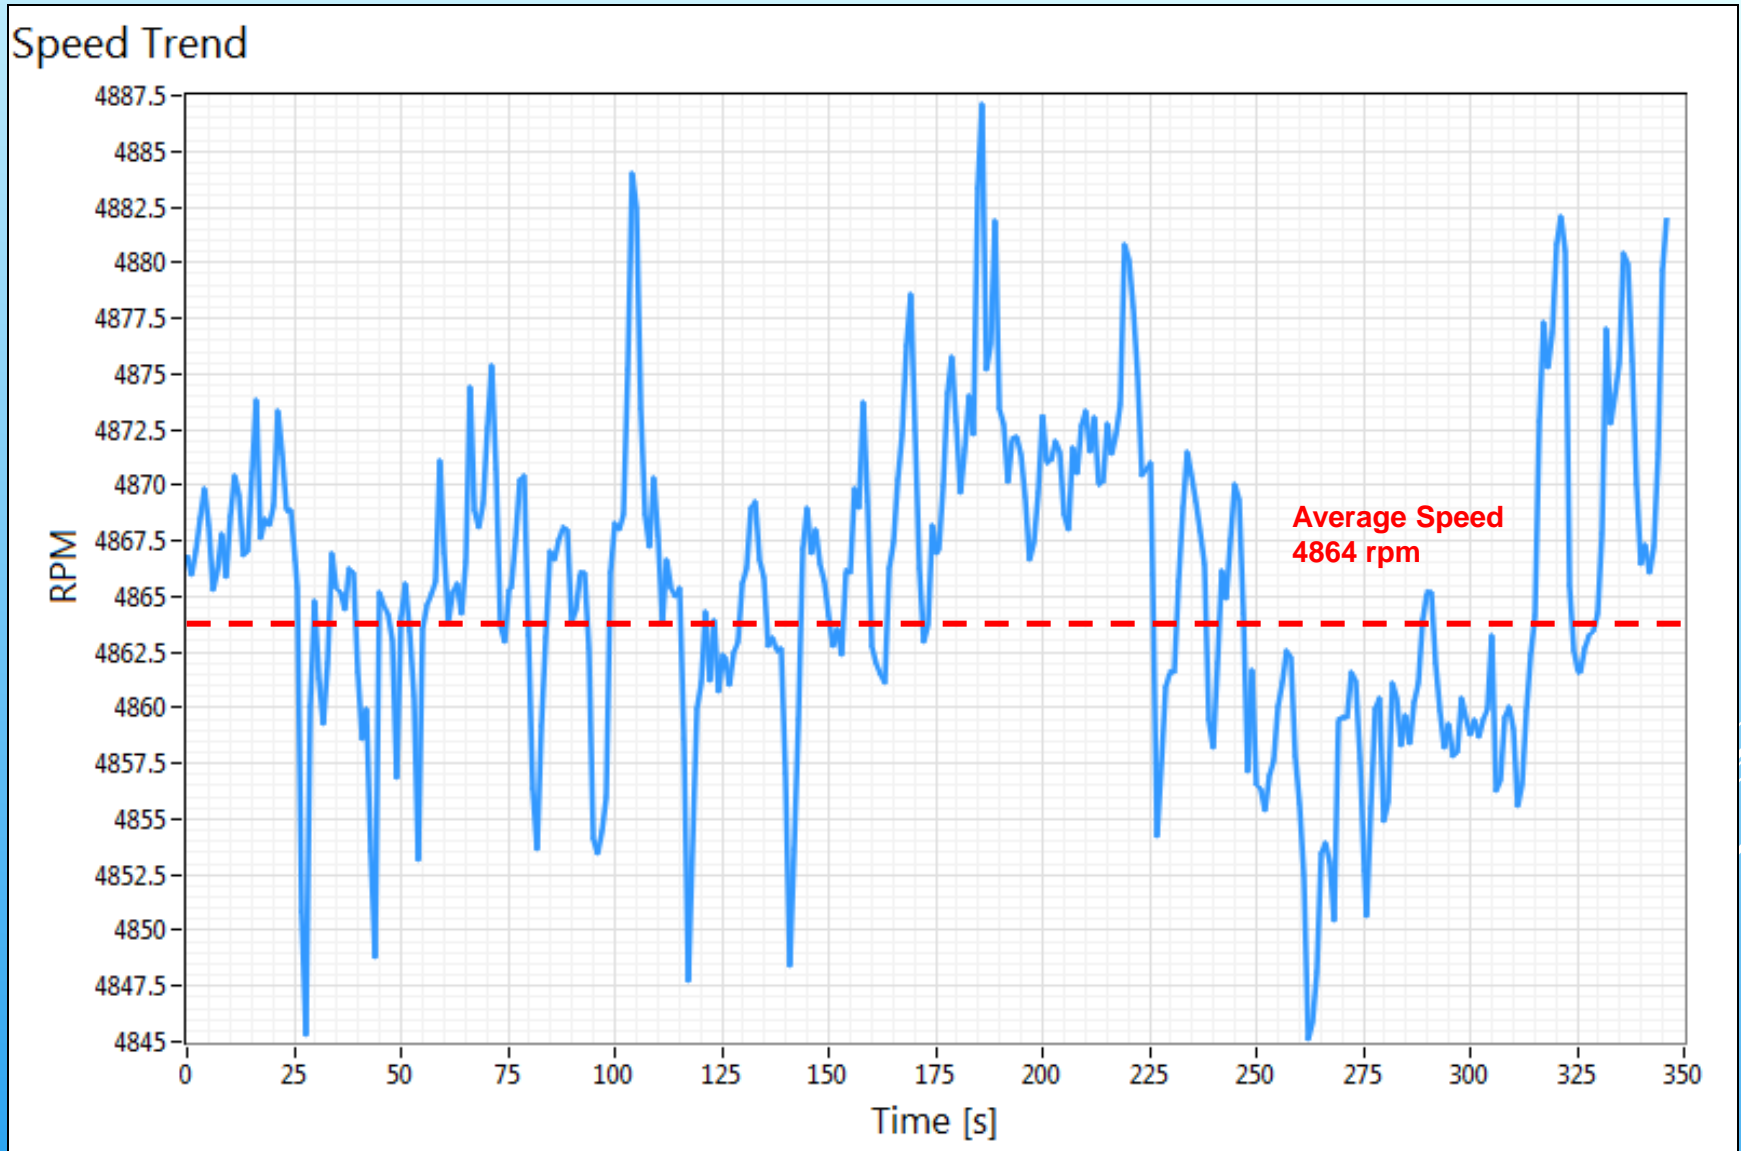
Vibration Testing – Speed Trend

- The vibration amplitude was not constant. The overall amplitude was fluctuating with a period between 10 to 60 seconds.
