PERFORMANCE LOSS INVESTIGATION USING THERMAL IMAGING

LEAD FIELD ENGINEER – SULZER PUMPS (US) INC

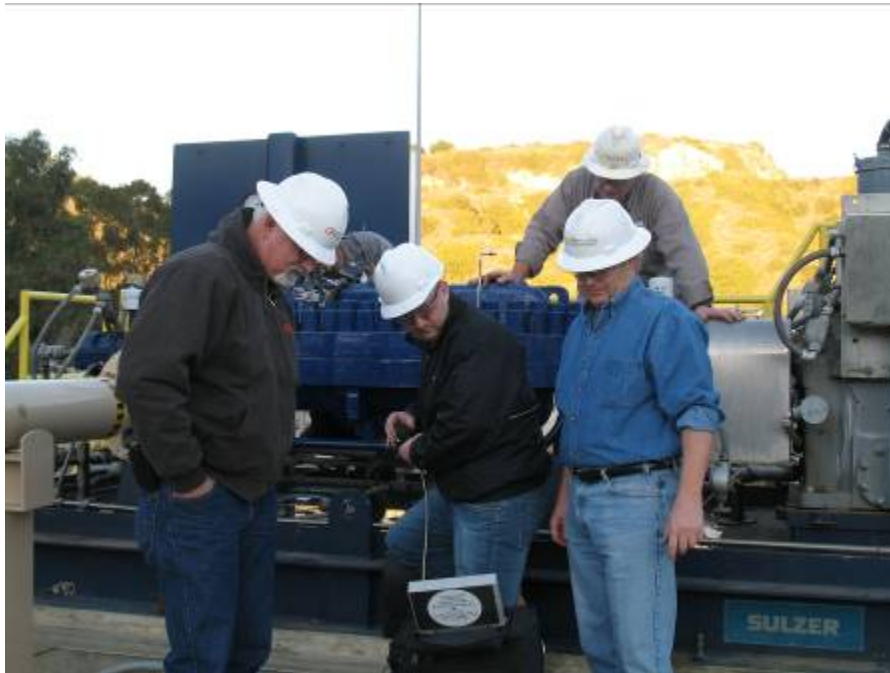
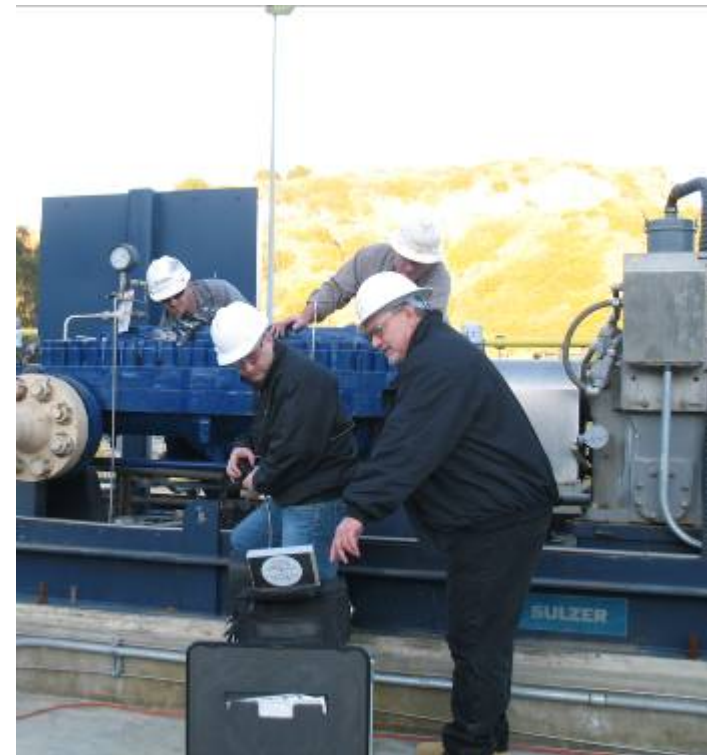
BORESCOPE INSPECTION

- Borescope with articulating head was utilized to perform internal pump inspection in the field.
- Camera fed through drain point on bottom half long crossover

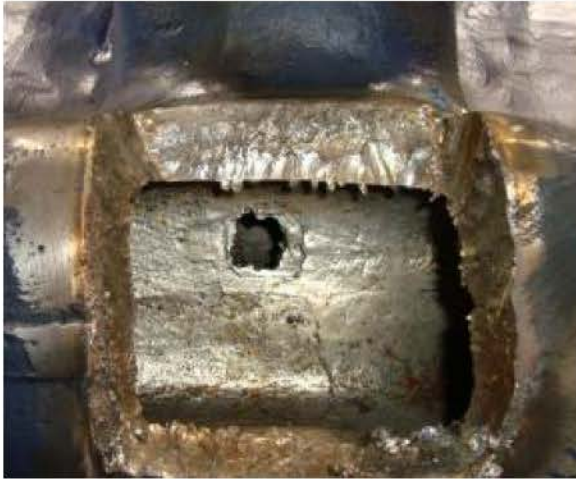
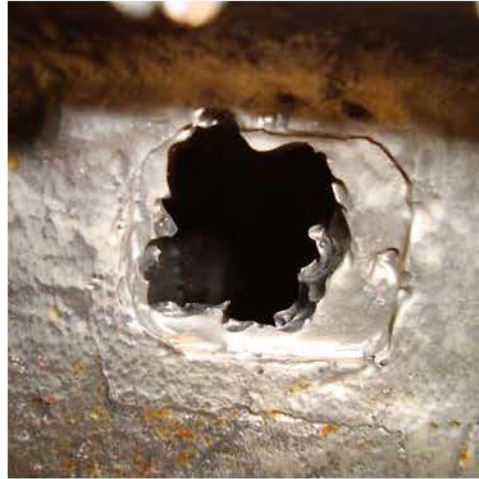
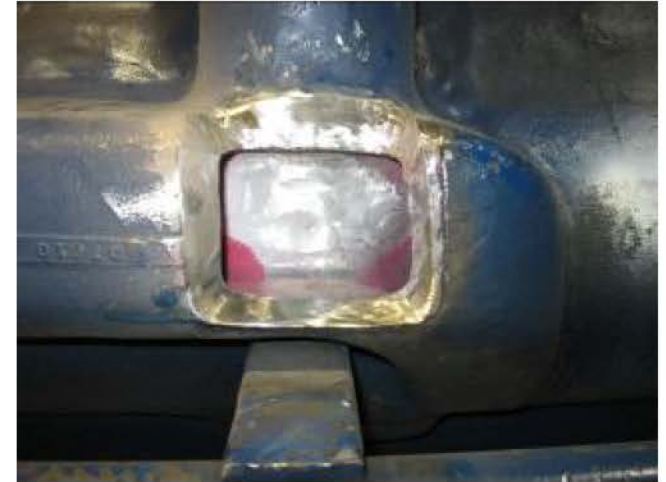
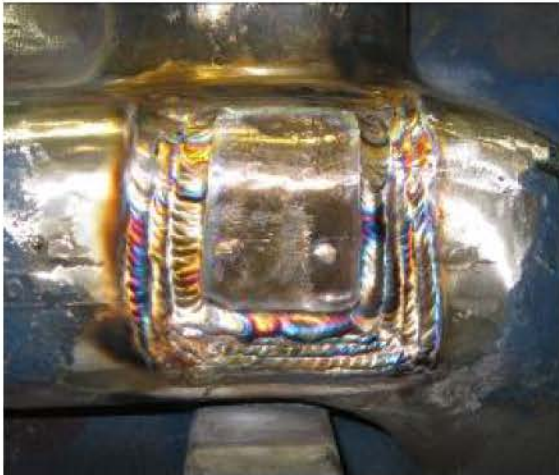
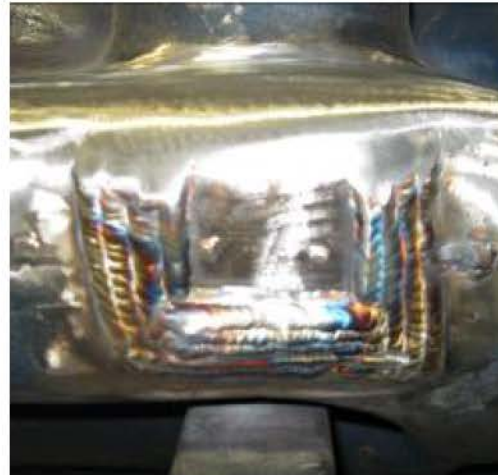
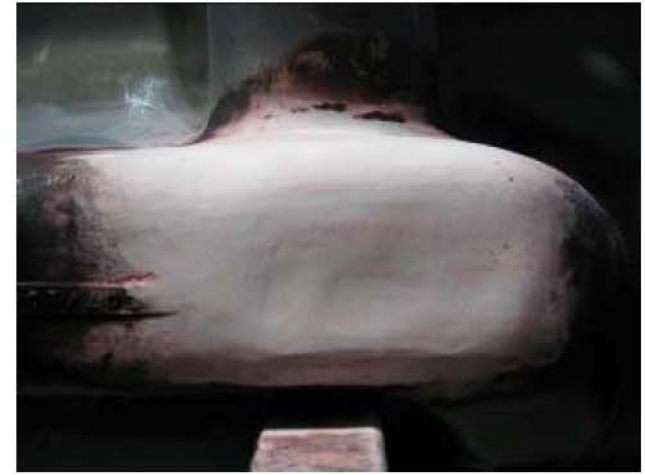
REPAIR PROCESS

- CHAPLETS (SHOWN BELOW) ARE USED TO POSITION SAND CORE BOXES DURING THE CASE CASTING PROCESS.
- THE CHAPLETS SHOULD BE MADE OF THE SAME MATERIAL AS THE CASTING AND IS INTENDED TO FUSE INTO THE CASTING AND BECOME A PART OF THE FINISHED COMPONENT
- IN THIS CASE IT APPEARS THAT THE CHAPLET MAY HAVE NOT FUSED, OR POSSIBLY BEEN MADE OF THE WRONG MATERIAL
- NOTICE THE SQUARE RECESS AROUND THE HOLE FOUND IN THE CROSS OVER
