JUSTIFYING THE REINSTALLATION AND UPGRADING OF PROBLEM ANSI PUMPS AT AN OPERATING CHEMICAL PLANT

by
Joseph F. Dolniak
Maintenance Engineer
Reilly Industries
Indianapolis, Indiana

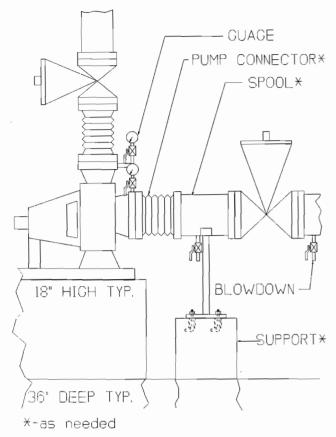
Figure A-3. Typical Piping Arrangement to Pump.

- 6.4 Gauges
- 6.4.1 All pumps must have gauges installed on the suction piping and discharge piping (Figure A-3).
- 6.4.2 Gauges should be installed such that they are in the vertical position and that they face the most accessible operation point. (i.e. start/stop switch) All gauges should be installed with valves positioned such that they can be replaced. See Figure A-3. Gauges should have a working range of no more than twice the expected pressure.

- 7.0 Attachments
- 7.1 Figure A-1. Typical Pump Hold Down Bolts.
- 7.2 Figure A-2. Pump Row Pad Spacing.
- 7.3 Figure 3. Typical Piping Arrangement at Pump.
